SPC/Fisheries 13/WP.4

SOUTH PACIFIC COMMISSION

WORKSHOP ON FISH AGGREGATION DEVICES

Fisheries Newsletter No.22, pp.1-5
July 1981

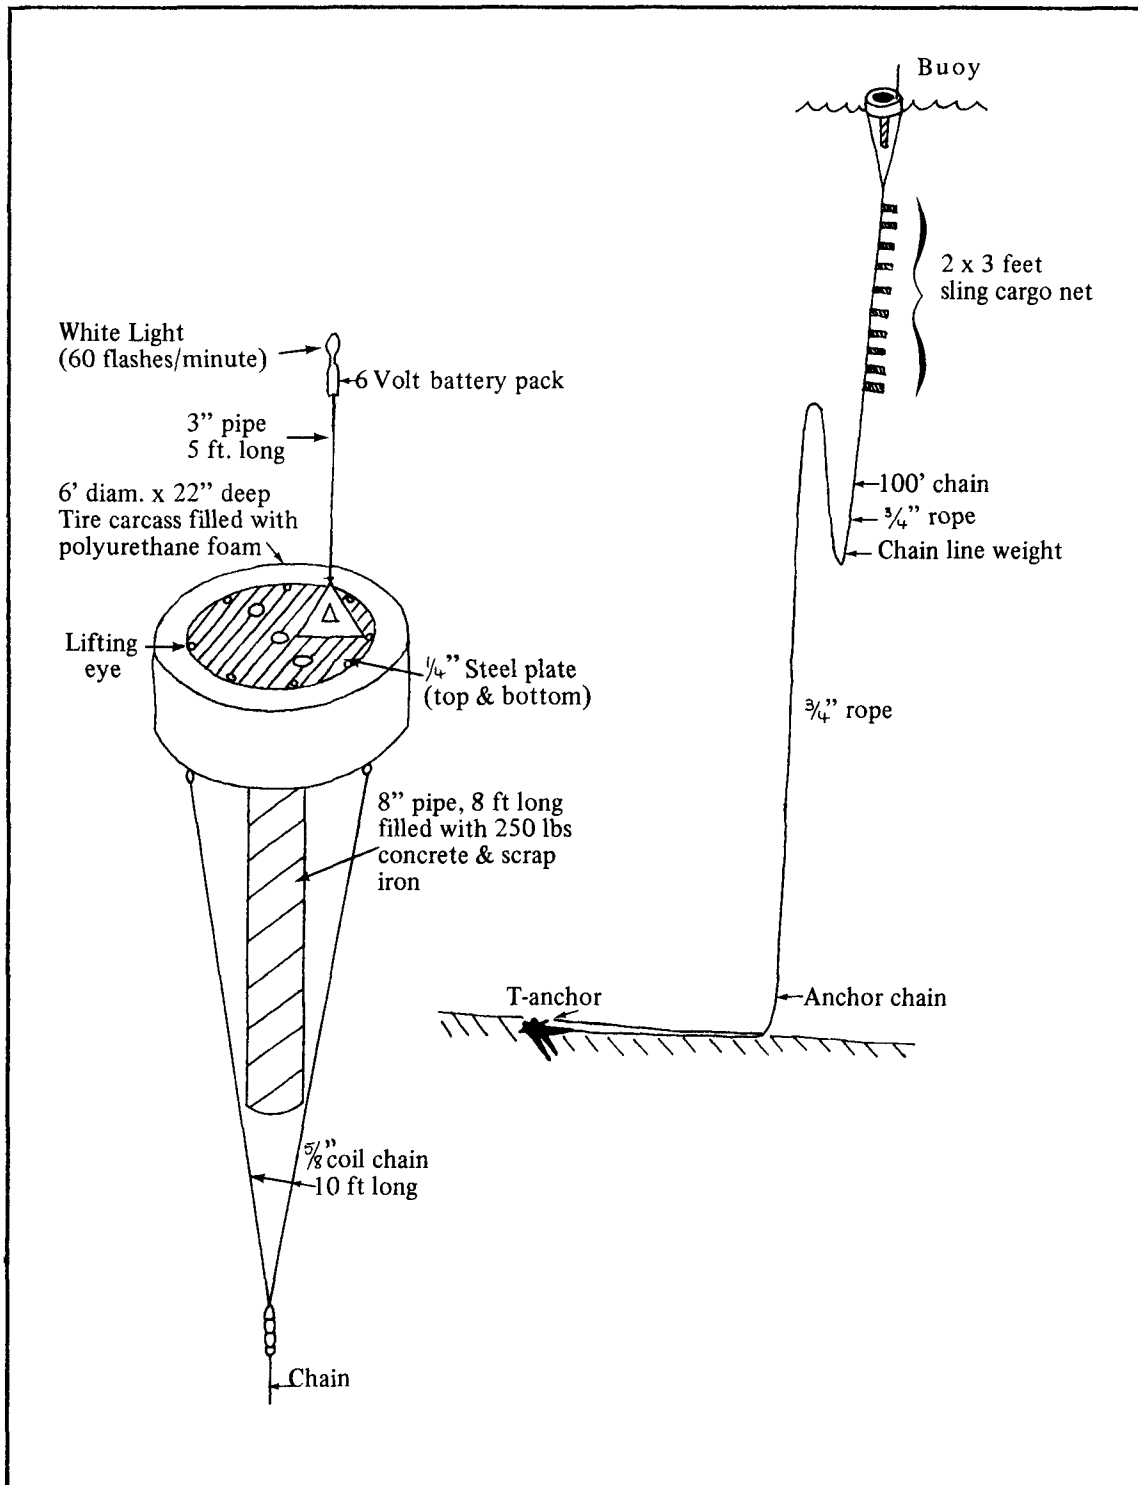
Figure 1: Hawaii Fish and Game FAD.

The workshop report gives detailed information about the various designs of F.A.D. presently used by each of the organisations represented at the workshop. All consist of a buoy with a mooring line consisting of lengths of chain and polypropylene rope arranged in various configurations, but usually consisting of a length of chain at the top, followed by a length of polypropylene rope and with a second length of chain at the bottom attached to the anchor. A weight is usually attached at the middle of the rope section to prevent the rope from floating to the surface. Typical of the designs presently in use is that employed by the Hawaii Department of Fish and Game (Fig. 1).

A total of 33 F.A.D.'s deployed by the represented organisations had been lost by October 1980. Of these losses, 17 definite and 4 probable causes of mooring line failure could be identified (Table 1). 12 causes of failure could not be determined since the buoys were not recovered. Reasons for failure included errors in design and construction as well as incorrect placement.

- (1) **shackle failure** - usually occurred as a result of the pin working itself loose. This can be delayed to some extent by securing the pin with galvanised wire, but there is always the possibility that the wire used could be too small and corrode within a short time or that some of the shackles could be overlooked and not secured at all.

- (2) **poor splicing** - particularly single, short splices, or loose splices are more likely to fail. This is especially so when using slippery synthetic ropes made of such materials as polypropylene and nylon.

- (3) **cable grip failure** - this was probably due to insufficient or uneven tightening of the two bolts. The buoys, in this case, were not in position long enough for corrosion to set in, but the small bolts on the grip could corrode in due time.

- (4) **nico-press sleeve failure** - this resulted from electrolysis caused by using copper sleeves on galvanised steel wire rope.
- (5) **rope twist** - the absence of a swivel between the top chain section and the rope section resulted in a break in the rope adjacent to the splice. The twist was imparted either by buoy rotation or rotation of the rope or both.

- (6) **rope cut by boat's propeller** - resulted from failure to attach sufficient weight to the rope. This allowed the excess line to float to the surface, where it was run over by a boat.

- (7) **rope chafing** - was largely due to misplacement of the buoys. The buoys were placed too close to bottom ledges or anchored in depths much shallower than intended. In the latter case, chafing is believed to have occurred when the intermediate weight reached the bottom. Rope chafing may also occur when the currents are strong enough to drag the anchor. One buoy was dragged into water shallower than the intermediate weight and was eventually lost.

Most of the failures listed above can be prevented if mooring lines are carefully designed and constructed. Failures stemming from the use of cable grips and copper sleeves and steel wire rope need not reoccur if these items are not used in construction. Incidences of rope being severed by propellers also need not occur if all are aware of the buoyancy of polypropylene rope and adjust it with an intermediate weight. Setting the buoys too shallow, resulting in rope chafing, and setting them too deep, resulting in complete submergence, need not occur if the buoys are set with the aid of proper navigational and depth sounding equipment.

Other failures involving shackles, rope splices and rope twists are more serious since they can occur in future moorings. These require extreme care in construction. Shackle failure can be reduced if the pins are secured and coated with epoxy or fibreglass resin. The epoxy and resin will inhibit corrosion and also freeze the pin and prevent it from working itself loose. An alternative would be to replace all shackles with oversized split chain links. These should also be coated with epoxy or resin.

Because of the numerous rope splices required to construct a deep mooring line, it is imperative that the splices are securely made. This is especially critical with synthetic rope since this type of rope is prone to slip. For added security, the rope ends should be double-spliced with each splice made at least 15 to 18 inches long and seized with twine at two or three places.

Line breaks due to twisting can be avoided by the addition of a sufficient number of swivels at critical places. These are at the ends of the top and bottom chain sections and at the lower end of the intermediate weight. Additional swivels may be added to the top of the intermediate weight and midway on the rope below the intermediate weight.
