# **COASTAL PROCESSES AND THE ROTUMA WHARF FIJI**

Brendan J. Holden  
SOPAC Technical Secretariat

*July 1992*

*SOPAC Technical Report 146*

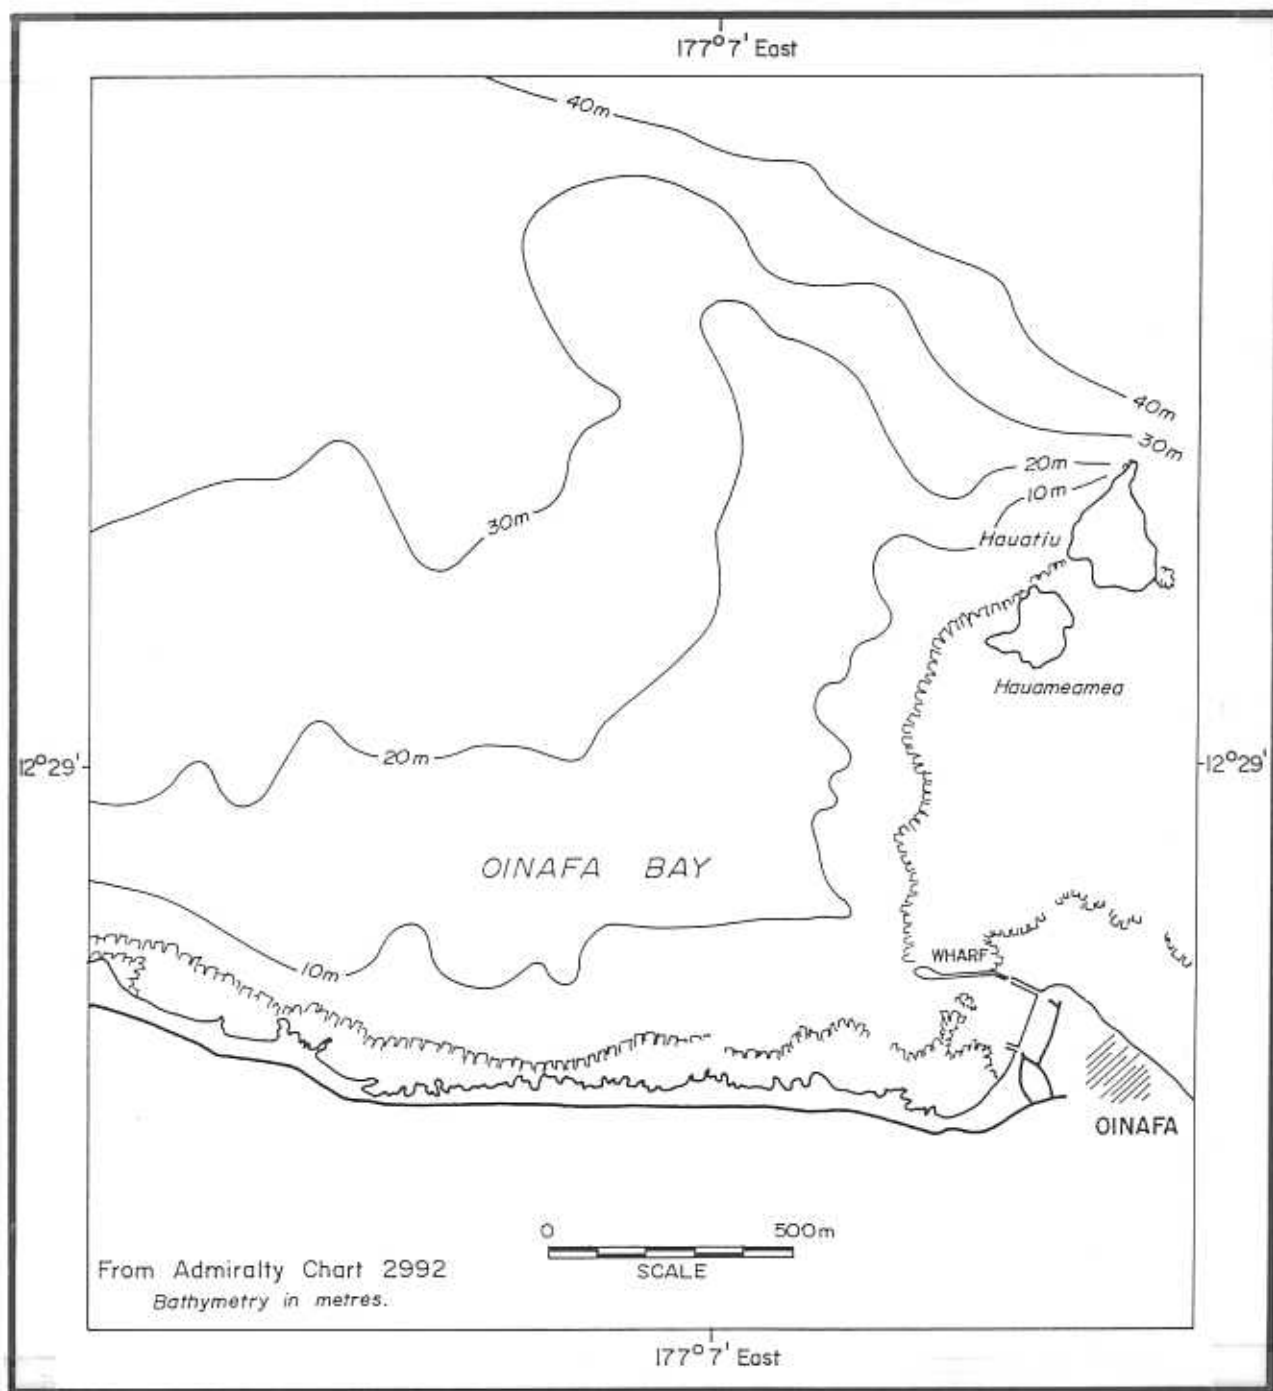
There are only two sites in Rotuma with a reef gap near shore suitable for ships to anchor: Oinafa Bay and Hopmafau Bay. In the 1970's a wharf and access causeway were constructed at Oinafa (Figure 2). The causeway was built west from the sand spit at Oinafa and has a small bridge part way along its length. The wharf basin has now shoaled such that the supply ship has difficulty mooring at the wharf.

Figure 2. Oinafa Wharf.

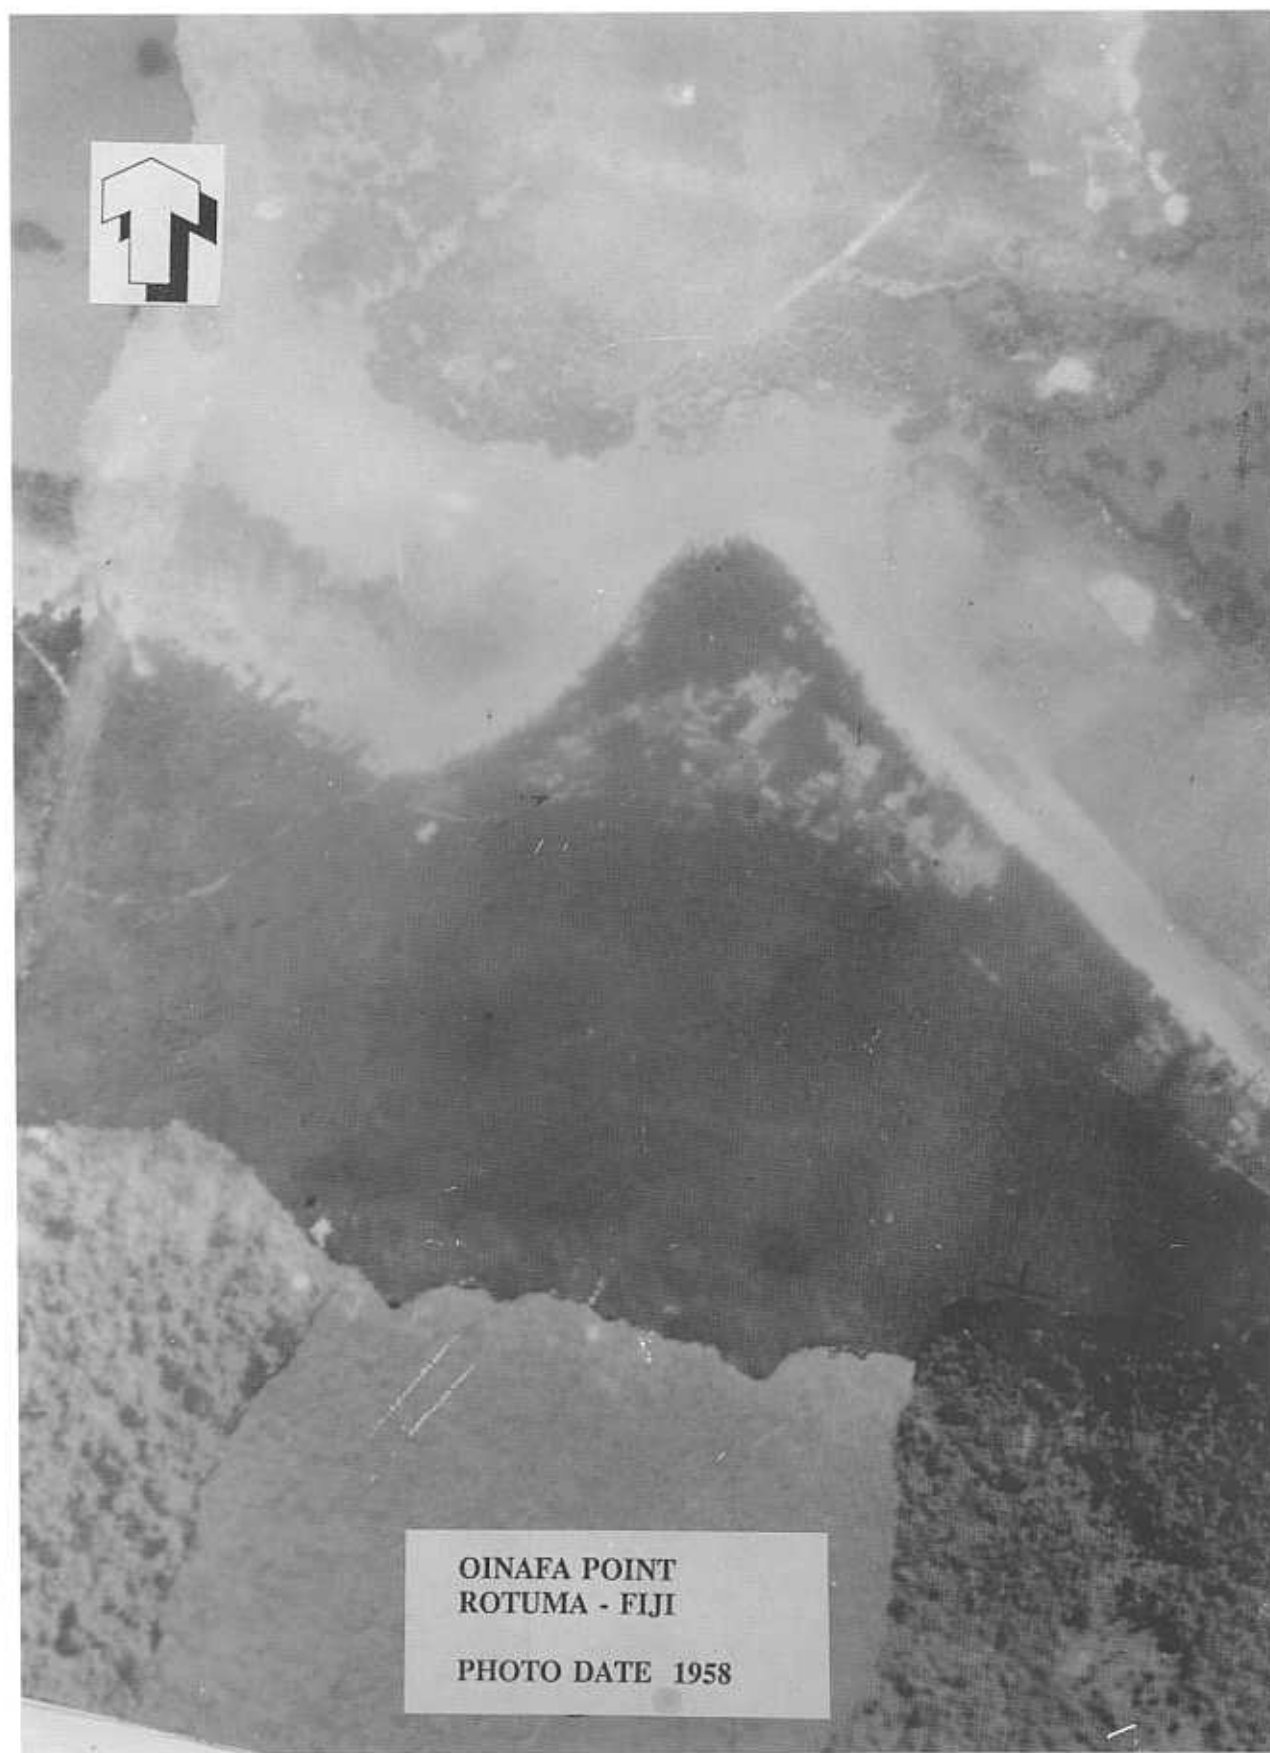
The 1958 photo (Figure 4) shows Oinafa Point as a symmetrical, rounded spit on the reef flat opposite Hauameamea and Hautiu Islands. The symmetrical rounded (rather than pointed) tip of the spit indicates that waves are refracting around the tip of the spit and impacting the shore from both east and west. The post-construction photos (Figures 5, 6) show a gradual shifting of

Figure 4. Oinafa 1958 air photo.

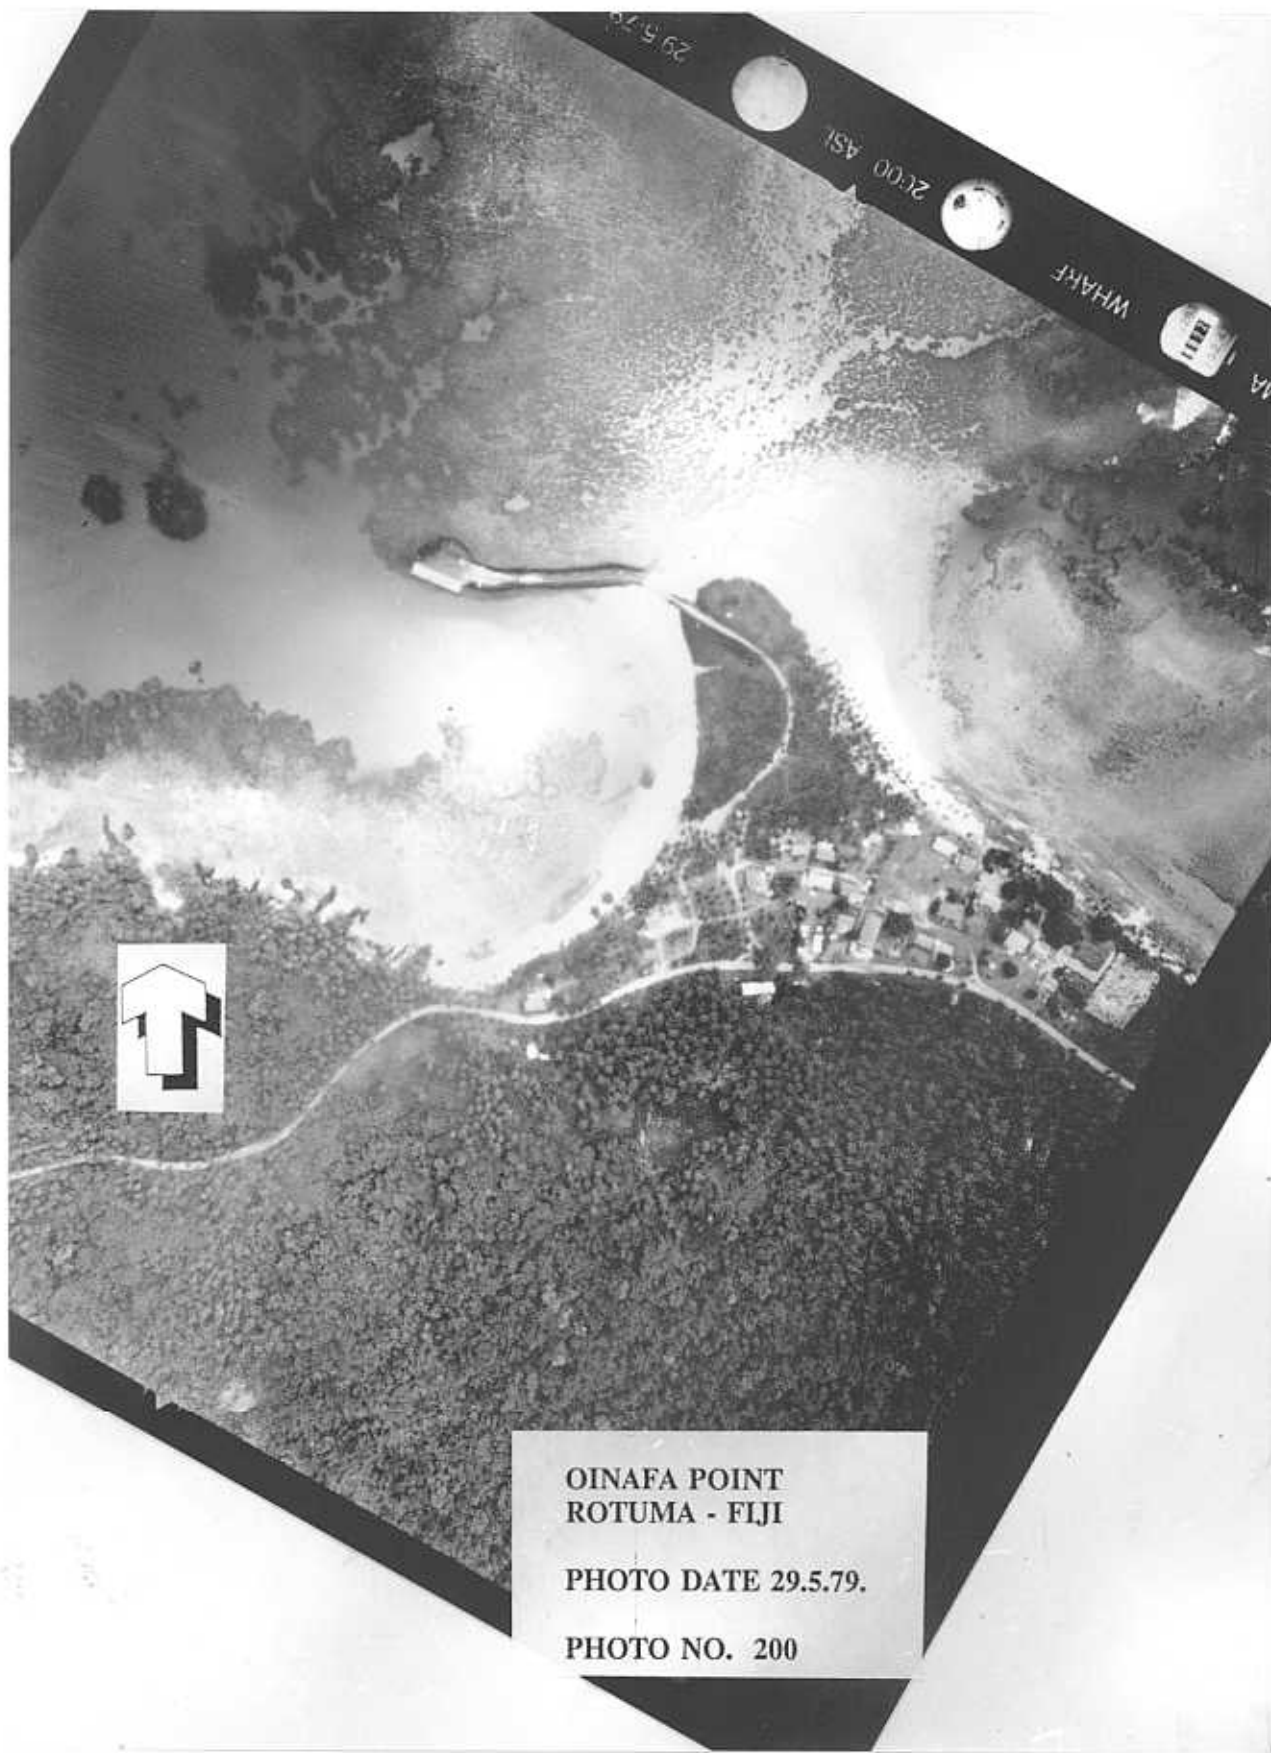
Figure 5. Oinafa 1979 air photo.

the spit so that it has become skewed westward toward the wharf. The beach on the west side of the spit has accreted since the wharf construction. A current airphoto and a detailed and accurate comparison of all these photos would be required to determine the exact changes to the shoreline.

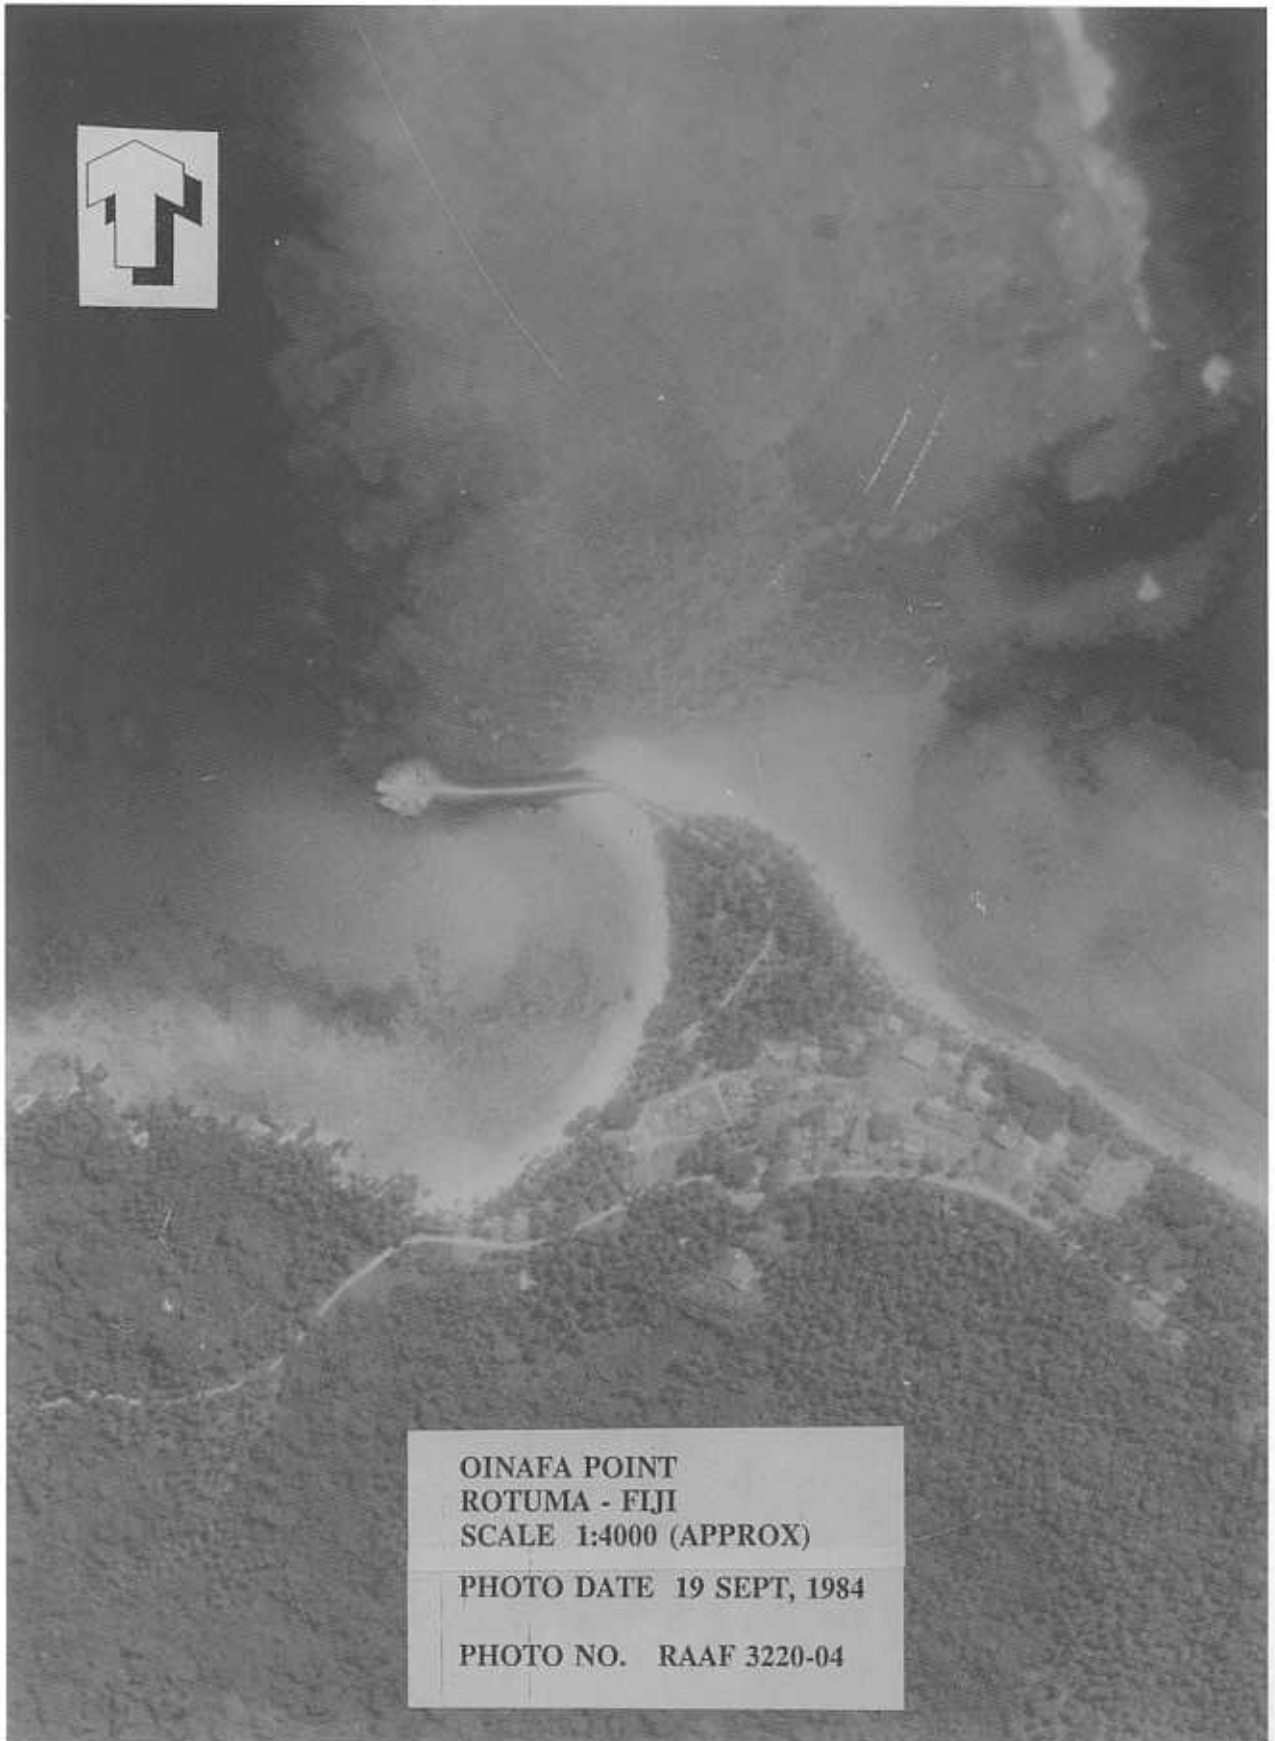
Figure 6. Oinafa 1984 air photo.

beach inside the wharf basin. The westerly waves could not push the sand back around Oinafa Point because of the causeway between the bridge and the original shoreline. If a longer open pile bridge had been built instead of this causeway, the sand would be able to move back around the point. Thus the beach has accreted out to the bridge on the west side and there is erosion on the east side of Oinafa Point. The excess sand has also filled in the wharf basin. Essentially the shoreline section of the causeway and short bridge have caused the wharf basin to become a sand trap and Oinafa Point to be skewed westward with an area of erosion on the east side and accretion on the west side (Figure 6).

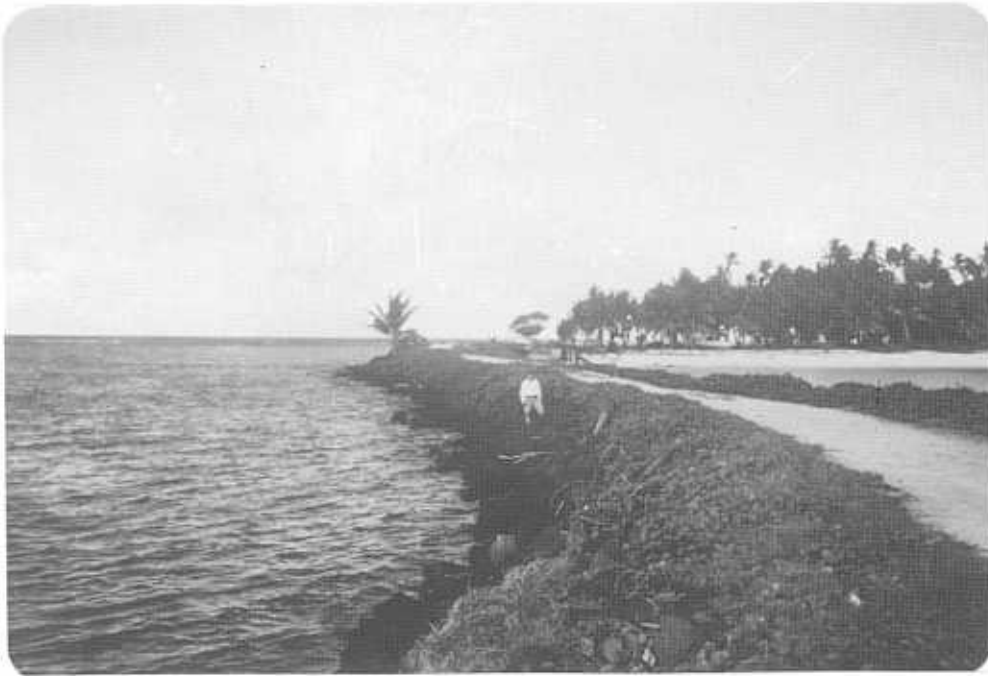
The wharf was constructed by building a causeway west from Oinafa Point. There is a small bridge in the causeway about 100m west of the original shoreline and the causeway extends about another 200m west to the wharf (Figures 7, 8). The north side of the causeway is armoured with rock and the smaller rocks have been moved by the waves. At the side of the causeway the 0.4m armour stones are stable at a 2/3 side slope. At the tip of the causeway the 0.6m armour stones are stable at a 2/3 side slope. Both the bridge and the wharf are concrete structures which have deteriorated and need to be rehabilitated or replaced.

Figure 7. Oinafa Wharf: north side of causeway showing armour stone sizes.

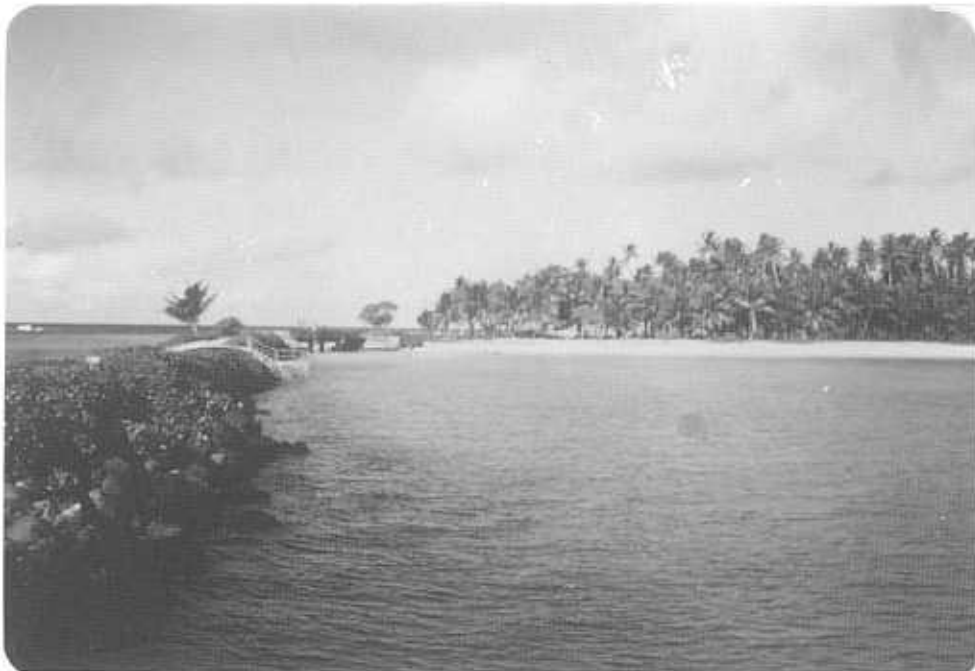
Figure 8. Oinafa Wharf: south side of causeway showing bridge at landward end of causeway.

After the wharf was constructed, the sand continued to move westward outside the causeway until it reached the bridge. The prevailing easterly waves pushed sand westward and under the bridge into the wharf basin. The westerly waves then pushed this sand back onto the

1. As the low cost solution, the Oinafa Wharf causeway could be modified by filling the existing bridge. This would stop sand from entering the wharf basin via the bridge, and enable this sand to be pushed back eastward by natural processes to stabilise Oinafa Point. The sooner the bridge is filled in the sooner the basin shoaling should cease or be lessened.

1. That the Oinafa Wharf causeway be rehabilitated by filling in the present bridge to make a continuous causeway. This should be done as soon as possible to reduce shoaling of the wharf basin and enable the sand to help stabilise Oinafa Point.
2. That the choice between:
  - (a) rebuilding the existing wharf and dredging the basin or
  - (b) building a new wharf on piles in deeper water to the northwest, be based on an economic comparison.
3. That, if the existing wharf basin is dredged, the dredged sand be dumped east of Oinafa Point to nourish and hasten the re-adjustment of the shoreline. Some dredged sand could be stockpiled for construction use.
4. That sand mining not be permitted from any beaches except at the terminal end of spits or where sand is being lost to deep water offshore.

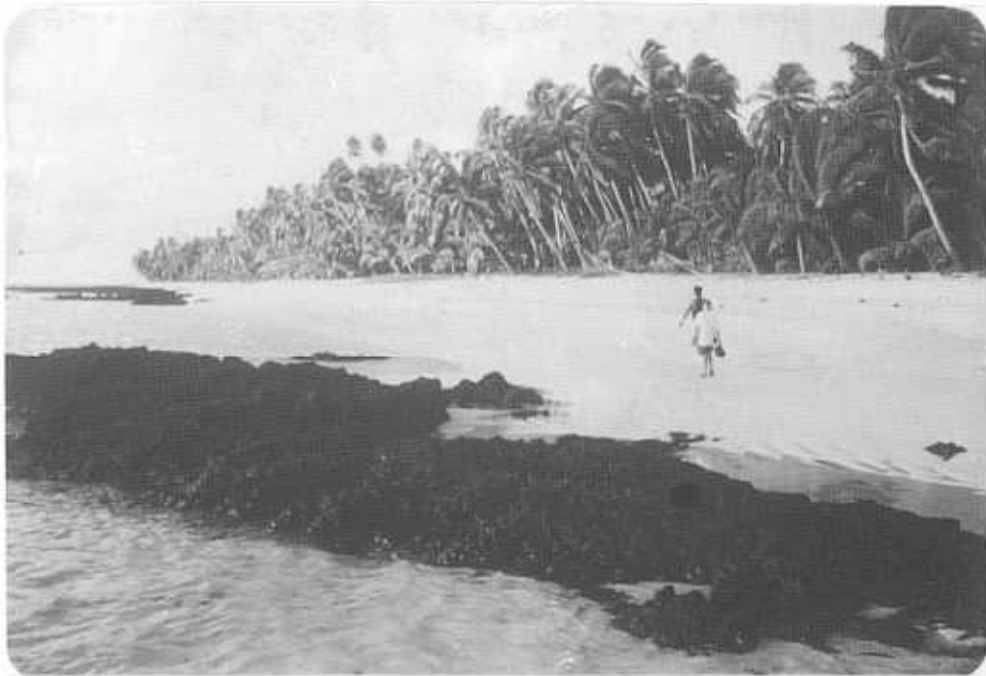
Figure 10. Paptea Village: fine sand beaches between black rock outcrops that act as groynes.

effect of these rock outcrops has formed a very good sandy beach (Figure 10). At several locations there are black rock boulders partially embedded in the beachrock slabs. An example of this beach type with small patches of sand is near Marama (Figure 11). From Marama to Noatau there is a scarcity of sand, some coarse material and some signs of erosion. Littoral drift may be alternately moving sand north and south from this area. Near Noatau there are old concrete foundation blocks on the beach and south of Noatau there are exposed tree roots. There is a large accumulation of fine sand off Ututu and a sand spit at Kalvaka at the entrance passage behind Solkope Island.

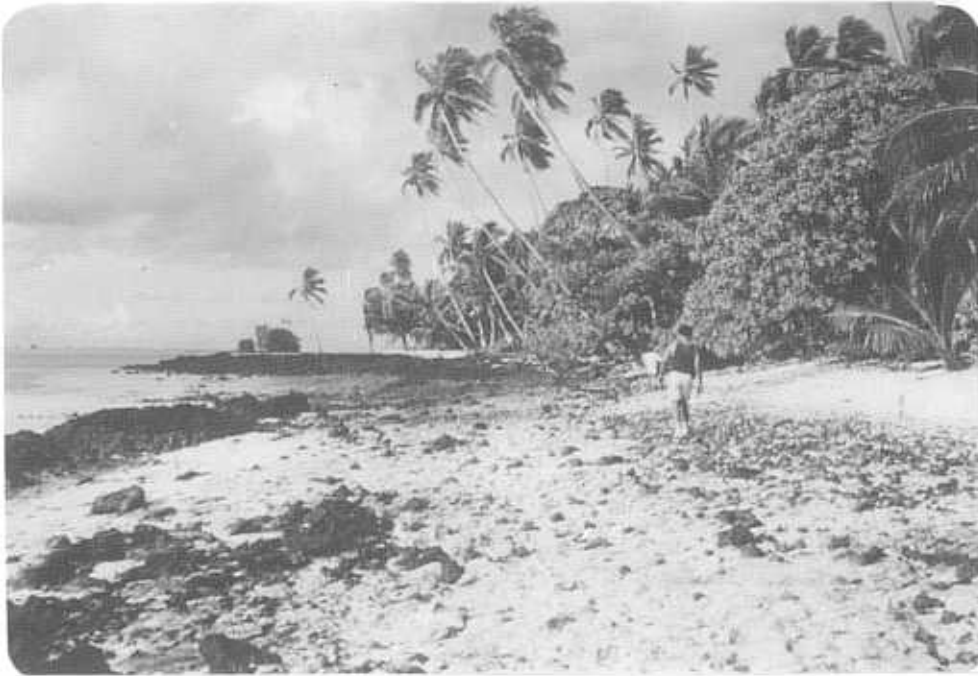
Figure 11. Marama: black rocks embedded (melted) into the beach rock and thin patches of sand.

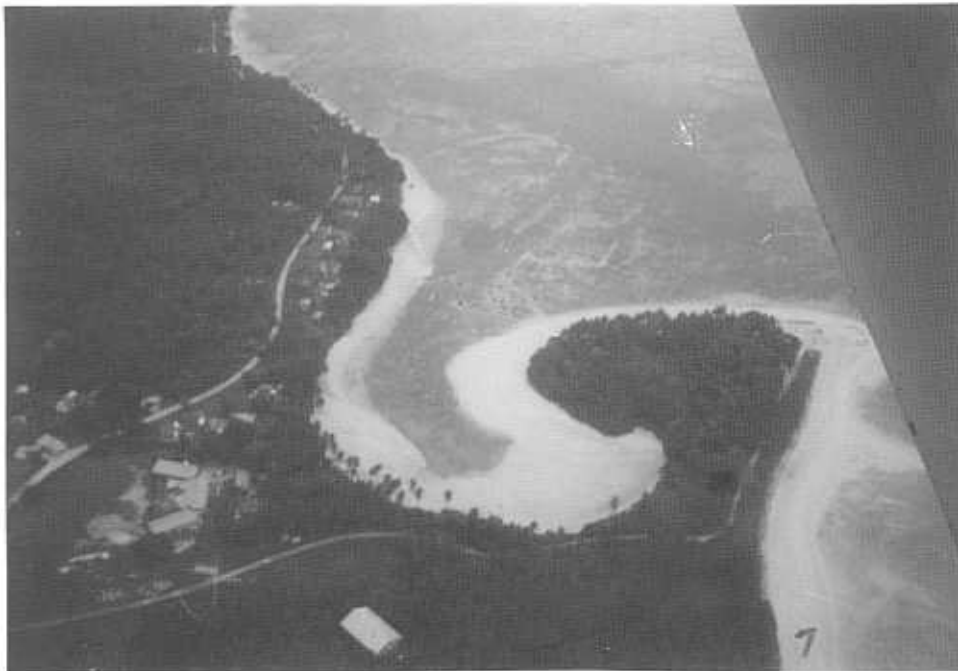
Figure 12. Motusa Point: oblique air photo at the sand pit on the south shore.

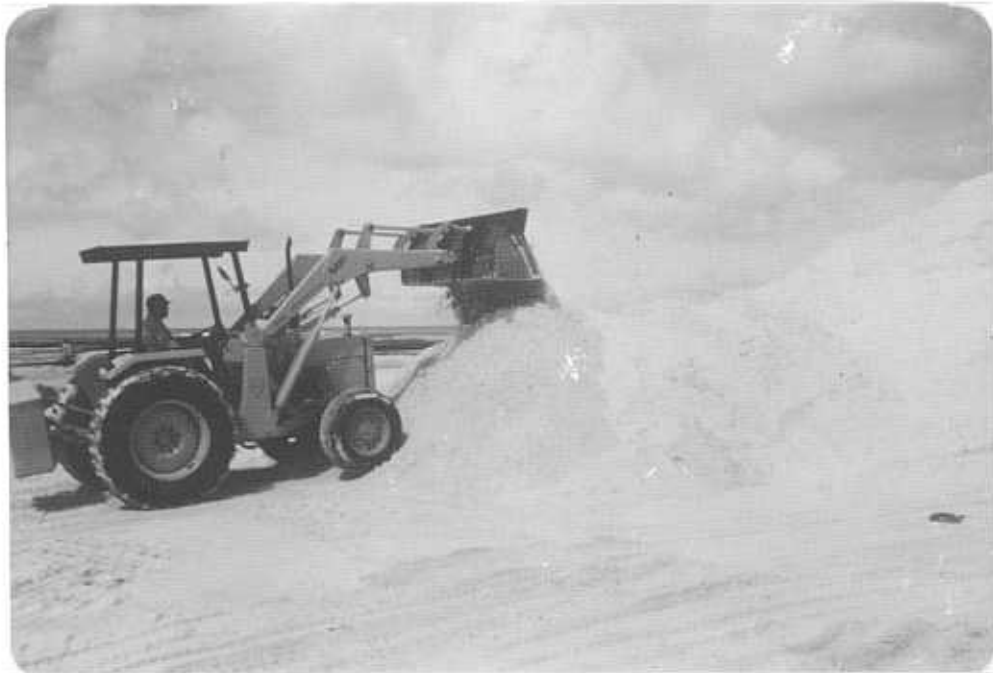
At Hopmafau Bay on the south side of the isthmus, the fringing reef follows close to the western shore and has a gap near the isthmus. This gap allows ocean waves to approach almost to the isthmus shore. It is reported by locals that this reef gap is completely natural and was never blasted or dredged. There are large exposed beachrock slabs near shore and some evidence of erosion. It is reported that there was a Brown & Joske building on the shore here in the 1950s and the site has now eroded. Just east of the reef gap, there is a large sand spit extending out from the shore, (Figure 12) which local residents say accumulated only in recent years. This spit location and shape is somewhat atypical but is believed formed by the ocean waves coming in through the reef gap, refracting to the east and pushing sand onto the sandspit. It is difficult to understand why this spit would only have formed recently, unless the reef gap had been widened or altered in some way. Public Works Department has a sand mining operation on the tip of this spit and from which it is hauling sand to repair the island roads (Figures 13, 14).

Figure 14. Motusa Point: sand mining at the tip of the spit.
