**COASTAL EROSION PROBLEMS IN THE  
GILBERT ISLANDS GROUP, REPUBLIC OF KIRIBATI  
Phase II**

April 1994

SOPAC Technical Report 191

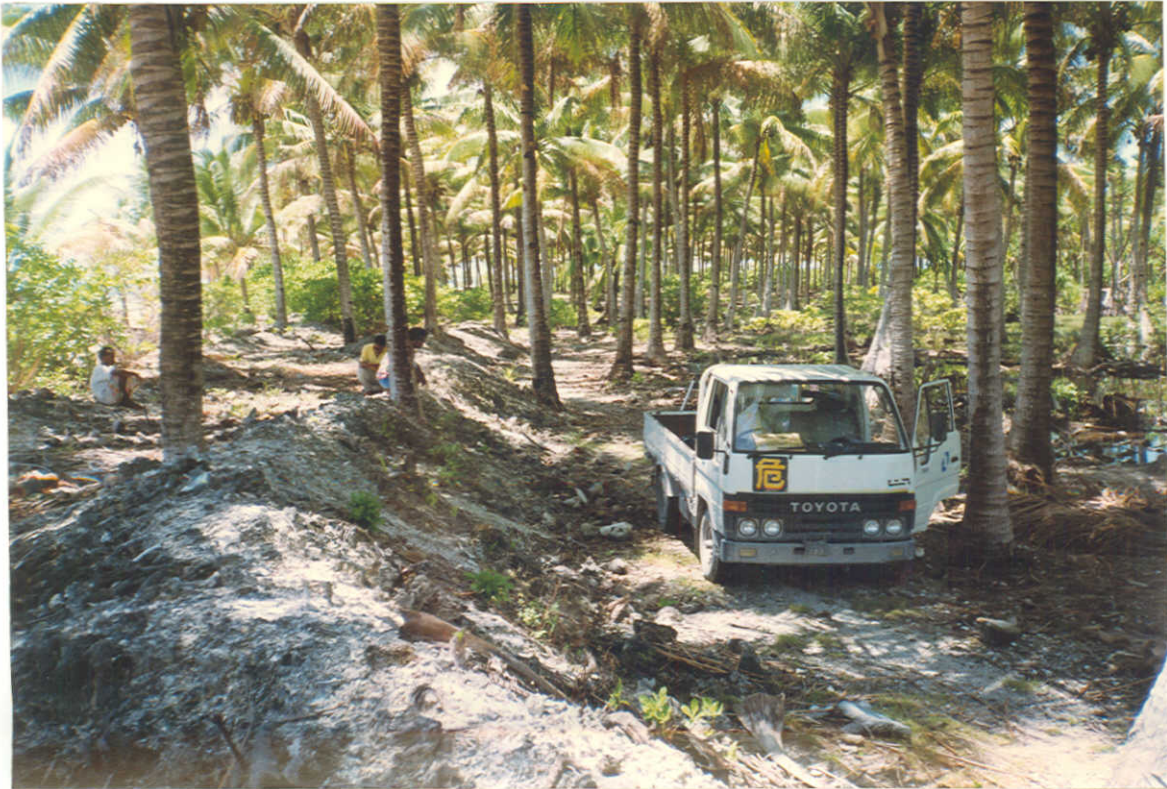
Shoreline flooding was occasionally a problem in the 1950s when high spring tides and strong westerlies caused sea water to inundate the low lying babai swamp. A ridge was constructed (Figure 3) in the 1970s using earth moving equipment available on the island during the airfield construction. Subsequently a rock seawall of traditional design was constructed in the 1980s. Material for the ridge was obtained by loader/truck from the reef flat and the seawall was built with coral boulders/slabs collected from the reef.

Figure 3. Tabontebike, Abaiang. View of man-made ridge between beach (out of view to the left) and the low lying, swampy ground (to the right of truck).

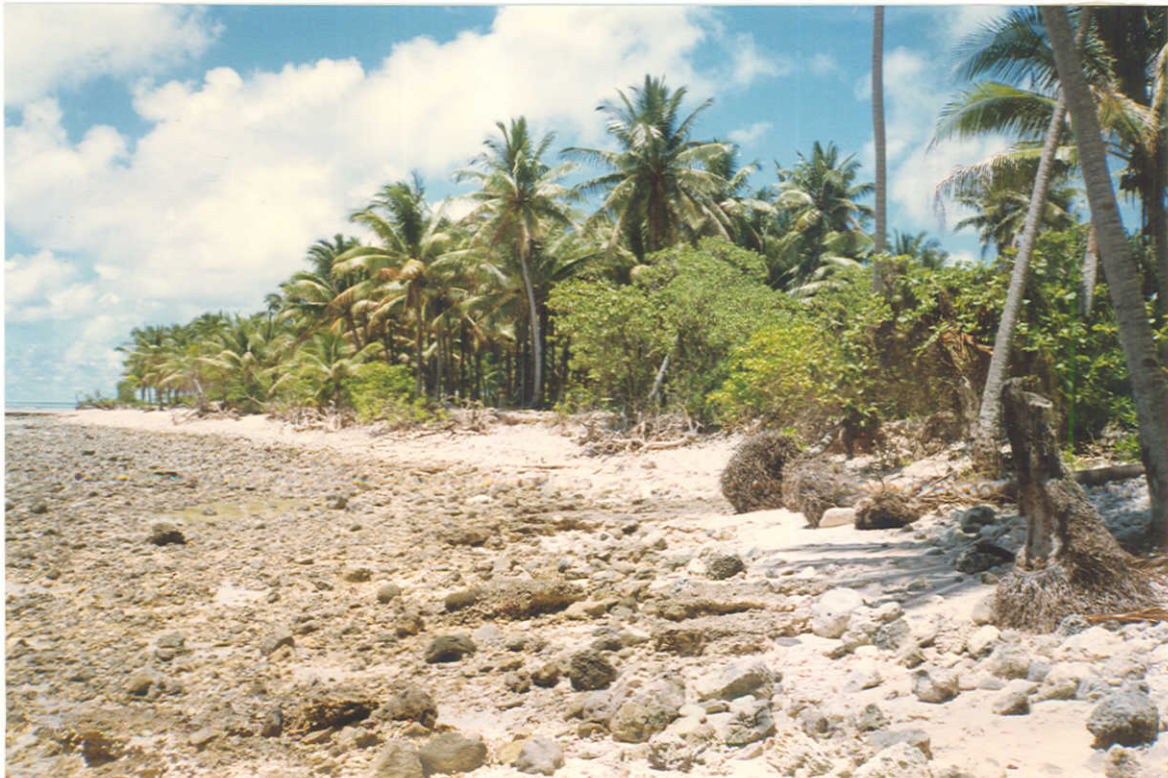
The erosion is probably due to natural causes but was also made worse by removing large amounts of material from the reef flat. This effectively deepened the water over a portion of the reef and left a pool of water visible at low tide. The deeper water allows larger waves to directly approach the beach. The ability of the reef flat to protect the shoreline has been reduced by the removal of material and increase in the water depth.

Figure 4. Tabontebike, Abaiang. View north along section of eroding shoreline immediately north of Bolton Point.

overtopping of the berm crest may occur, given the close proximity of the backshore swampy area to the ocean it was not thought that this would lead to any significant change in groundwater salinity. The priority for any action at this site is not urgent nor is the magnitude of the natural physical hazard and the amenities which would be potentially affected large. Therefore, no immediate action is recommended for this site.

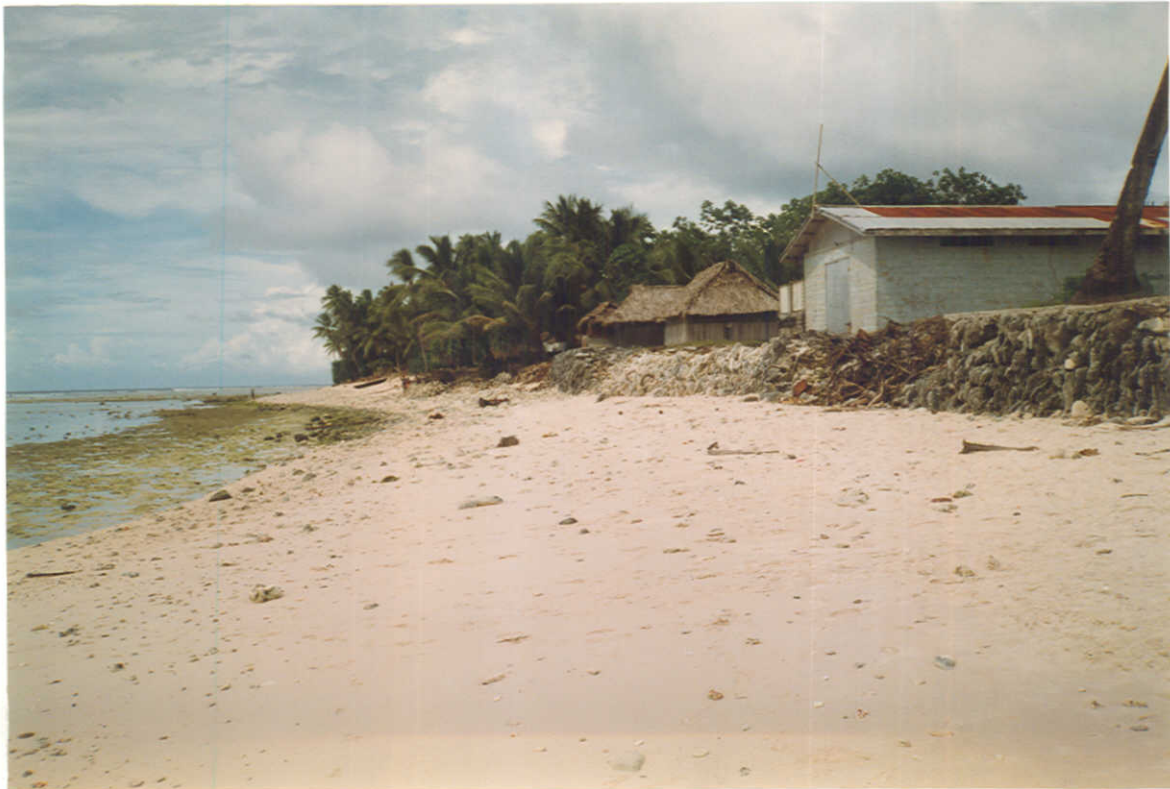
13  
6298

Evidence of erosion is visible as a lowered beach level near the channel as compared to areas further away (Figure 11). Vertical seawalls from 2-3 m high back the beach where the loss of beach has been greatest (Figure 12). Steep eroding cliffs (as indicated by land washed from under the roots of large trees) of 1-2 m in height are also present to the north and south. To the north the remains of a concrete foundation of a house was being undermined. We were told the foundation was over 40 years old.

Figure 11. Rawannawi, Marakei. View north (at location of reef passage) along shoreline showing protection response with locally constructed, near vertical seawalls.

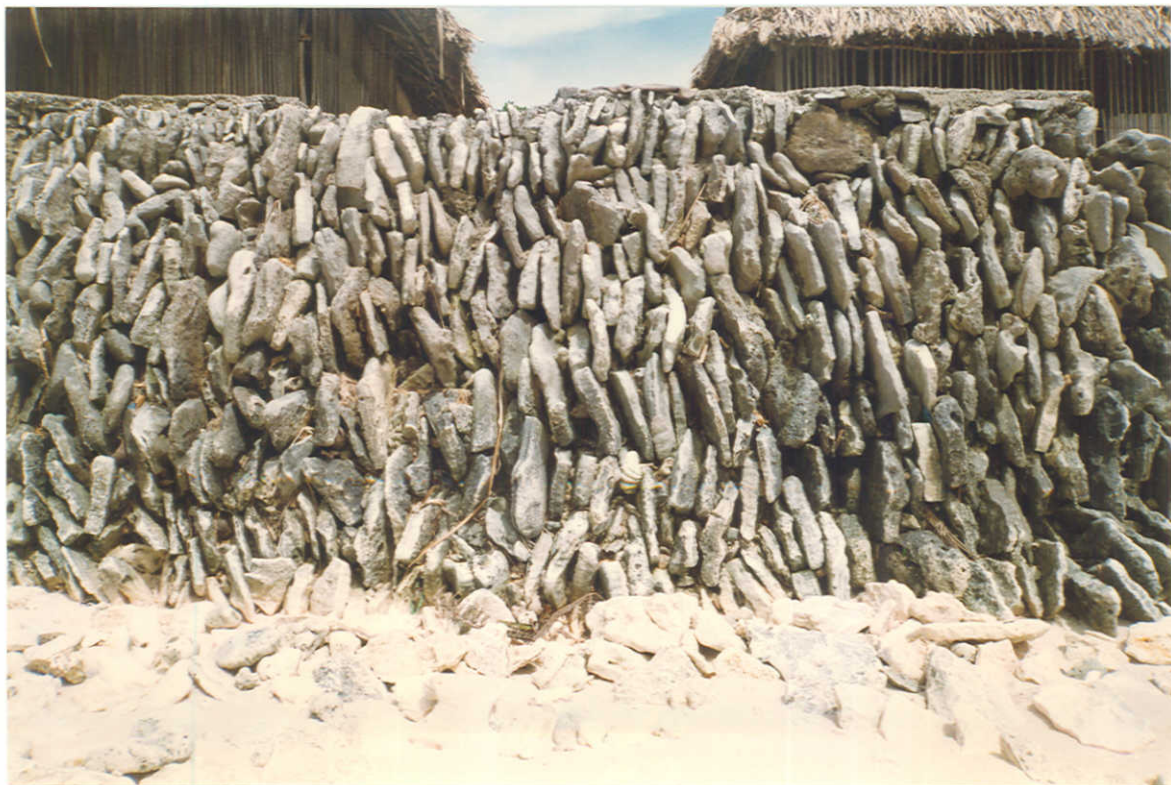
18  
6233

Figure 12. Rawannawi, Marakei. View of near vertical seawall constructed of tabular coral and beachrock slabs. The wall is over two metres high.

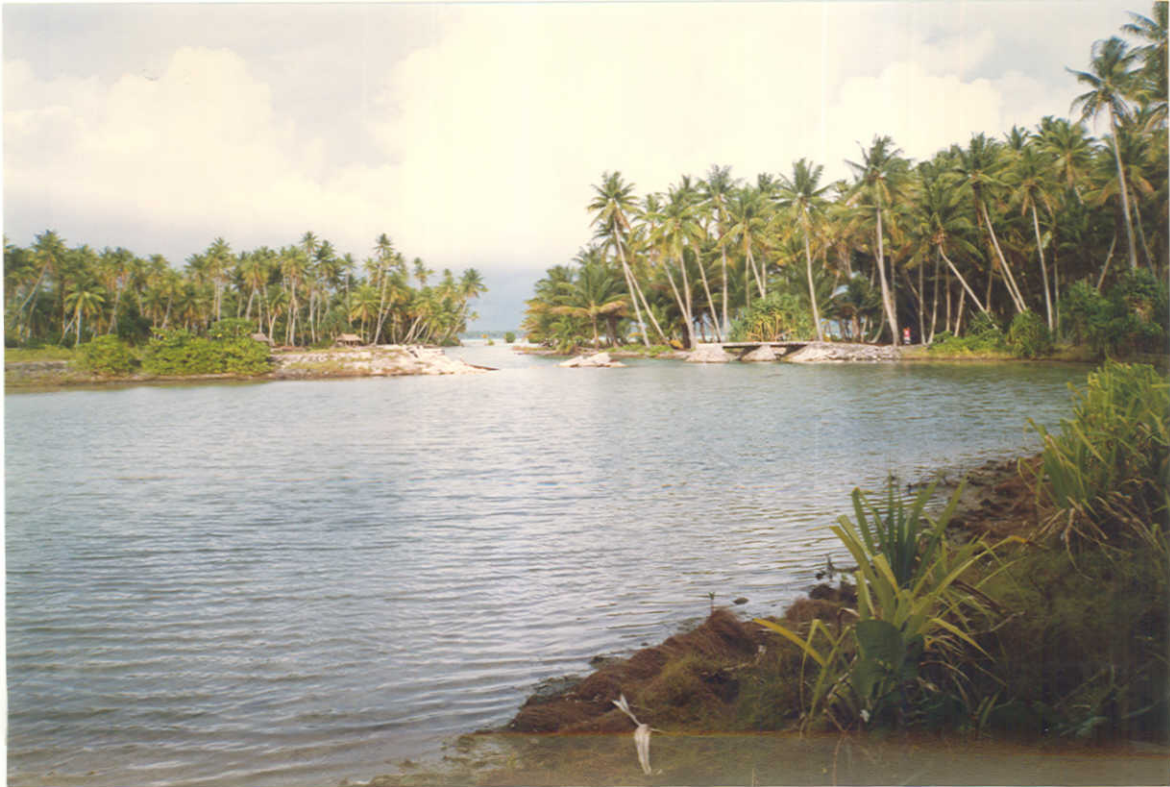
19  
6238

Figure 14. Baretoa Passage, Marakei. View east through passage past abandoned causeway and towards lagoon. Since closure of the passage the causeway has been partially removed in an attempt to restore the natural flow and re-open the passage.

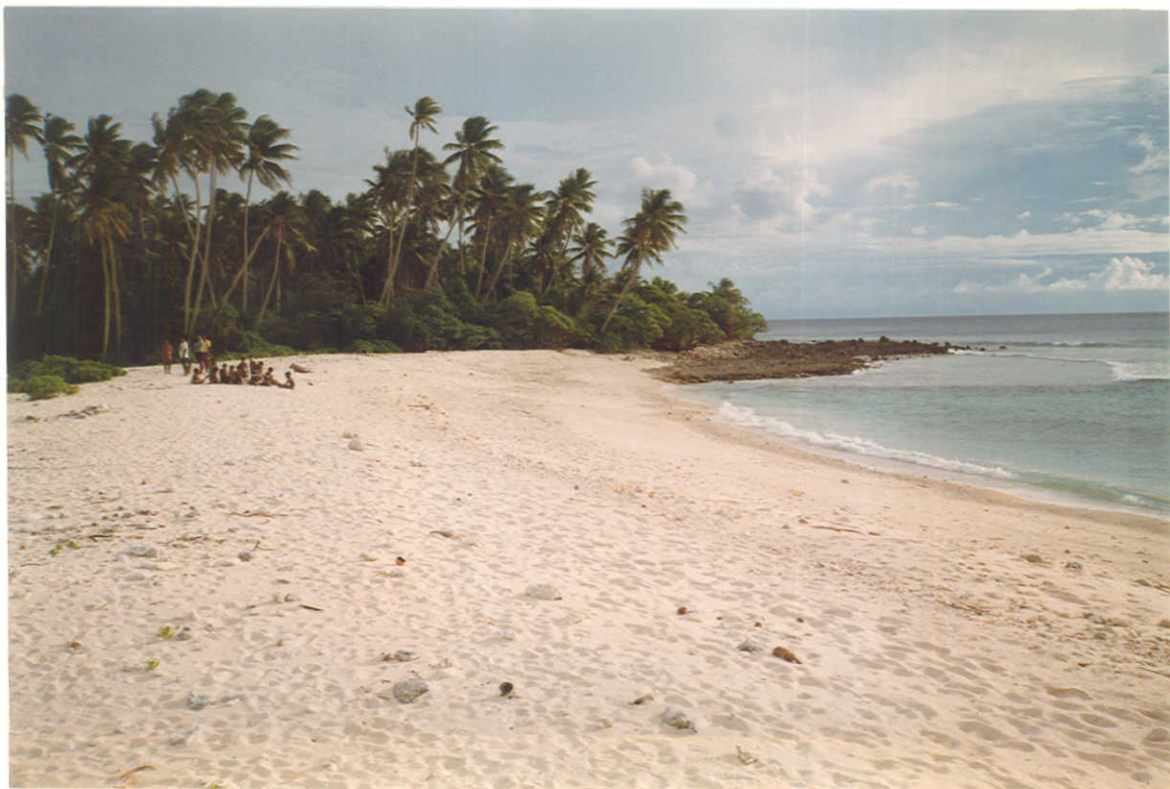
22  
6238

Figure 15. Baretoa Passage, Marakei. View south along the crest of the large beach ridge which has closed off the western entrance to the passage.

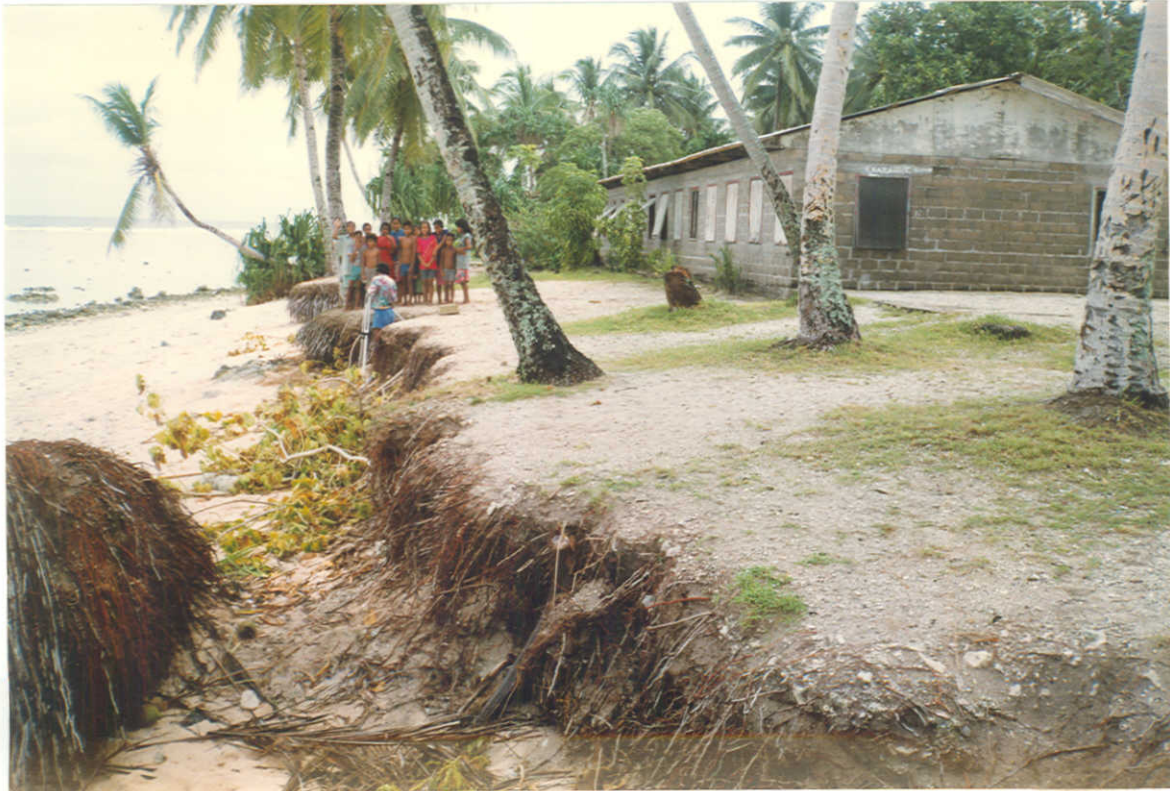
35  
6238

The erosion may have reached its maximum and beach erosion may stop. However, the erosion is close to affecting the school building and some form of protection is warranted considering the economic value of the assets to be protected. However, if the erosion observed in March 1993 has stopped and accretion has taken place since then there may be no need for coastal protection. In this regard, it should be recognized in Kiribati that (1) valuable buildings should not be built close to the shoreline where they are at potential threat from the normal changes which occur in the shoreline; and (2) valuable buildings should not be built adjacent to shorelines which have been determined to have a long term or chronic erosion problem.

Figure 17. Naka Primary School, Makin. View north along beach scarp. Local estimates of erosion have amounted to 7 metres since the late 1970's.

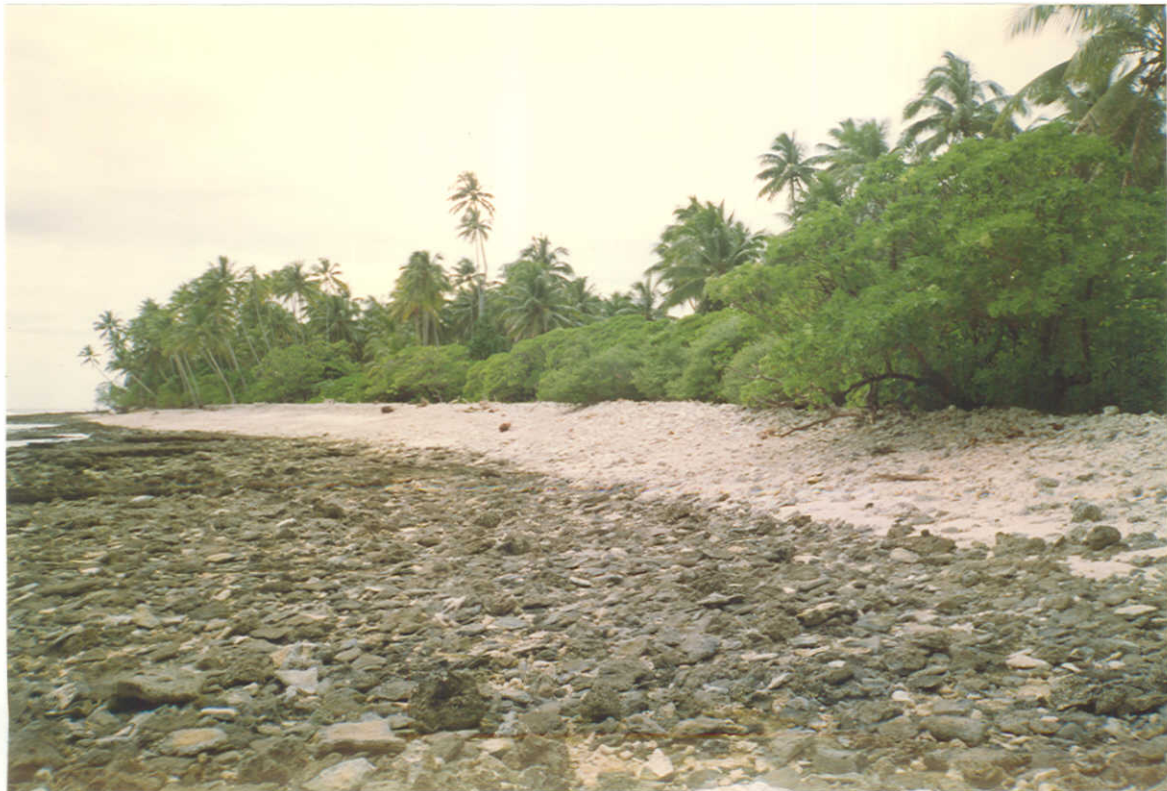
Figure 20. Ukiangang Point, Butaritari. View southwest along eroding section of beach. Waves occasionally overwash beach and cause salt water intrusion into backshore swamp areas.

The infrequent saltwater inundation of marginal babai pits and minor coastal erosion do not justify foreshore protection.

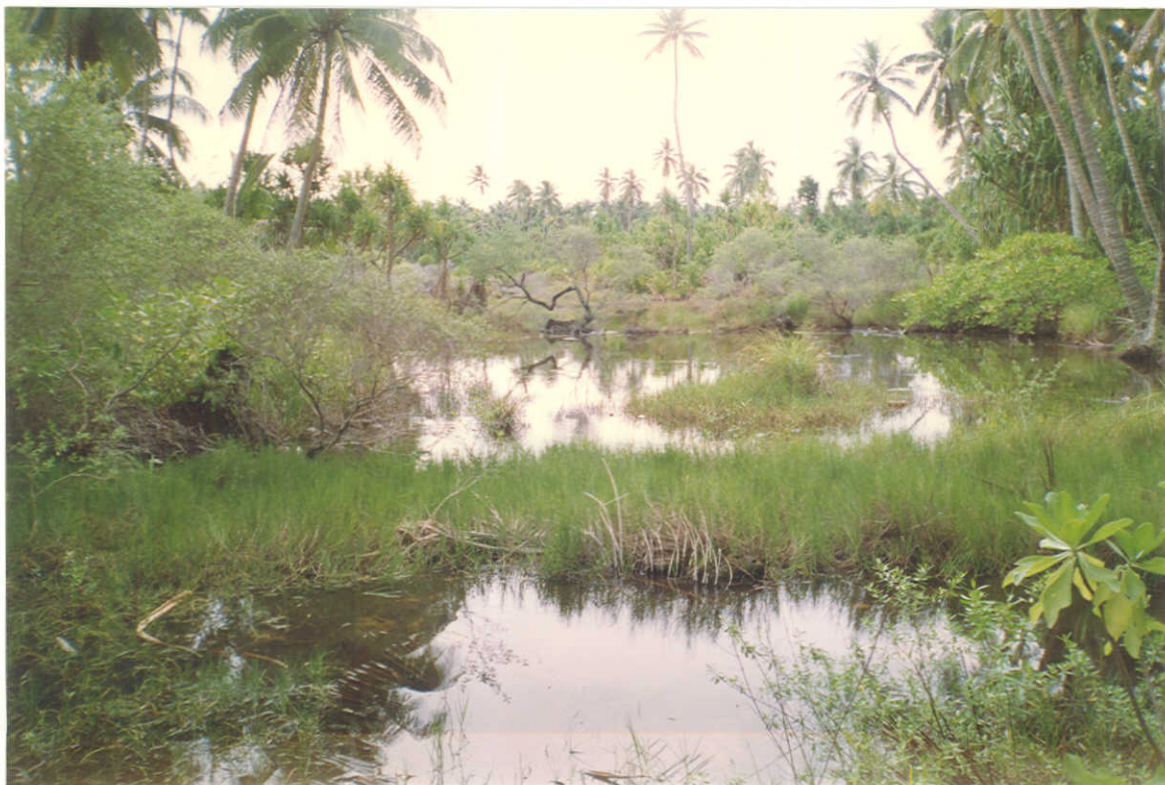
Figure 21. Ukiangang Point, Butaritari. View of backshore swamp area immediately behind beach road. Swampy sites further inland, which are less salty, are used for growing babai.

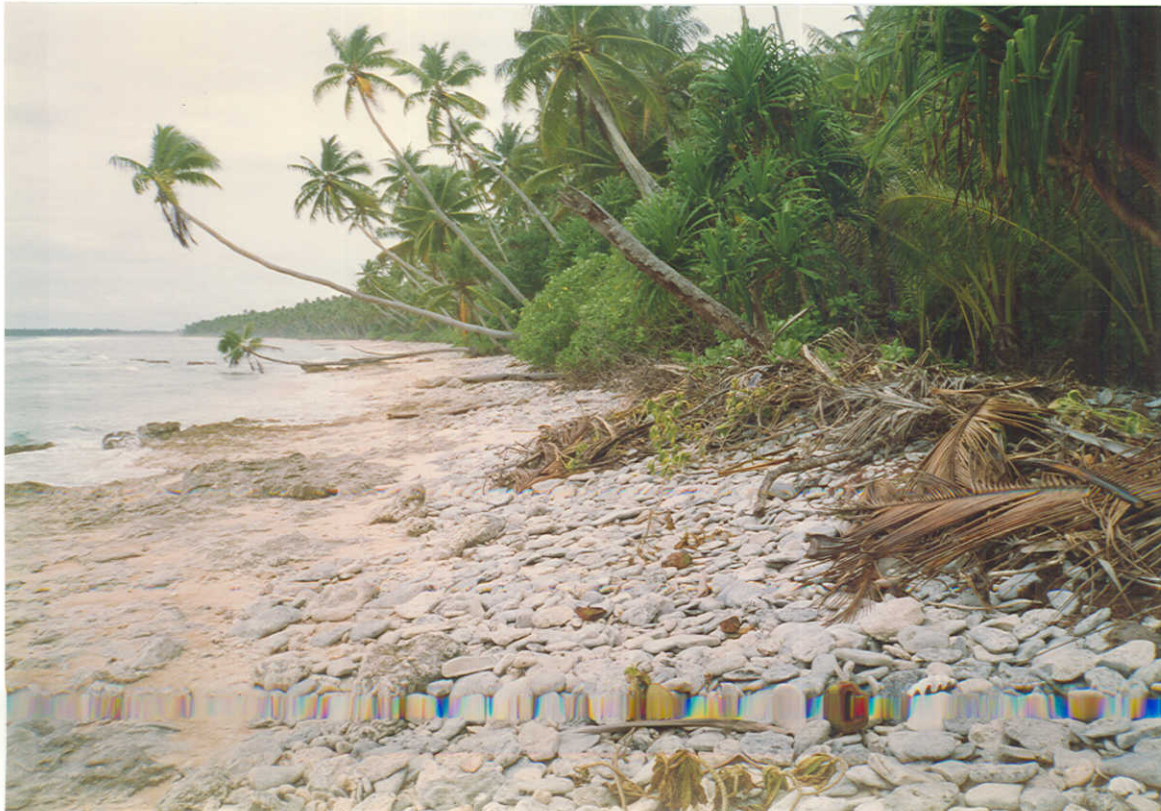
Figure 23. Keuea Village, Butaritari. View southwest along ocean shoreline east of Keuea Village. The beach at this location is composed of a very narrow zone of coral boulders with minor sand.

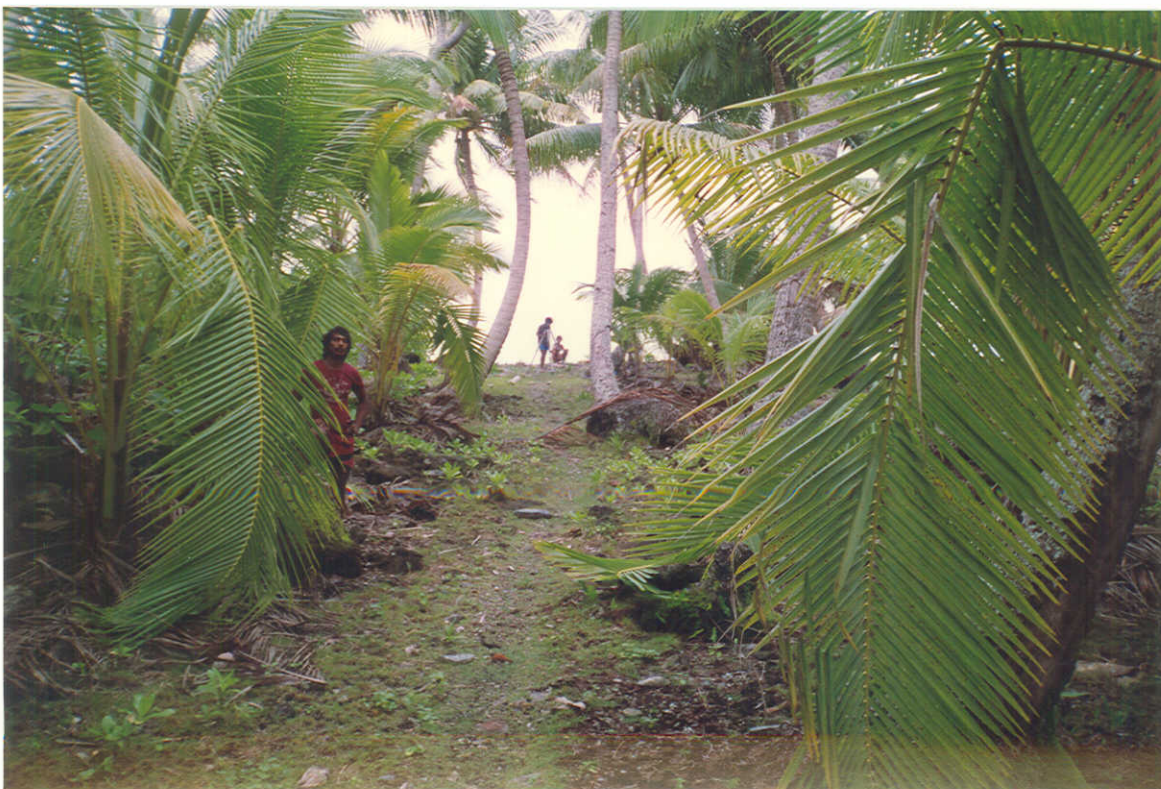
Figure 24. Keuea Village, Butaritari. View seaward along line of beach profile. Note the greater height of the most seaward point (on the beach ridge). Information provided by local sources indicates that waves sometimes wash salt water over the ridge and into babai growing pits immediately landward of this location.

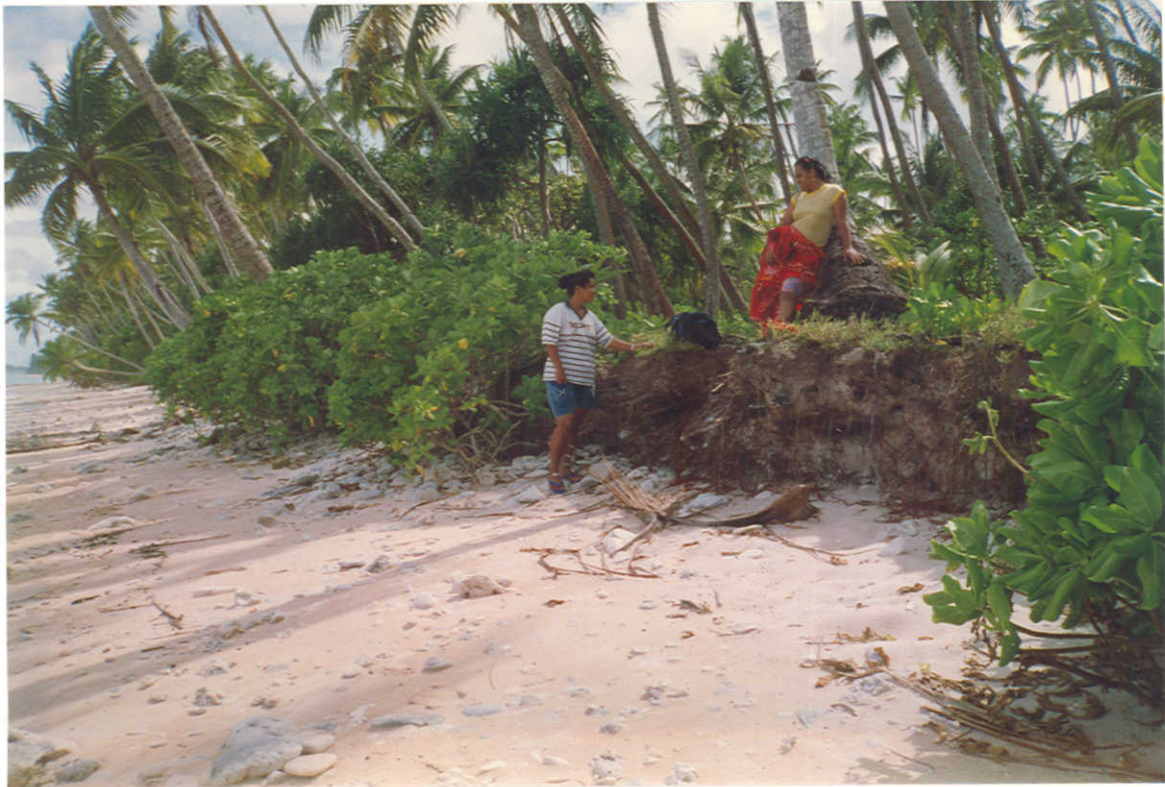
20  
6286

Figure 25. Keuea Village, Butaritari. View of scarp eroding into beach ridge along ocean shoreline.

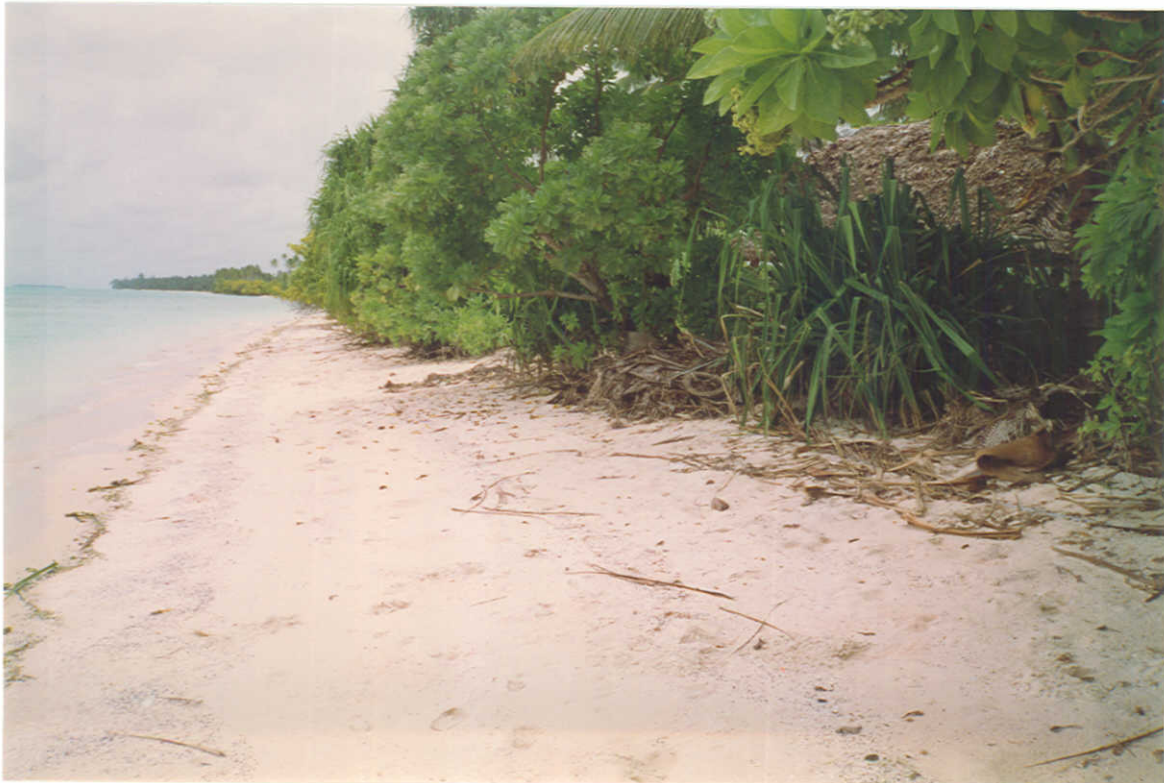
17  
6286

Figure 26. Keuea/Tanimainiku School, Butaritari. View north along narrow sandy beach on lagoon shoreline.

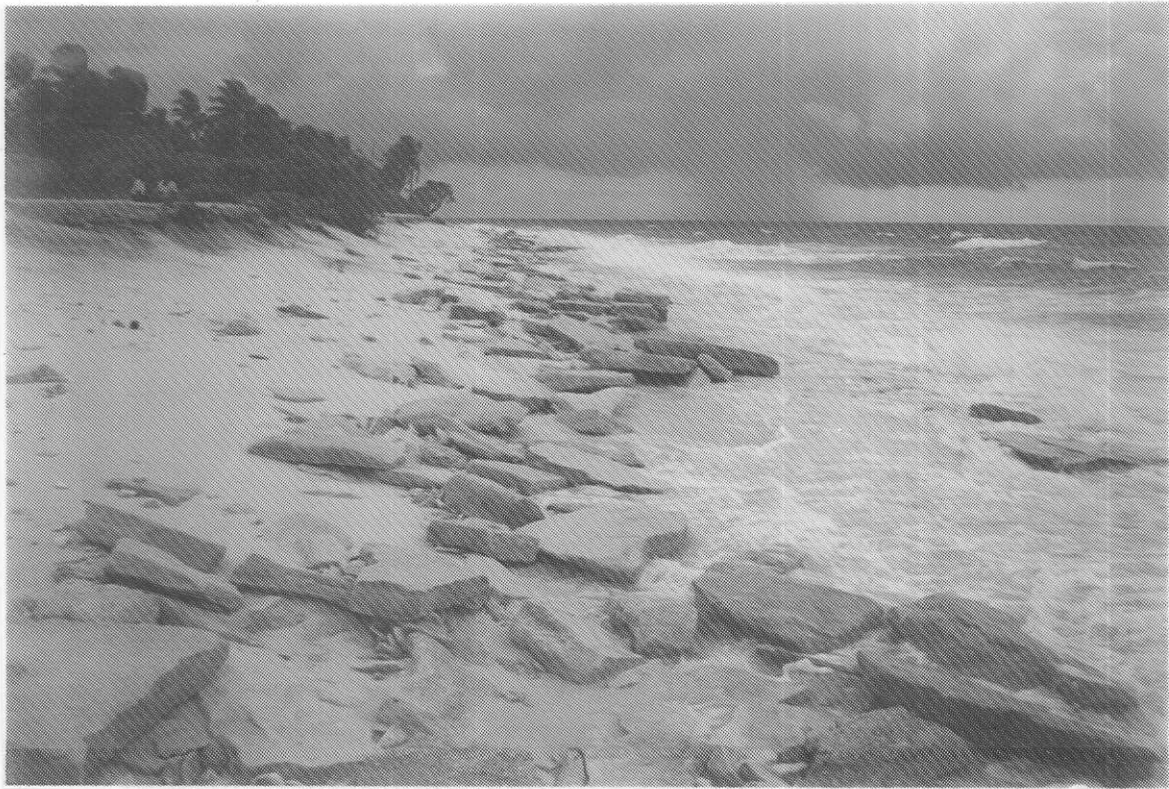
Figure 29. West end of airfield runway, north of Barebuke, Tamana. View south showing erosion scarp at left and scattered slabs of broken beachrock.

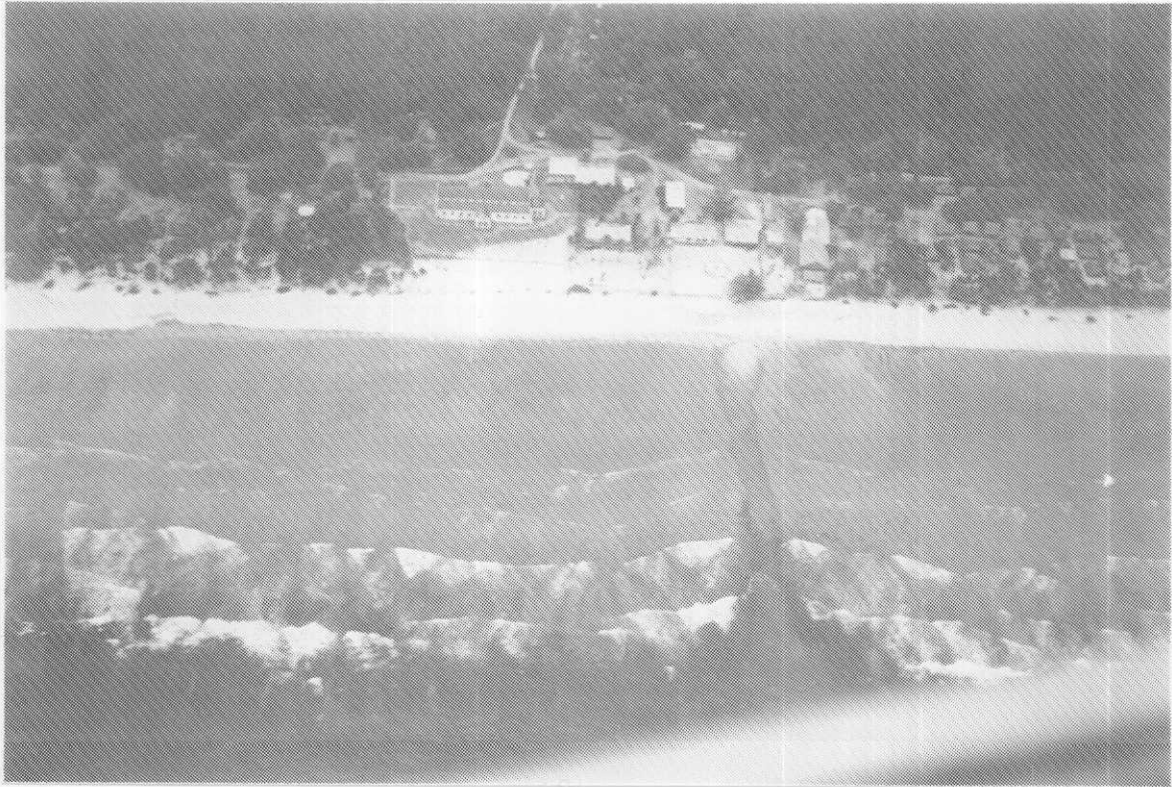
Figure 30. Bakaka, Tamana. Oblique aerial view showing man-made boat channel across reef and shoreline fronting large church and government buildings. Note that the permanent buildings are set well back from the shoreline.

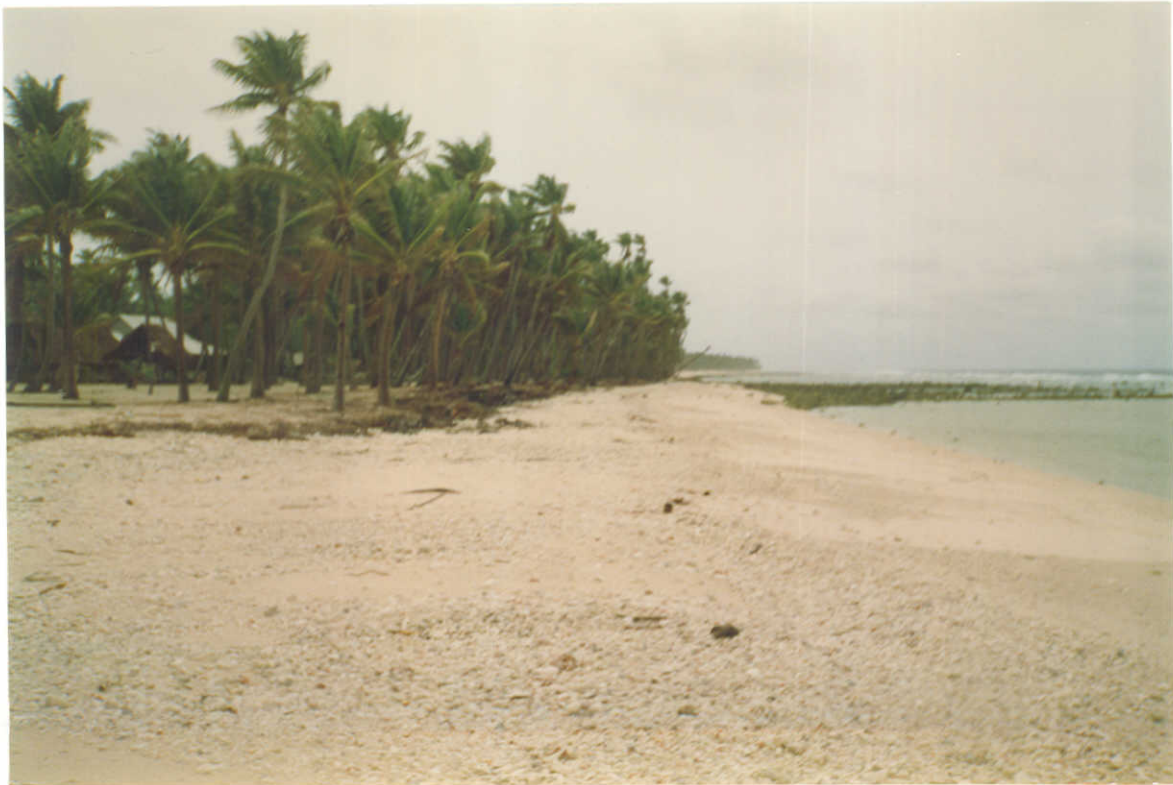
13  
6285

Figure 34. Tamaroa, Arorae. View southeast at location in front of large LMS church. The beach ridge is composed of coral rubble and is presently accreting in front of an erosion scarp created during the early January storm surge.

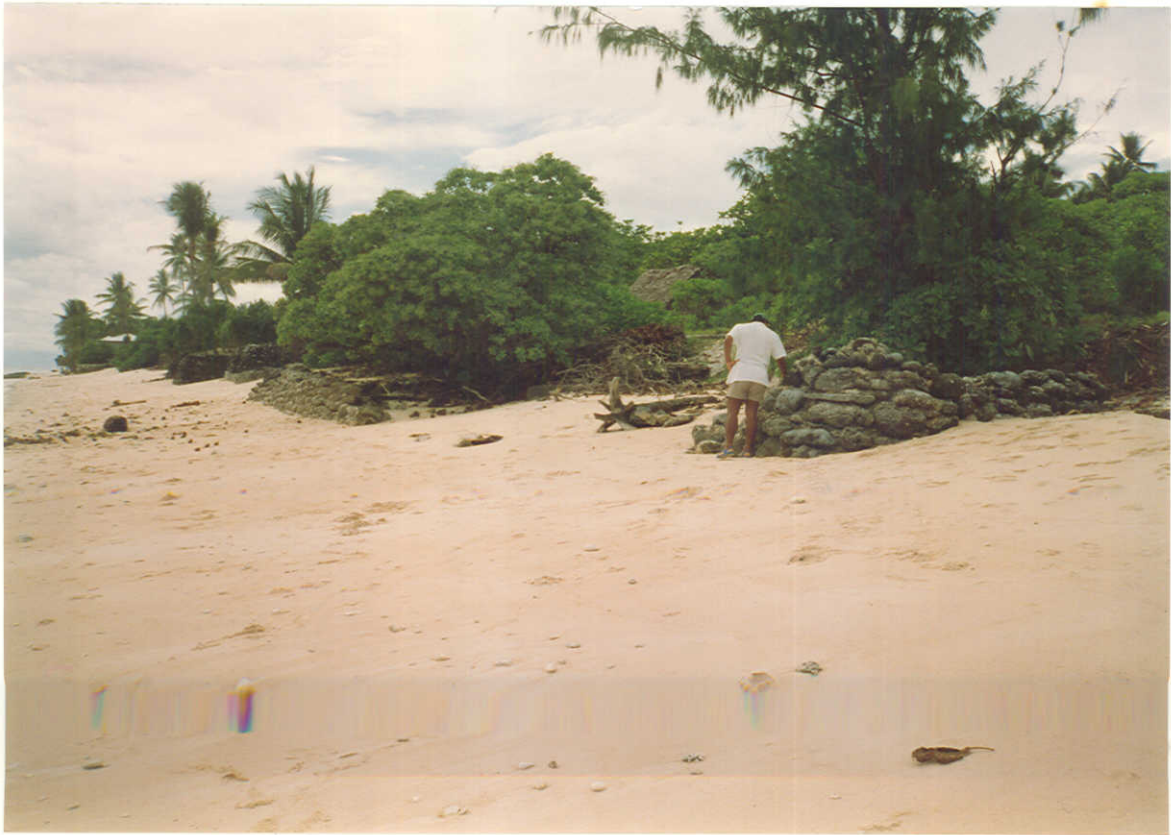
Figure 42. Tabomatang, Nikunau. View northwest at location of beach profile site showing remains of seawall on upper foreshore.

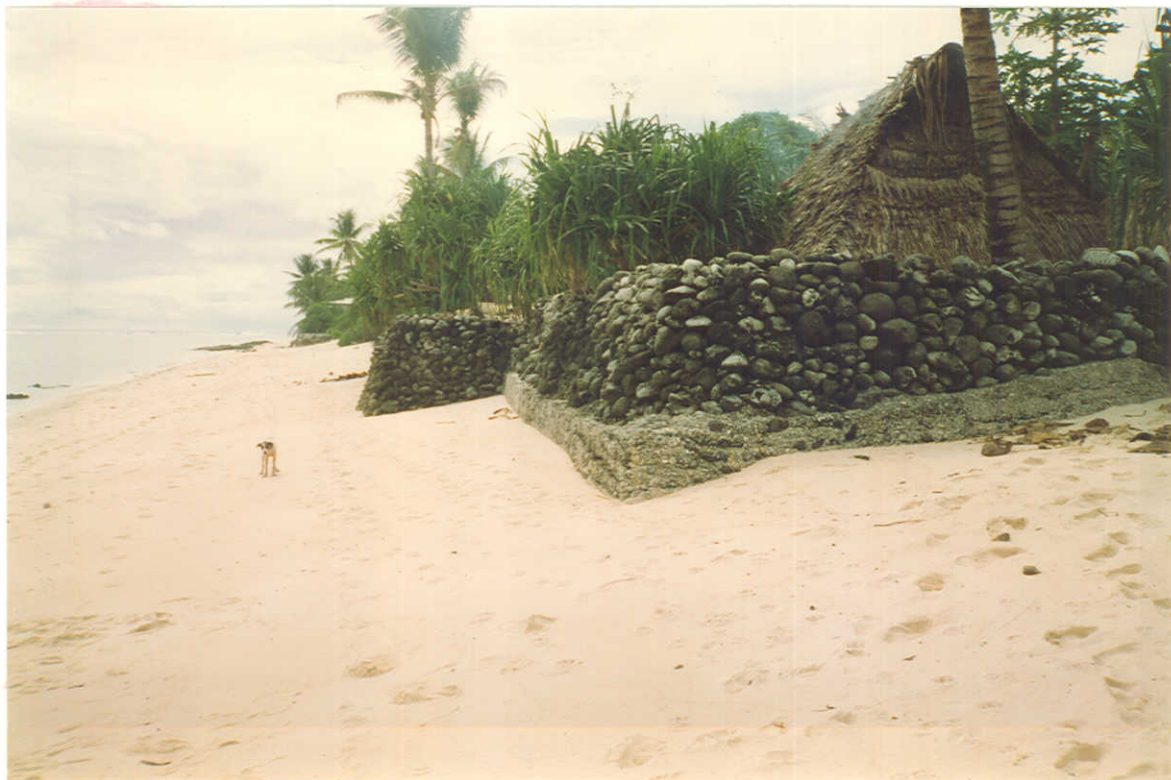
Figure 43. Tabomatang, Nikunau. View northwest at location approximately 100 m north of beach profile site (Figure 42) showing area of extensive seawall construction.

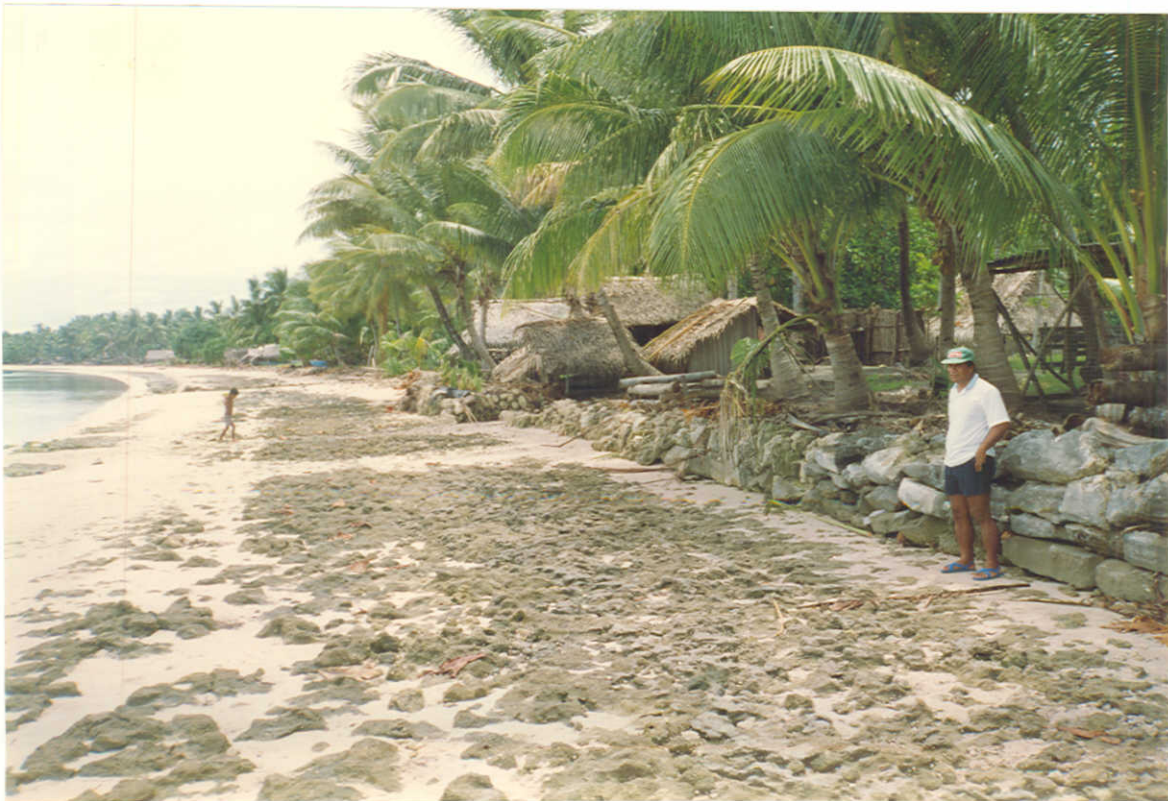
12  
6287

Figure 48. Buariki South, Aranuka. View north at beach profile site showing exposed beachrock in front of seawall constructed of beachrock slabs quarried from the lower foreshore. Note absence of any beach sediment on upper foreshore.
