**INITIAL RECONNAISSANCE OF THE
EFFECTS OF CYCLONE KINA IN
CENTRAL AND EASTERN VITI LEVU**

April 1993

SOPAC Miscellaneous Report 149

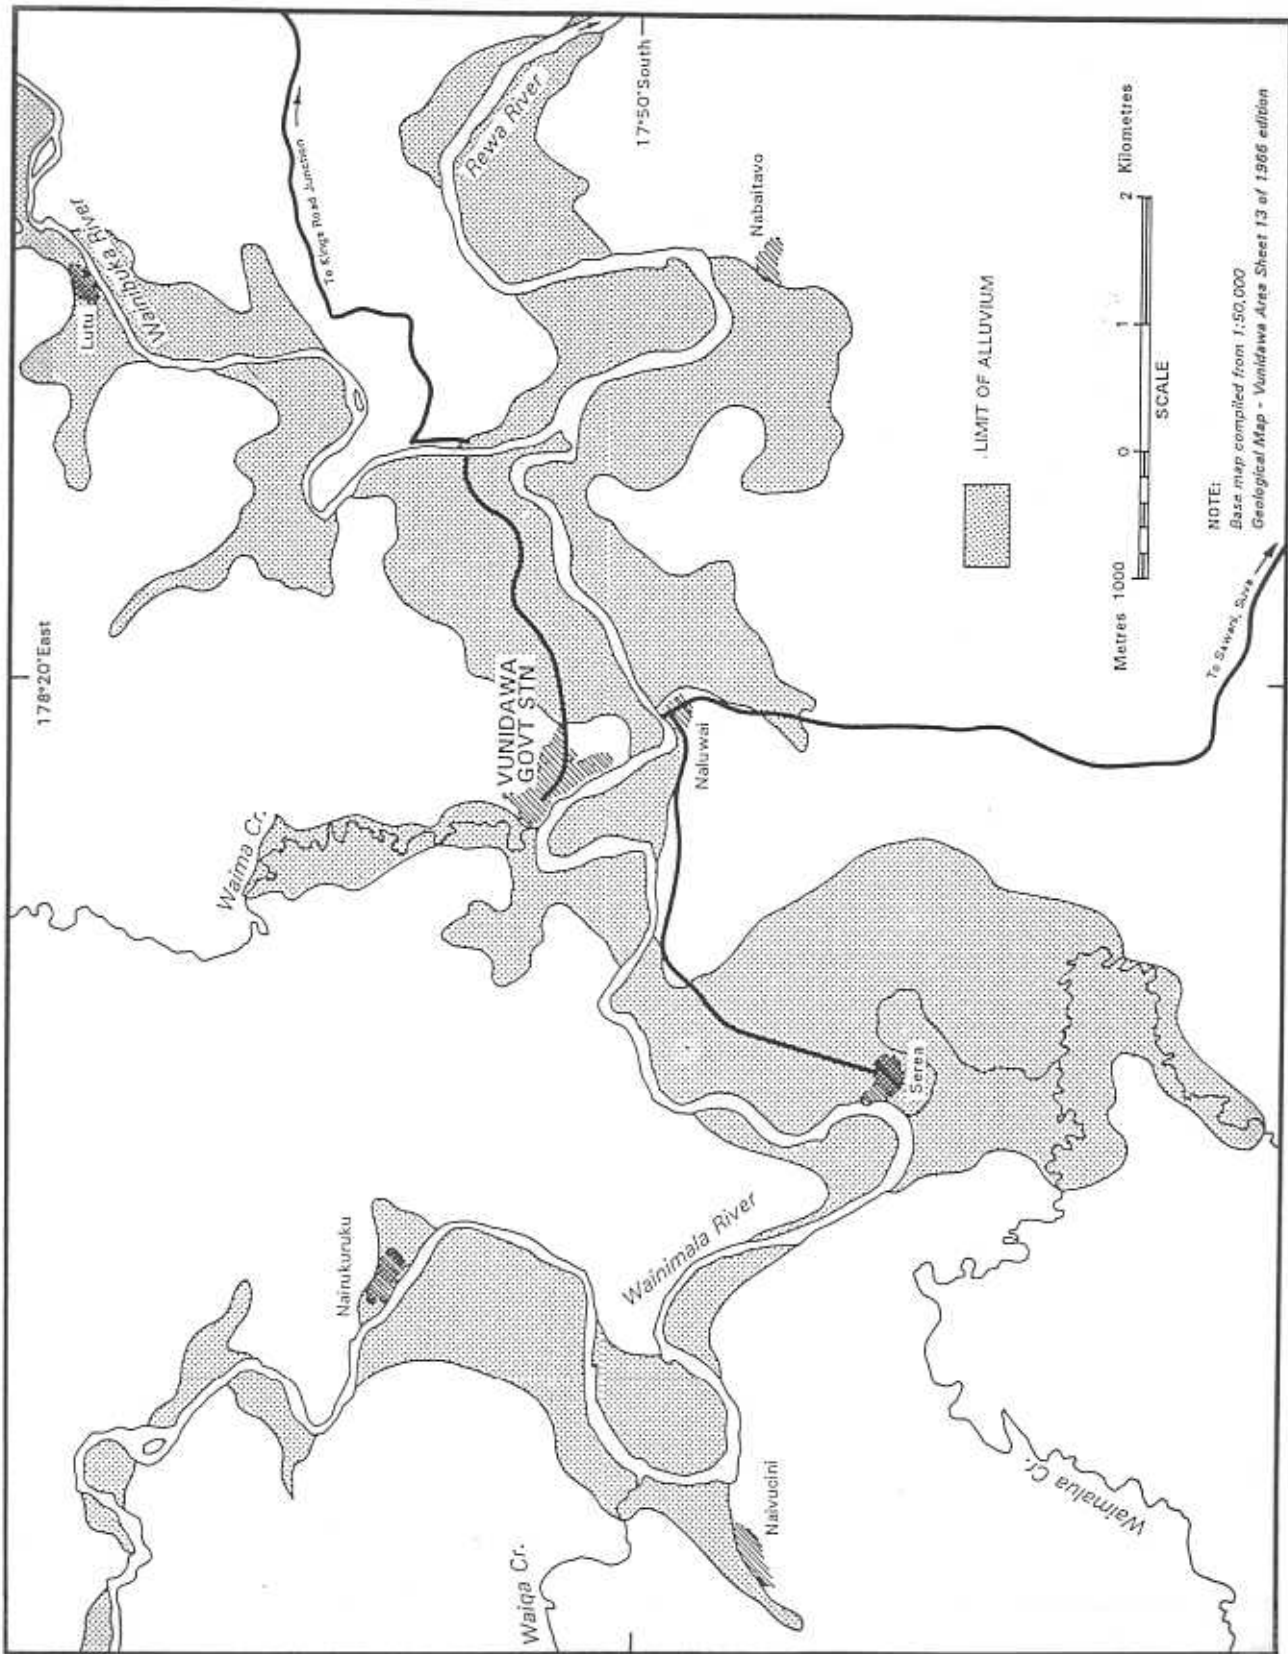
As a result of the high rainfall associated with and proceeding Cyclone Kina, the rivers occupied the flood plain with average water depth of 2-3 m in the area close to Vunidawa (Figure 4). Indications are that water levels may have risen an average 14 m and perhaps by as much as 17-18 m in places.

Figure 4. Map of the Wainimala, Wainibuka, Rewa rivers confluence near Vunidawa showing the extent of the alluvial flood plain, which was estimated to have been flooded to an average depth of 2-3 m as a result of rainfall associated with Cyclone Kina.

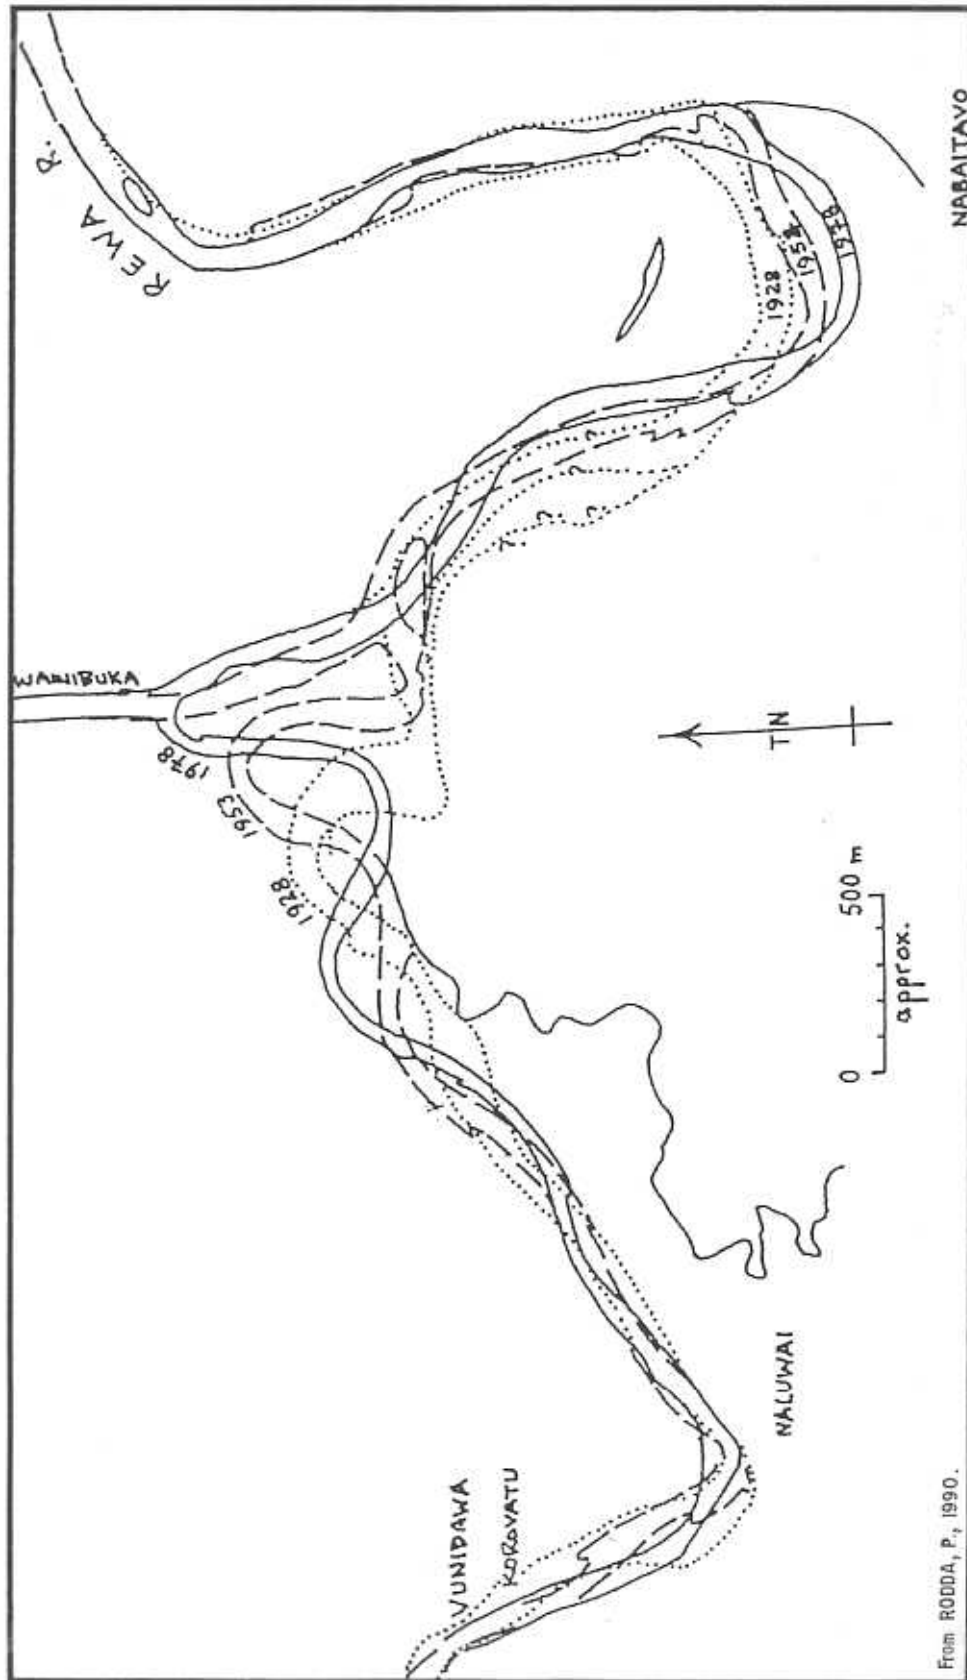
At the same time the river banks around the meander loops were eroded and the main channel pattern were shifted downstream (Plate 4). This has yet to be documented, though Rodda (1990) reported up to 75 m shift in the Wainibuka-Wainimala-Rewa confluence in the period between 1928 and 1978 (Figure 5).

Figure 5. Sketch map reproduced from Rodda (1990) showing the movement over the 50-year period 1928-1978 of river meander channels at the Wainimala, Wainibuka, Rewa confluence.

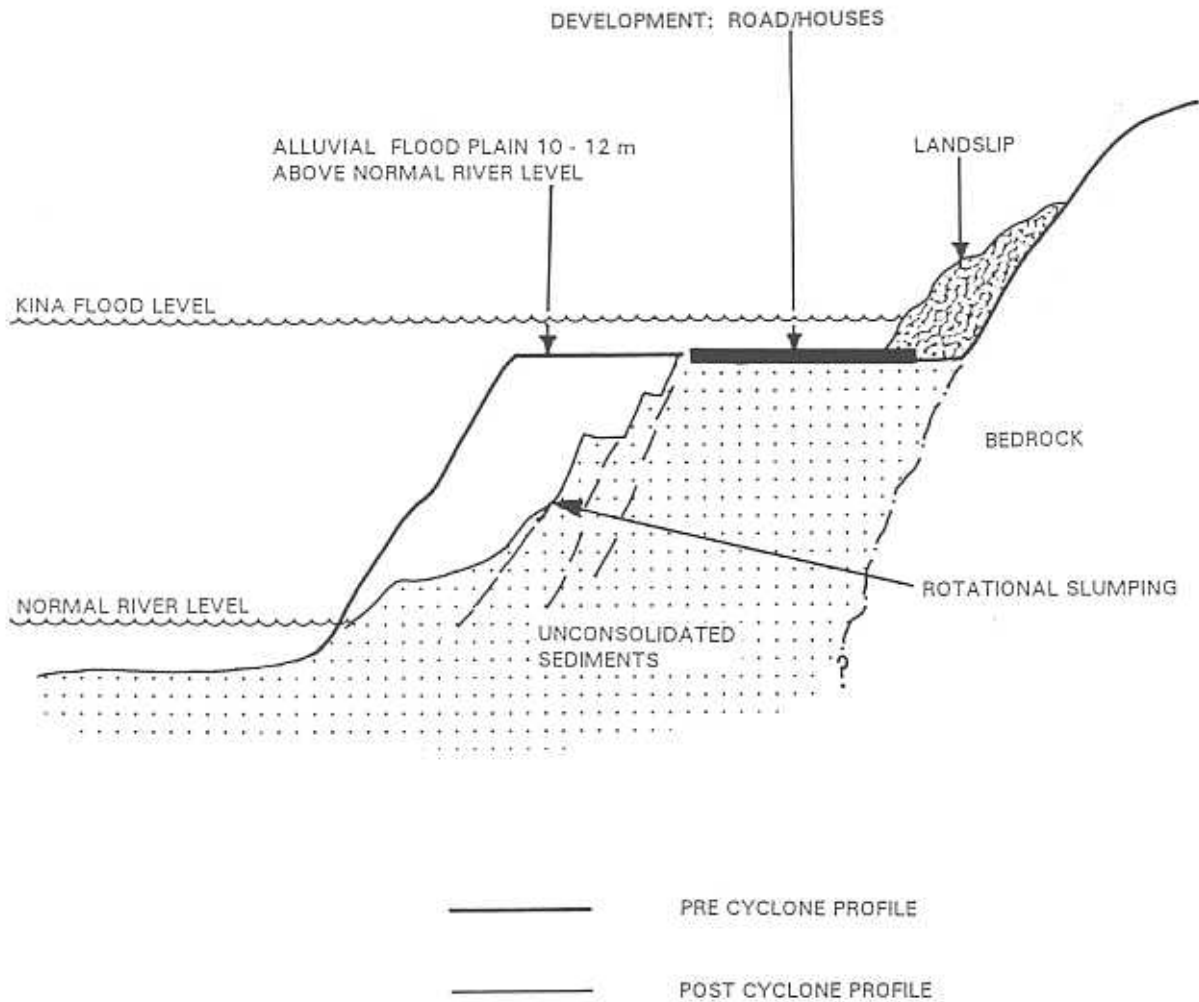
COMPOSITE CROSS SECTION FOR WAINIMALA, WAINIBUKA AND REWA RIVERS

As water levels receded, substantive deposits of silt became evident on the flood plain, and new gravel bars appeared in the channels. As water levels fell to normal the undercut channel banks were left exposed, steep to vertical and unstable. These are now undergoing rotational slumping to re-establish equilibrium (Figure 6). Where the valley is narrow, for example in the middle reaches of the Wainibuka, this caused major damage to infrastructure such as roads and villages (Plate 5).

Figure 6. Composite cross-section for the Wainimala, Wainibuka and Rewa rivers showing effects of Cyclone Kina, in particular note the river bank failures now taking place as the eroded and oversteeped channel sides now attempt to stabilise by rotational slumping.

2. Re-establishment of infrastructure, including roads, schools and houses in the narrow Wainibuka gorge area, needs to be carefully planned in view of the current instability of the slopes cut into the unconsolidated alluvial deposits.
3. Development of infrastructure on the Navua and Rewa deltas has to a large extent totally disregarded pre-existing abandoned river channels which act as natural floodways.
4. The natural floodways on major river deltas such as the Rewa and Navua need to be carefully mapped and their importance recognised and publicised.

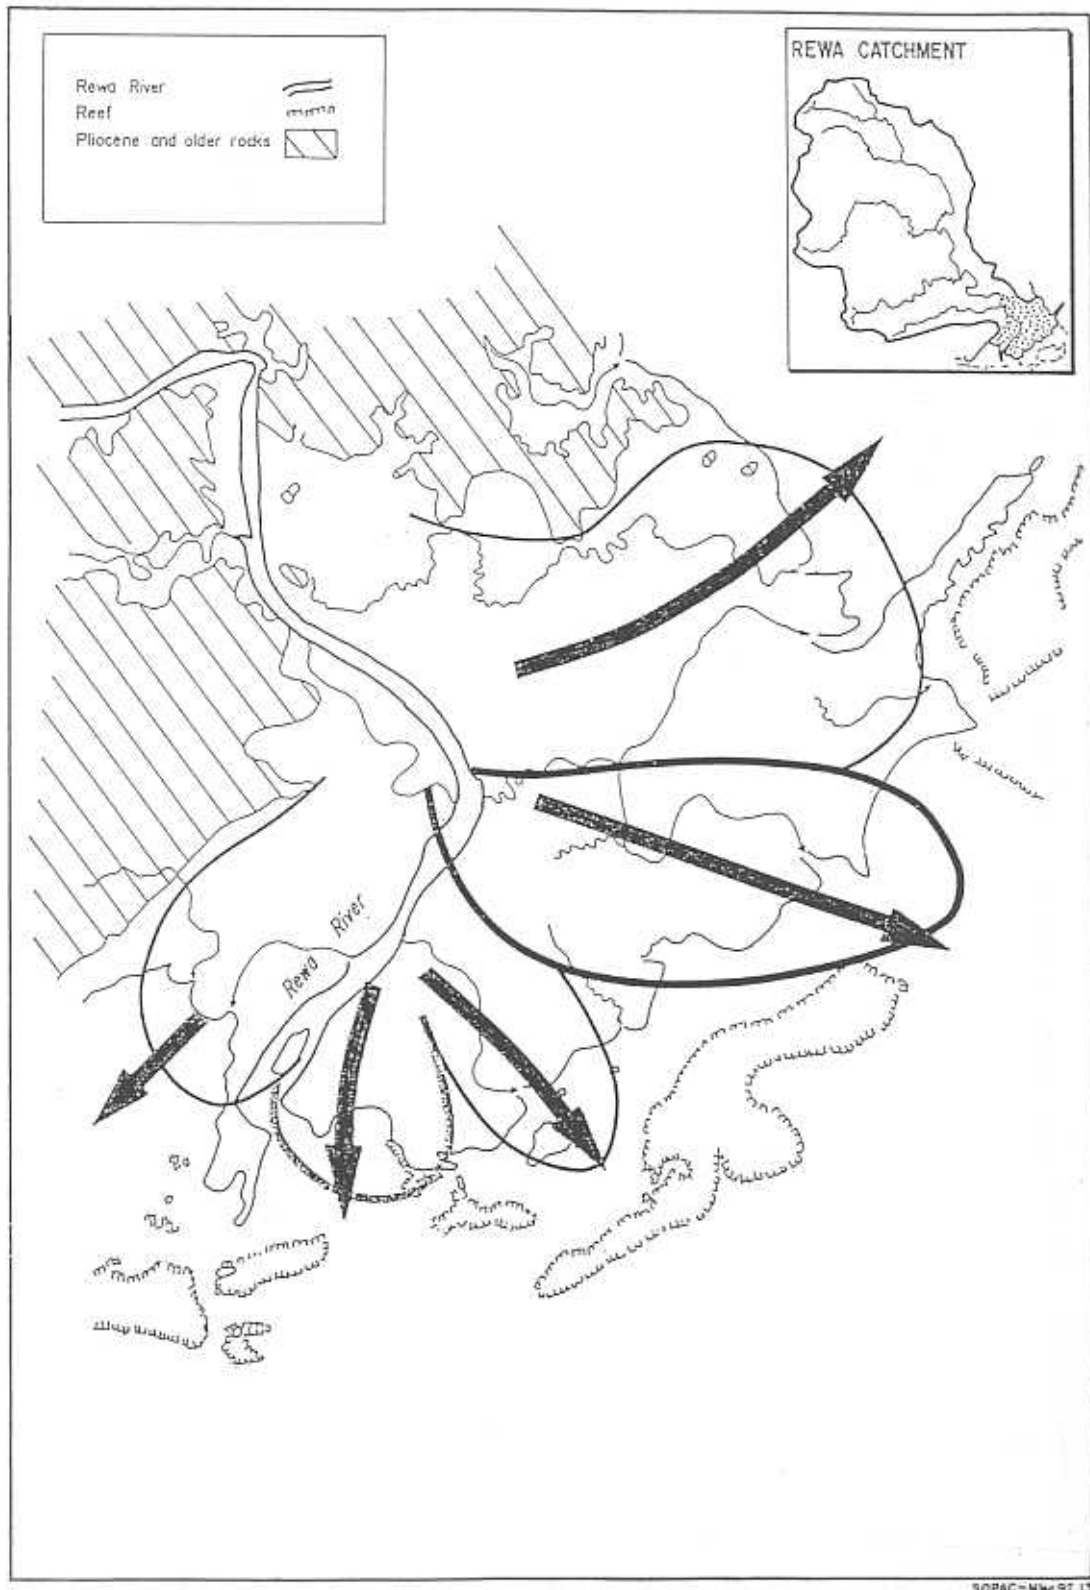
The Rewa Delta downstream from Kasavu (Plate 6) is a composite structure made up of at least five principal lobes (Figure 7). Each has been the major outlet for the Rewa River over recent geological time.

These lobes each have their own system of channels across the delta, many of which are abandoned during normal river flow conditions and are only occupied by water during floods. Much damage occurred where development has taken place which disregarded this natural and well-developed system of flood channels.

Figure 7. Map of the Rewa delta showing the principal lobes which constructed the present delta over the past 6000 years. Arrows indicate the main direction of discharge as each lobe was active. Note the position of present major channel and old channels, many of which are abandoned in normal flow conditions.

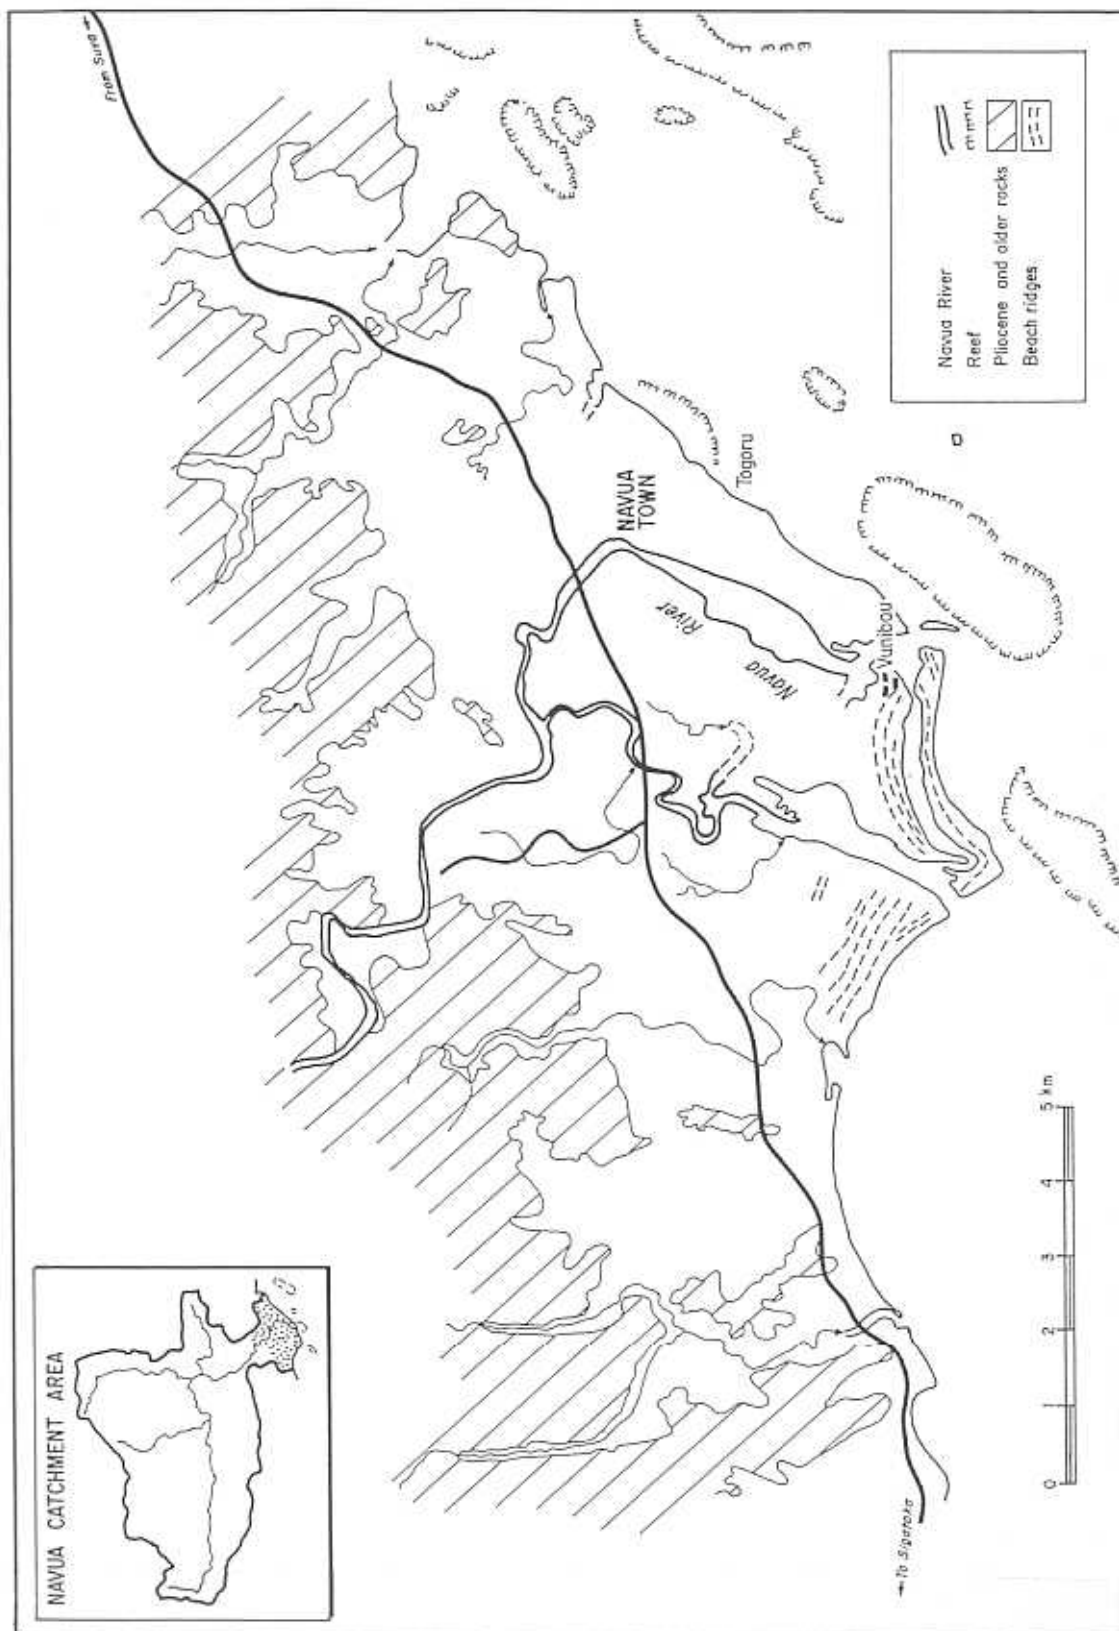
Road embankment erosion was severe along Queens Road from Navua Bridge to Nasasa Road junction. The erosion was most severe in the vicinity of Vakabalea Road junction where the Suva-Nadi highway crosses an abandoned river channel (Figure 8). Erosion of this type was also very common in this area as a result of Cyclone Wally (Plates 10, 11). The

Figure 8. Map of the Navua delta, note position of Suva-Nadi highway in relation to abandoned river channels.

extensive gully of the road embankment on the coastal side was caused by strong currents and small water falls formed when water flowed over the road from north to south. A whole range from small potholes roughly 1 m in diameter to major scouring up to 2 m deep and 50 m in length are seen.

5. Seawalls built in lowlying areas often cause more damage during storms and periods of flood than they are designed to prevent.
6. In reconstructing the Suva-Nadi highway across the Navua delta, adequate culverts should be provided to cope with at least the 20-year flood in areas where the road embankment crosses old channels.

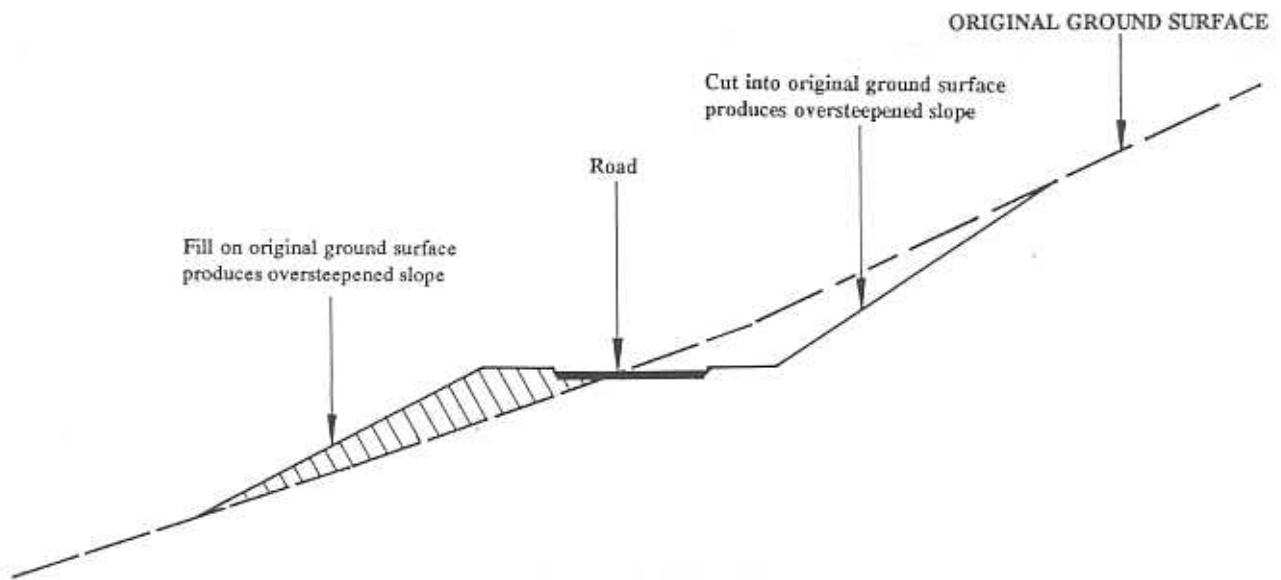
Slope failures in excavations above the road level were typically debris slides over failure planes. The planes are inferred to be relict structures such as bedding, faults, and joints. Following displacement, the slide mass has disintegrated due to the very low strength material involved (Plate 13).

Slope failures below the road level have occurred at the heads of steep gullies and took the form of earth flows/mud flows which scoured the gullies for up to a hundred meters. The flows occurred within the red, lateritic soil and have involved the road fill placed on the natural ground surface.

Figure 10. Sketch cross section of a typical hillslope "cut-and-fill" construction used for road development.

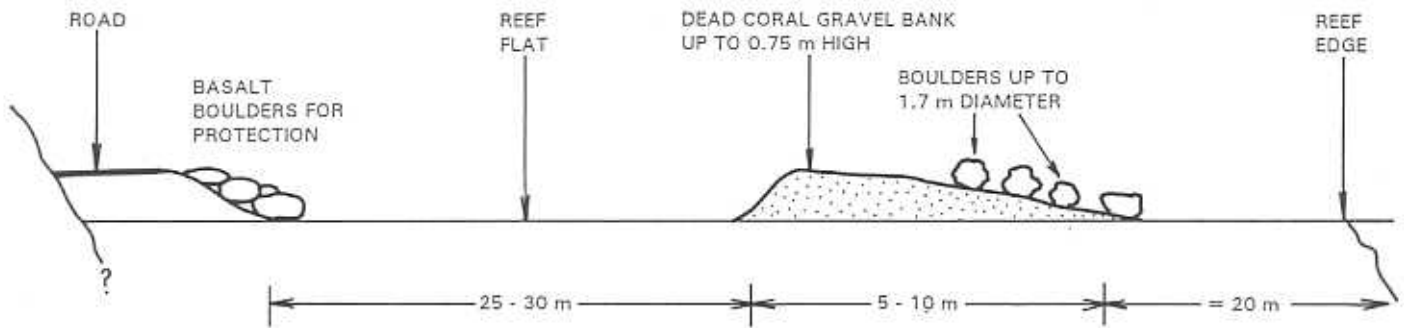
KINA CYCLONE BANK OF BURELEVU (NEAR QVS)

As Cyclone Kina approached from the northwest this coast of Viti Levu was subjected to sustained onshore easterly winds. Once the cyclone had passed this coast was largely sheltered from the southerly winds. During the period of easterly winds a "bank" of coral debris was deposited on the reef flat and close to the reef edge, discontinuously along the entire coast (Plate 18). The material was uplifted from the reef front by the wave action. An example of such a feature can be readily seen, close to the road north of Burelevu near Queen Victoria School (Figure 12, Plates 19, 20).

The shape of the bank is a wave form with a steep inland facing slope and gentle seaward facing slope, which would be expected from a dominant onshore flow direction. The dimensions of the bank were 10-15 m wide and up to 0.75 m high at the inland edge. Most of the debris was gravel size, dead, branching coral but included scattered boulders up to 2-3 cubic metres. On the larger boulders, some live coral (blue tips) were seen eight days after the event.

Figure 12. Kina cyclone bank north of Burelevu near Queen Victoria School. Note that mangrove protects the road along most of this stretch of the coast.
