# KIRIWATSAN Water Resources Assessment Nikunau Island, Kiribati

## Water Resources Assessment

### NIKUNAU ISLAND, KIRIBATI

April 2015

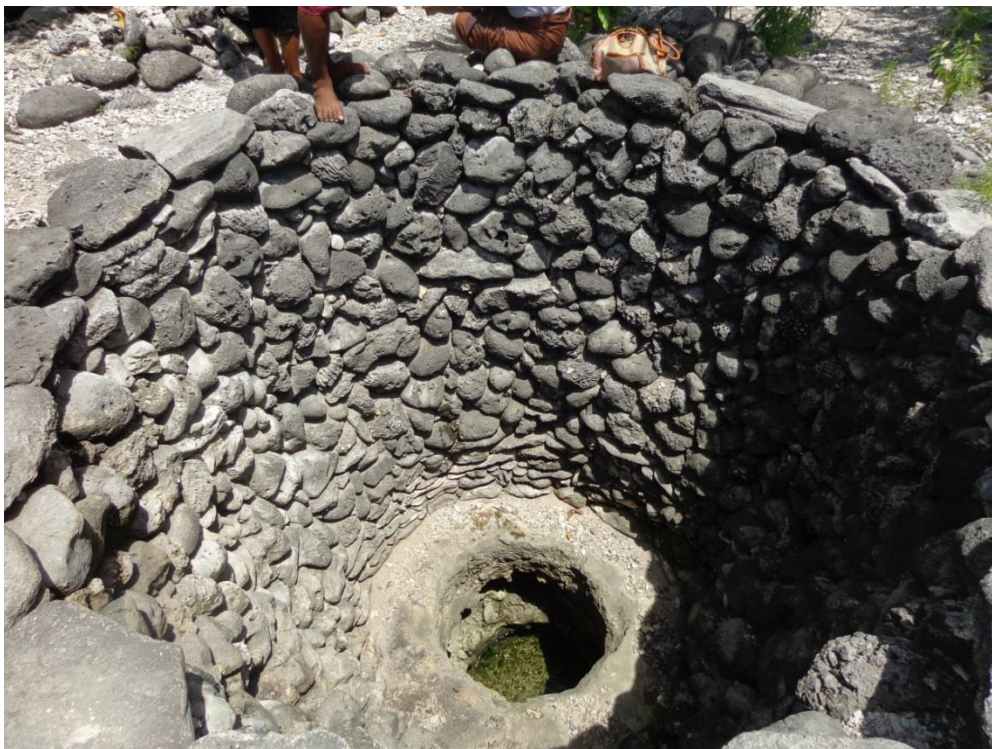
In Nikunau, groundwater is the reliable water source for most communities for drinking and domestic needs. Generally groundwater is accessed by shallow wells and unprotected or poorly protected wells<sup>2</sup> (Figure 9) with an estimated 73% of households abstracting the groundwater with the use of bailers (Figure 10). Most wells are poorly sited and constructed. Many wells have inadequate casing or are unlined, and constructed with minor consideration to reducing the potential for contamination or with regard to optimal water quality.

**Figure 9. Typical household well excavated down to bedrock and using coral rock as casing materials, without parapet and fence.**

- Use of concrete as apron material to prevent the infiltration of surface water close to the well.
- Construction of fences to protect well infrastructure and minimise access by animals.
- Promote the use of *Tamana* pumps to reduce the potential of contamination from bailers.
- Promote the use of bailer stands to keep the bailers off the ground where bailers are continued to be used.
- Decommissioning and/or relocation of wells too close to potential contaminant sources.
- Backfilling of all abandoned wells up to ground level.
- Boiling of all well water prior to any human consumption.

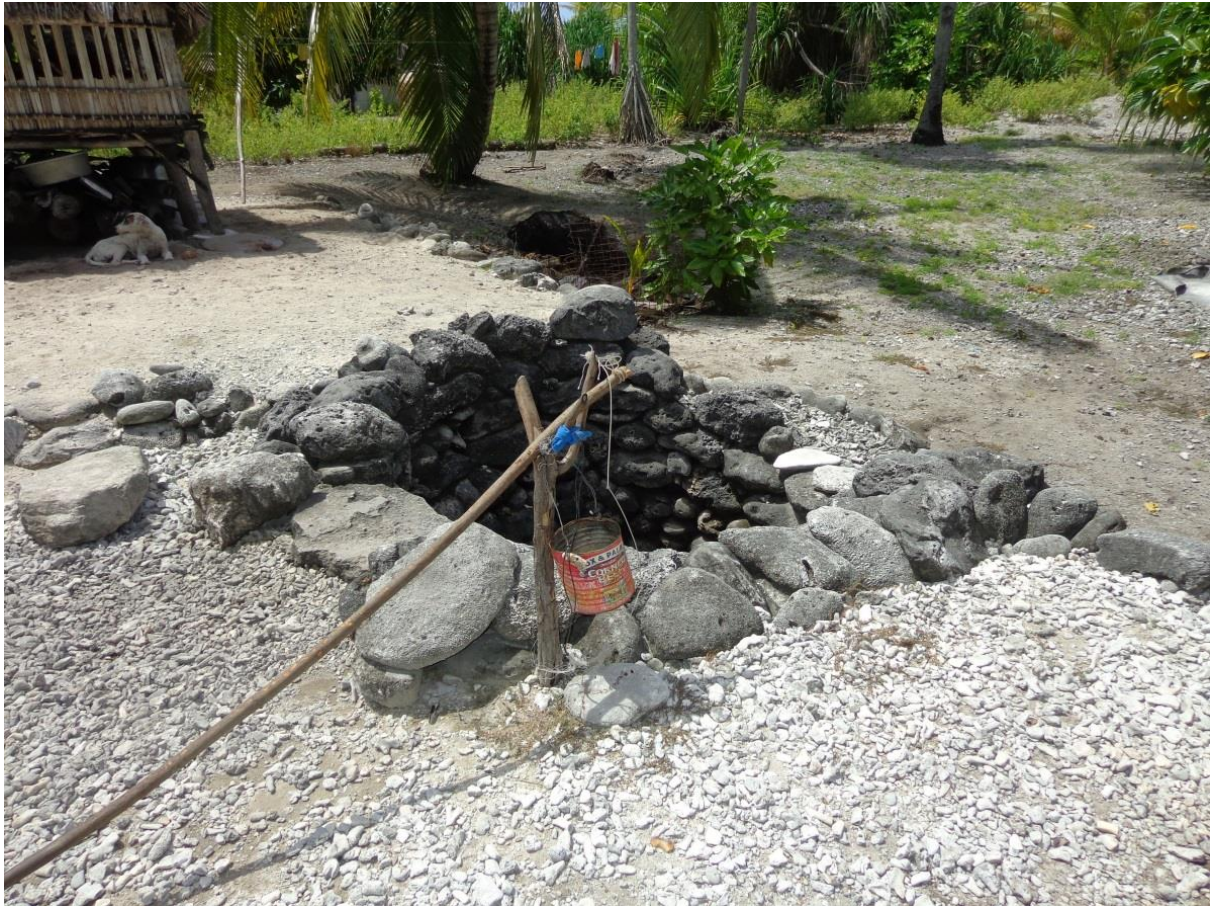
**Figure 10.** Typical bailer used for abstraction of groundwater from a local well, Nikumanu, Nikunau.

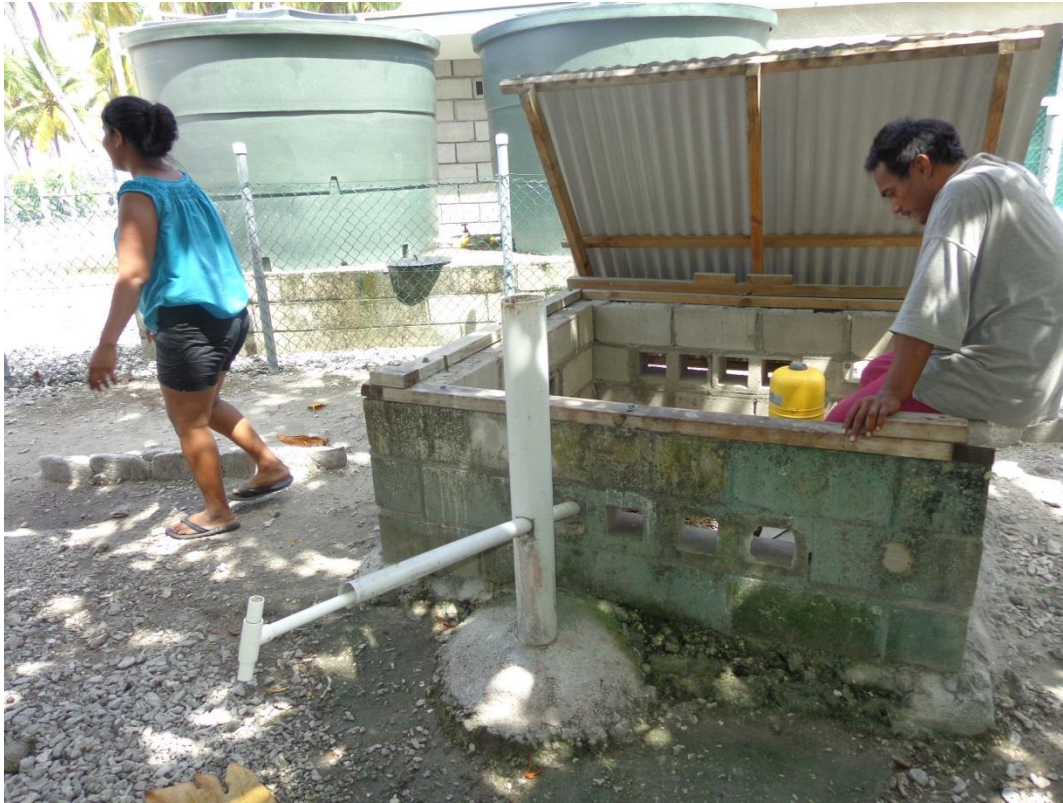
**Figure 11.** *Locally-made Tamana pump or hand pump used for abstraction of groundwater from a nearby local well, Nikumanu, Nikunau.*

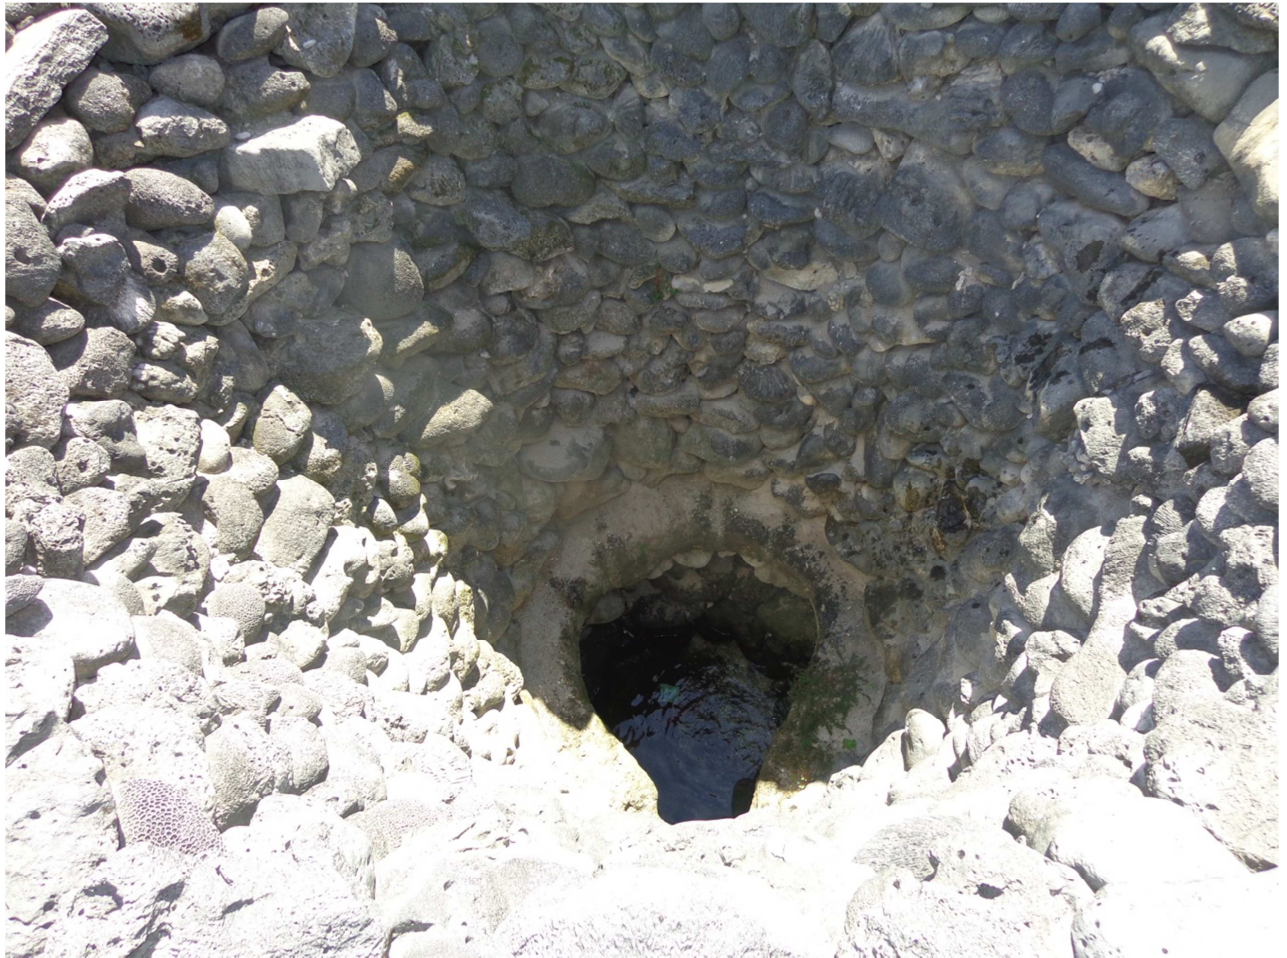
**Figure A11-1.** *A household well using coral rock as casing material right down to bedrock.*

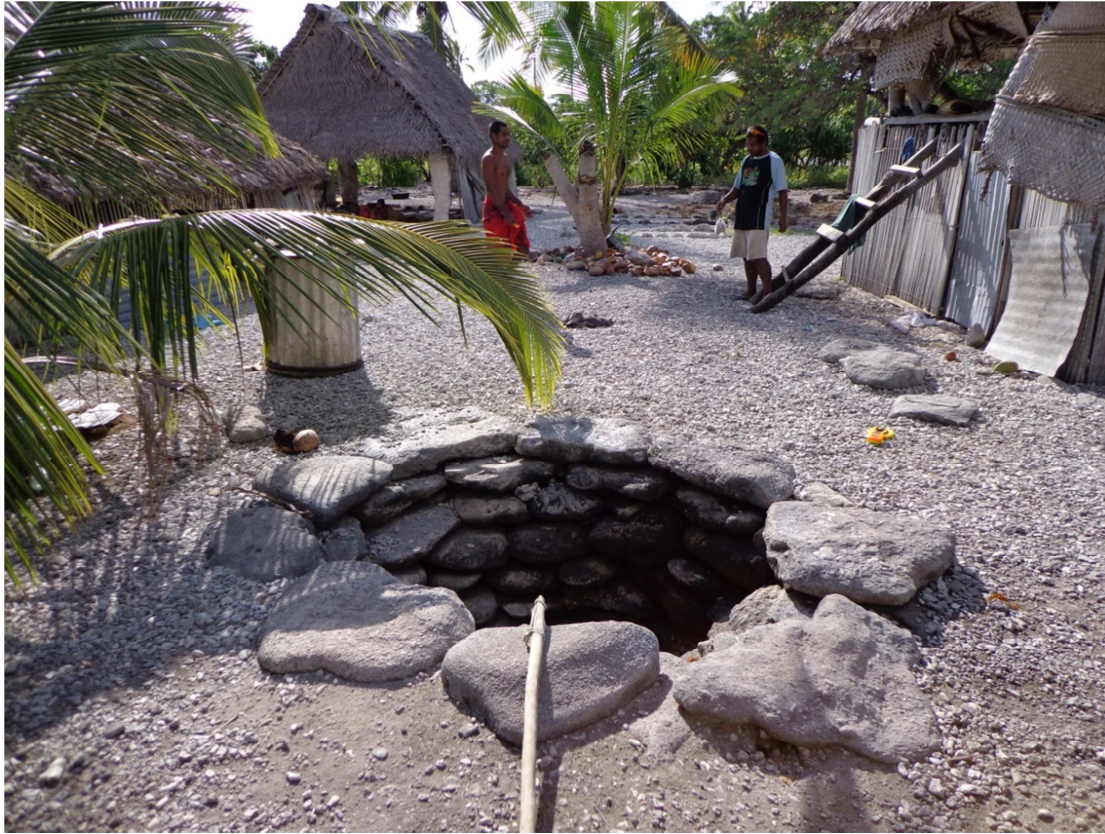
*Figure A11-6. Tamana distribution line from a poorly protected household well.*

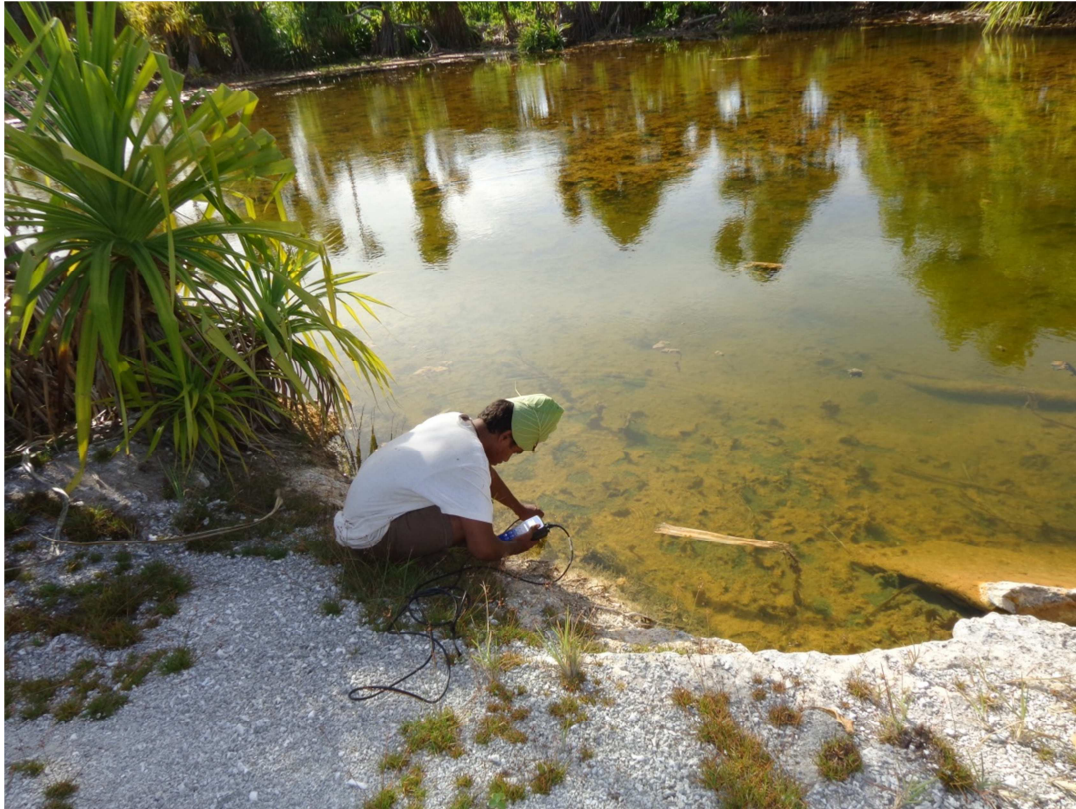
**Figure A11-8.** Salinity measurement of the saline lake located inland from Rungata Village with 15.6 mS/cm suggesting some mixing with adjacent freshwater bodies.
