**COASTAL DAMAGE INSPECTION  
SOUTHWEST VITI LEVU, FIJI  
AFTER CYCLONE SINA**

Brendan J. Holden  
SOPAC Technical Secretariat

*July 1992*

*SOPAC Technical Report 148*

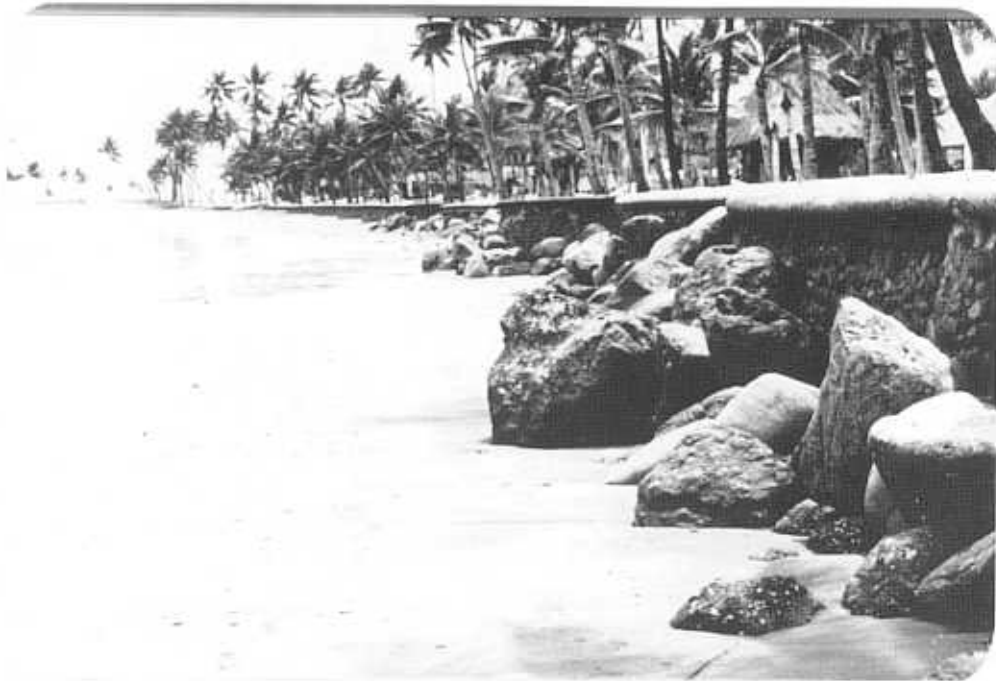
September 1990: Sheraton seawall before Sina.

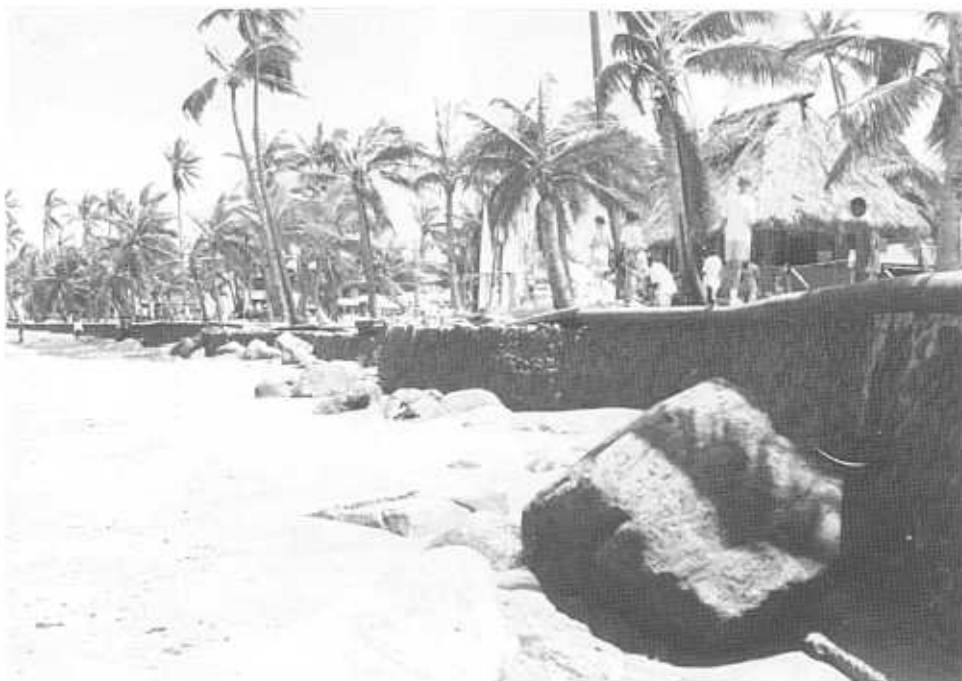
Figure 3.

At the Sheraton Hotel, there is a south-facing, decorative, rock and mortar seawall with concrete cap slabs. After Sina, there was about 0.3 m more sand at the foot of the wall; however, the concrete cap slabs were knocked off some parts of the wall, and there was about 0.3 m eroded off the lawn behind the wall (Figures 3-9).

December 1990: Sheraton seawall - after Sina. Note the buildup of sand fronting wall.

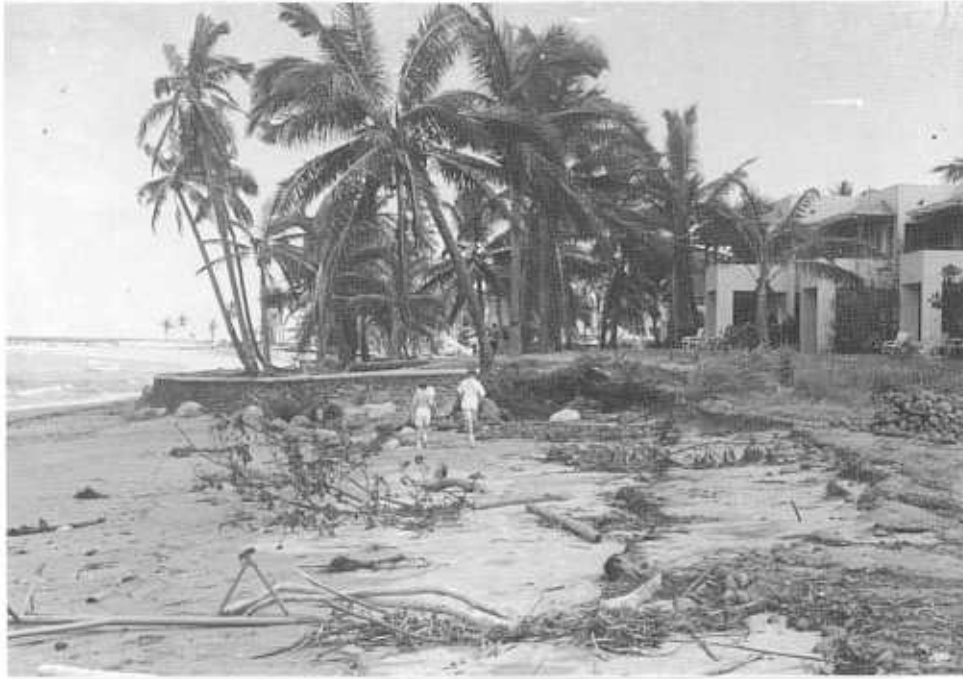
If these hotel beaches had been left in their natural state with the natural gentle slope, it is probable that they would have sustained little damage. This is shown in the area east of the seawall where the natural beach slope has been left essentially unaltered except for scour at the end of the wall (Figure 4). A natural gently sloping beach is better able to absorb storm waves than a seawall. If the beach hotels had been built back (setback) from the natural boundary of the sea, there would likely be much less erosion damage (Holden 1987).

December 1990: Sheraton seawall - after Sina. Note scour around the east end of the seawall but the adjacent original natural beach slope is changed little.

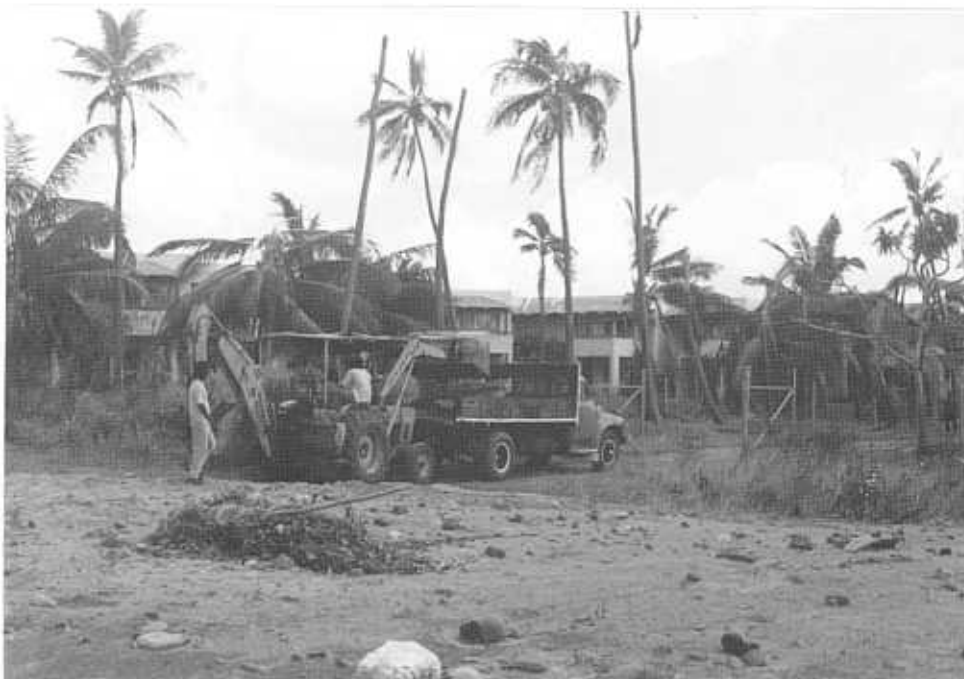
Figure 4.

December 1990: Sheraton seawall - after Sina. Note original natural beach east of seawall has an extra layer of sand and gravel after the storm.

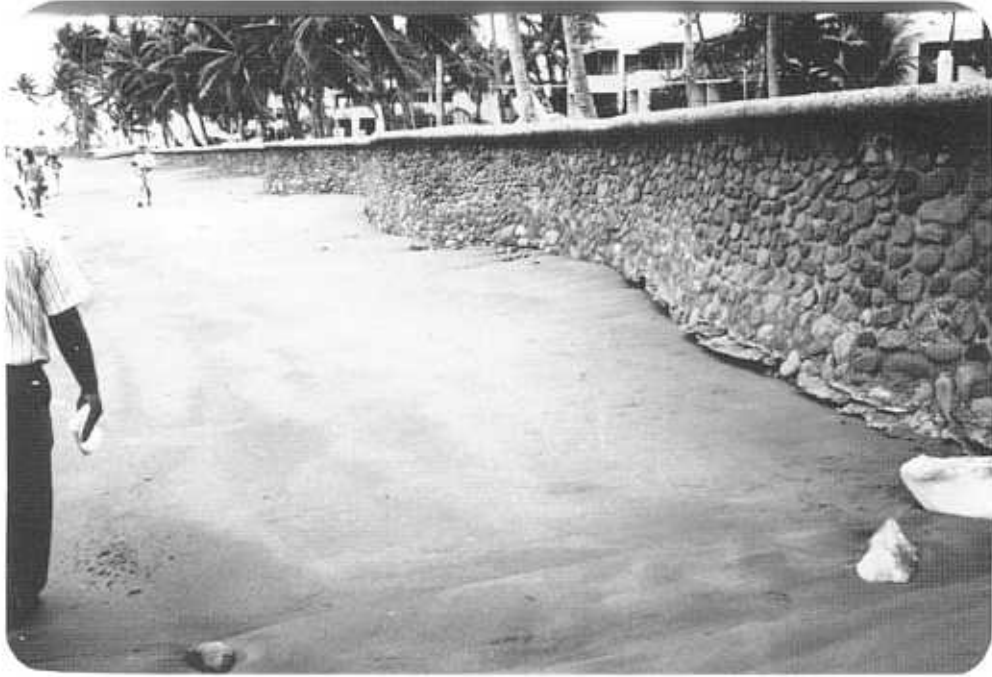
September 1990: Sheraton seawall - before Sina. Note under cutting of wall in foreground.

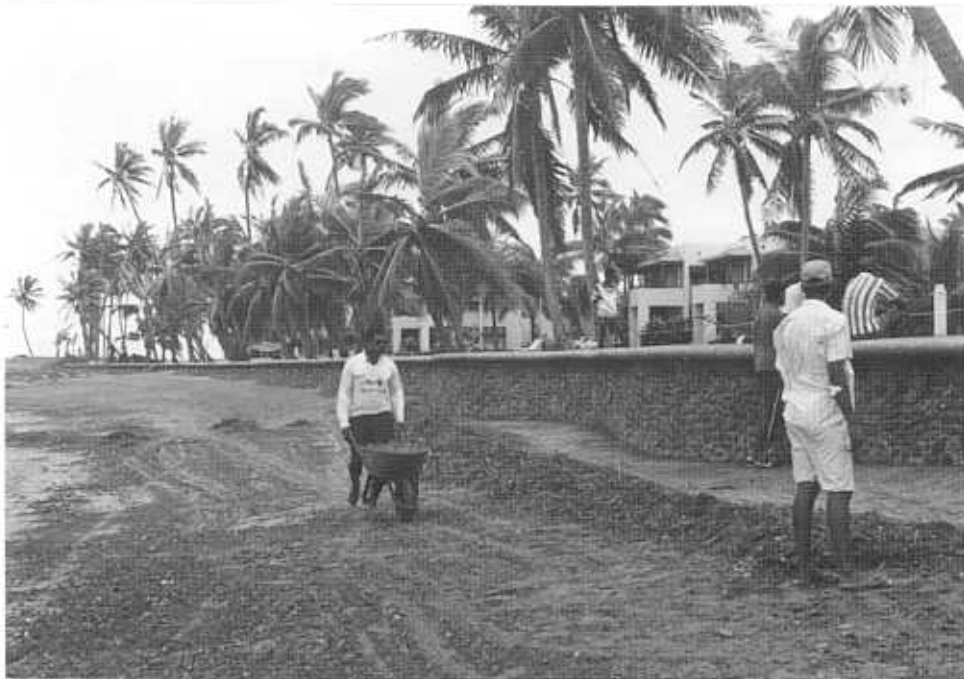
Figure 5.

December 1990: Sheraton seawall - after Sina. Note buildup of sand fronting wall.

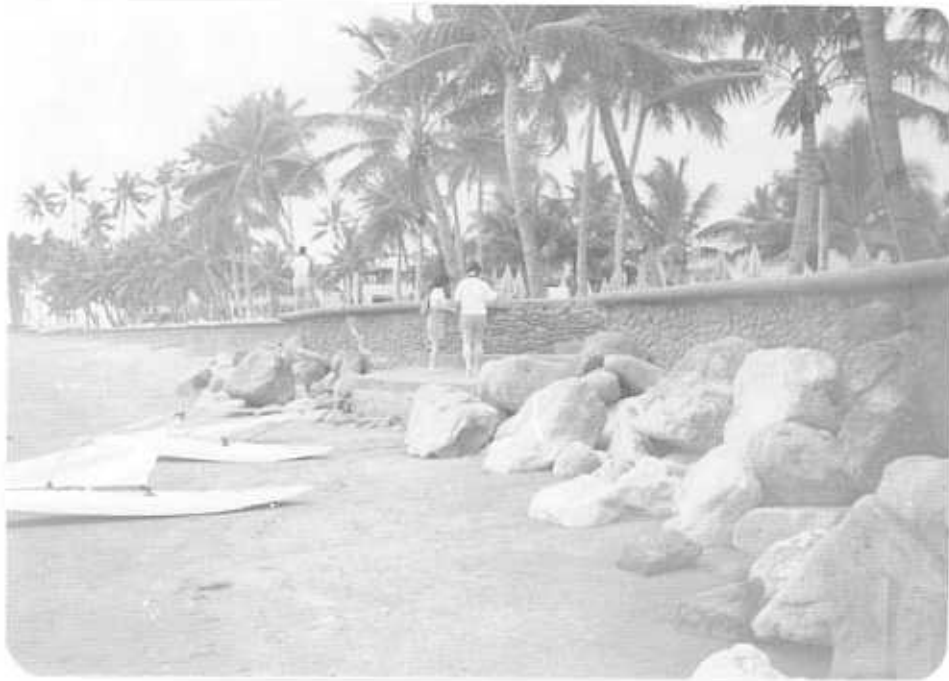
September 1990: Sheraton seawall - before Sina.

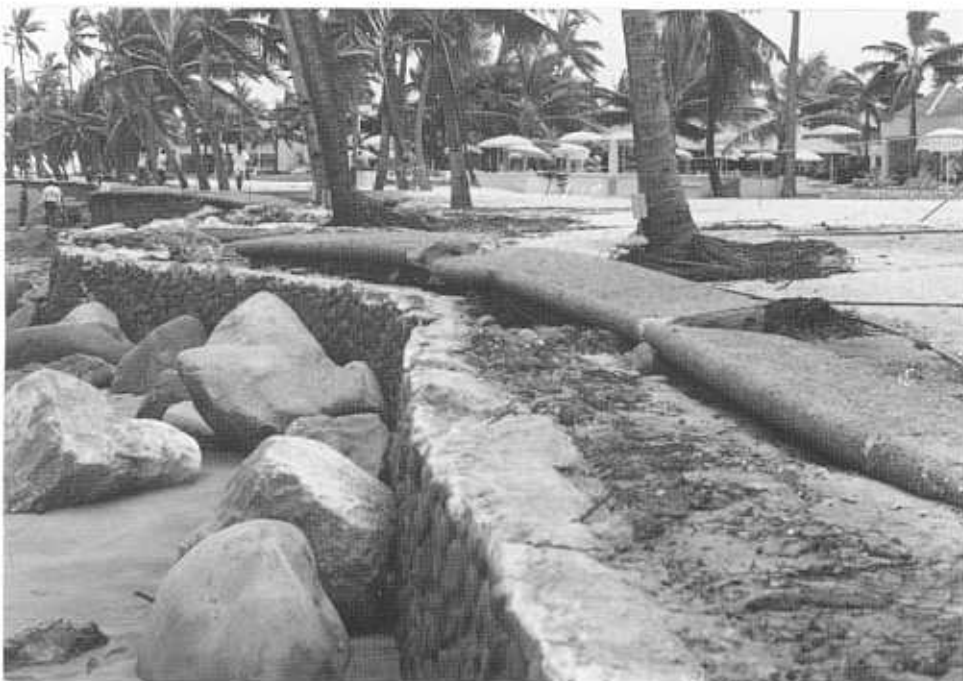
Figure 6.

Vertical seawalls tend to reflect the incoming waves and sometimes cause a standing wave much higher than the incoming wave in front of the wall. This phenomena causes scour in front of the wall and the result is a beach which is lower than the original natural beach. The effect of this scour could be seen in September 1990 at the toe of the Sheraton seawall (Figure 5). The buildup of sand at the toe of this seawall after Cyclone Sina indicates that the storm waves did not hit the wall directly. The waves which impacted this beach must have been refracted and attenuated so as to be essentially shallow water waves. These waves also lifted the cap slabs off the wall and overtopped the wall to scour the lawn behind the wall Figures 6, 7).

December 1990: Sheraton seawall - after Sina. Note buildup of sand fronting wall and removal of concrete capstones.

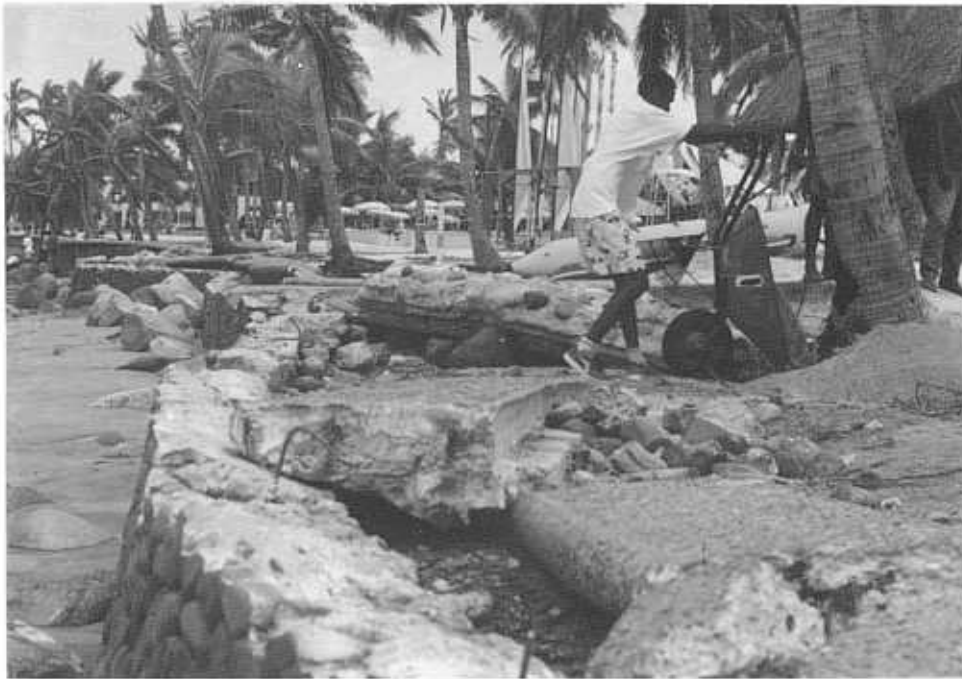
December 1990: Sheraton seawall - after Sina. Note: removal of concrete capstones and scouring behind wall.

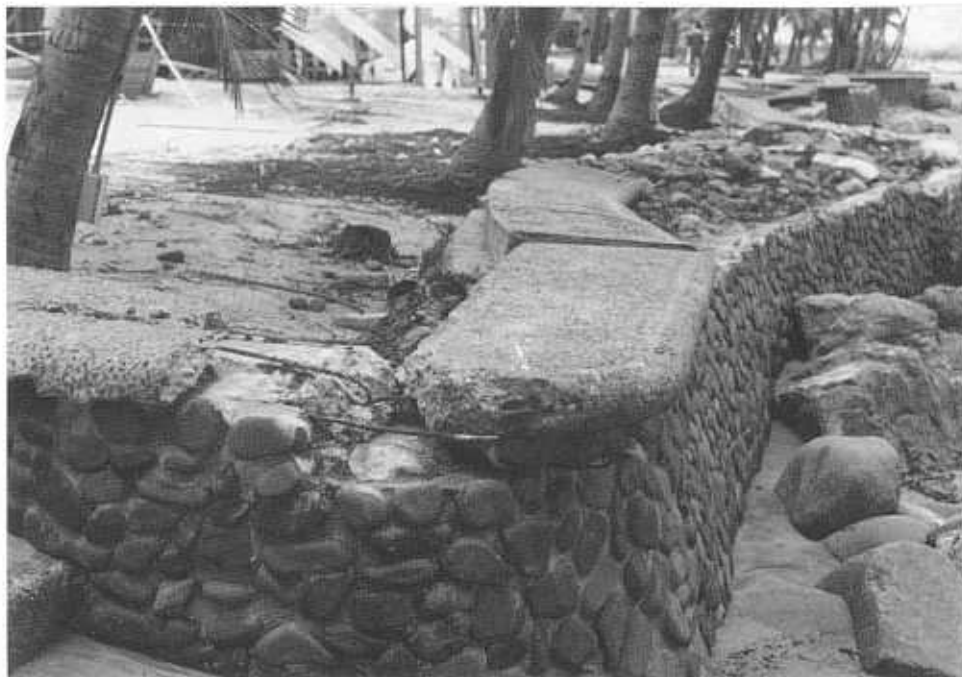
Figure 7.

December 1990: Sheraton seawall - after Sina. Note: scouring and broken capstones.

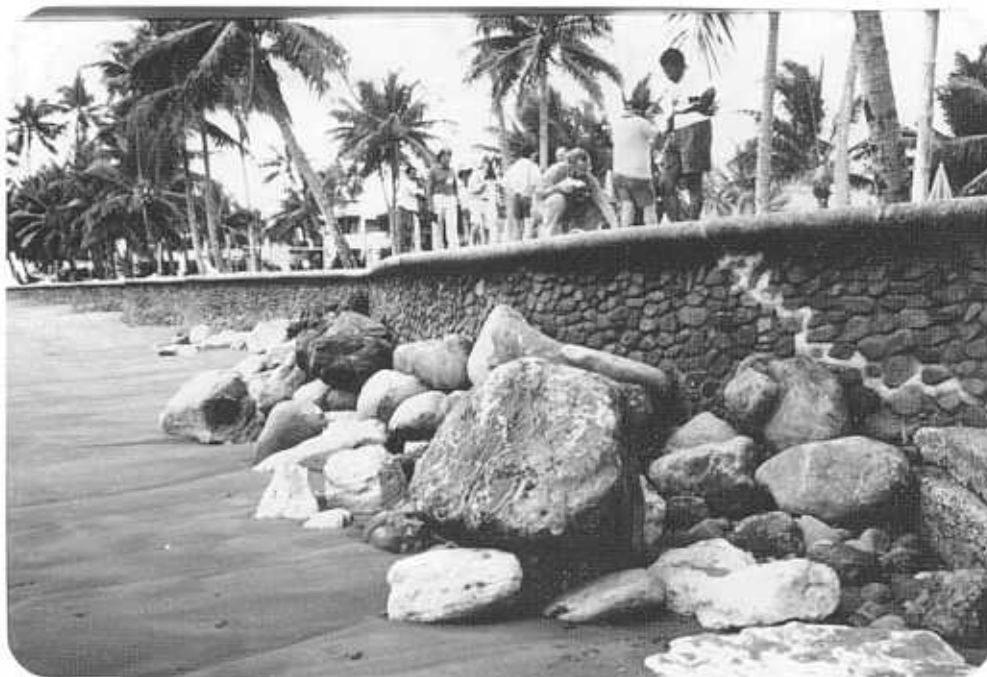
September 1990: Sheraton seawall - before Sina. Note: scouring of bottom step.

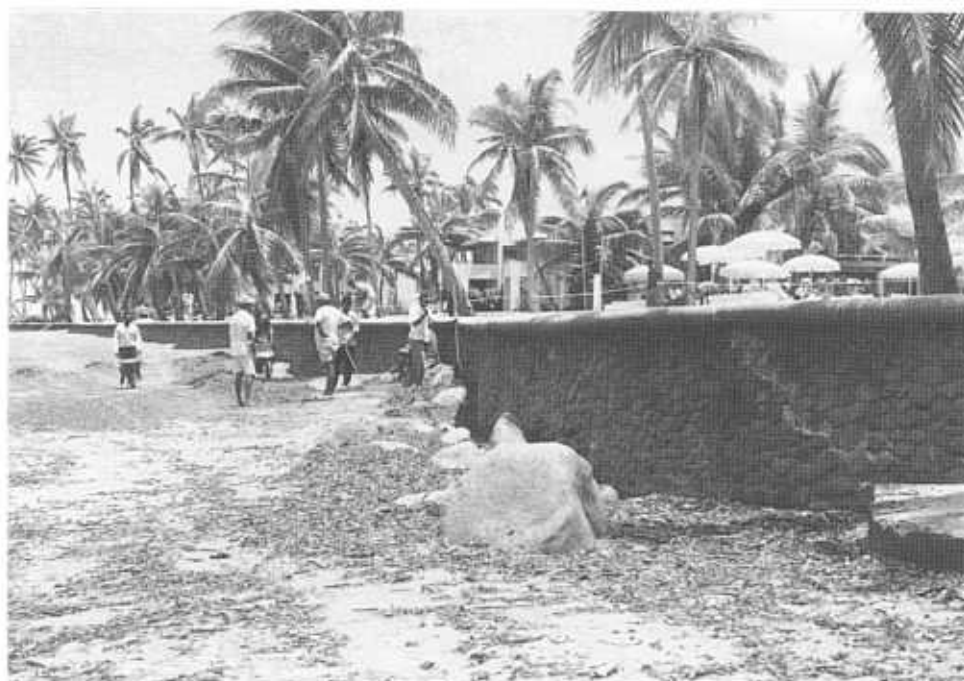
Figure 8.

December 1990: Sheraton seawall - after Sina. Note: buildup (0.5 m) of sand at bottom step.

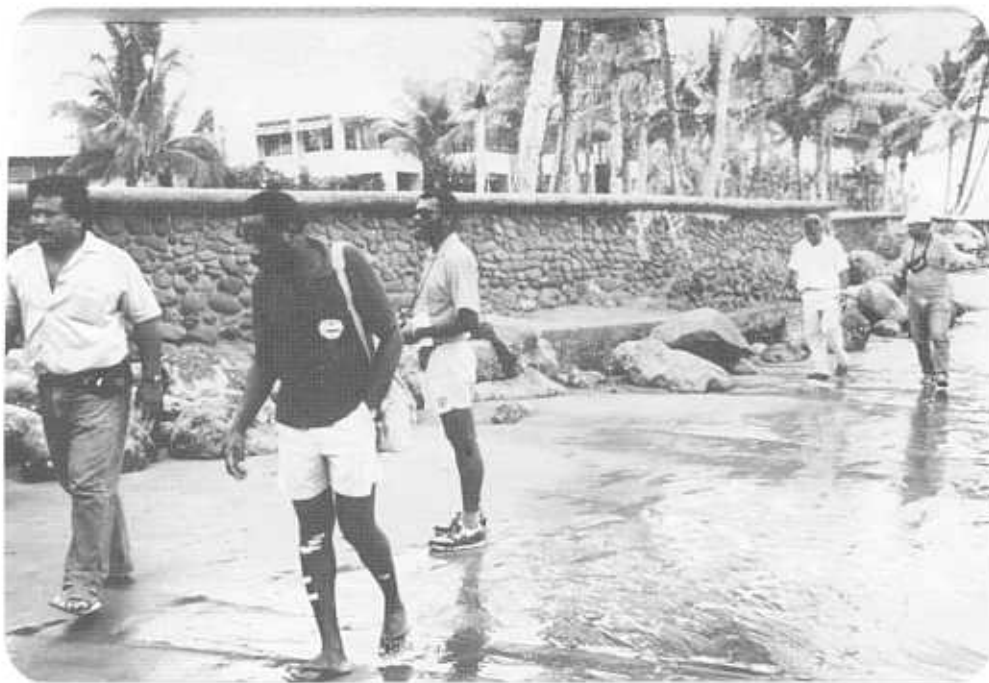
September 1990: Sheraton seawall - before Sina. Note: concrete slab toe protection in front of wall.

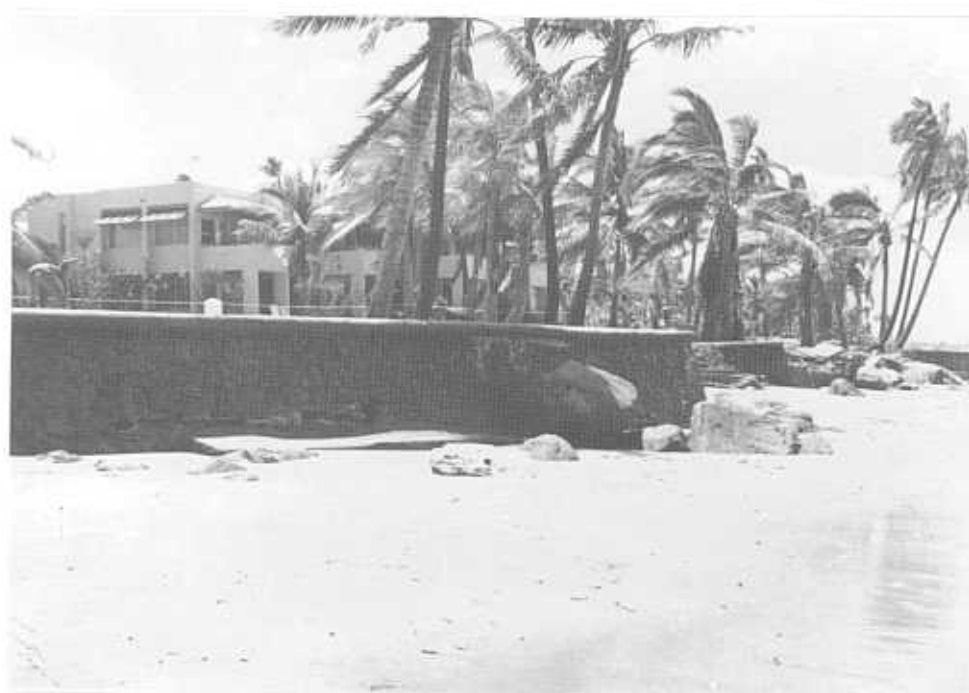
Figure 9.

December 1990: Sheraton seawall after Sina. Note: sand buildup (0.5 m) flush with concrete slab and boulder (1 m diam.) upon concrete slab.

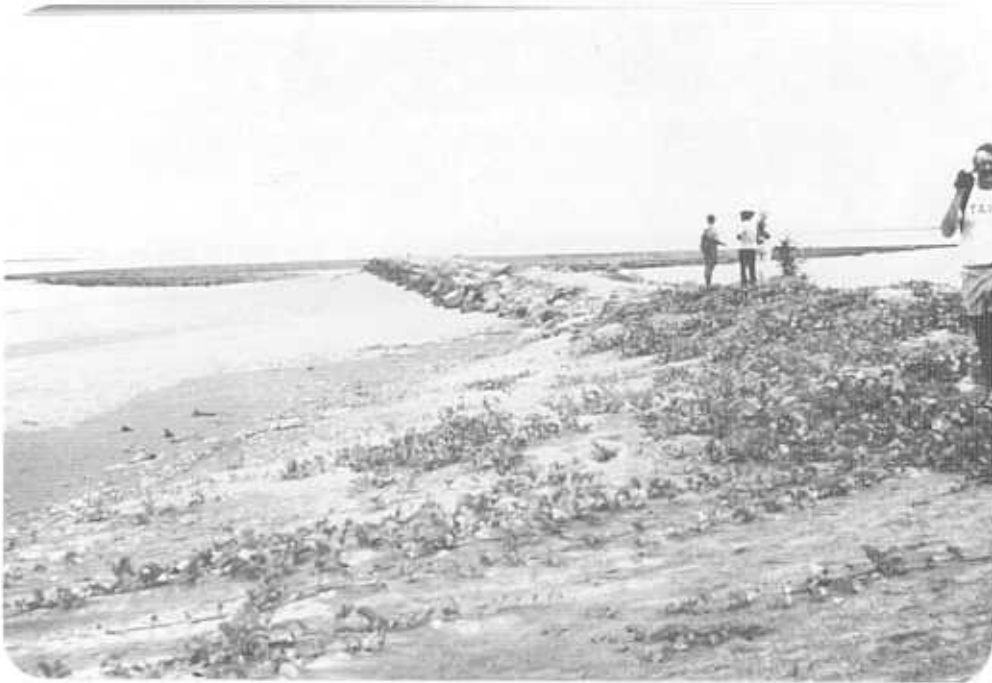
The Sheraton also has a large rock groyne running south from the western corner, (Figures 10, 11) where the shoreline turns about 90 degrees and runs northward. In September, this groyne had a build-up of sand on its updrift (eastern) side and a scarcity of sand on its western side. On the western side of this groyne, the shoreline runs northward for the remainder of the Sheraton property and was protected by a rubble (rock and gabion) seawall. After Sina, this shoreline was eroded from about 7 to 15 m and only remnants of the rubble seawall remained in a line along the beach (Figures 12-15). The area behind this seawall appears to have been landfill because of the fill debris evident in the eroded bank (Figures 13, 15).

September 1990: Sheraton groyne - before Sina. Note: buildup of sand and vegetation.

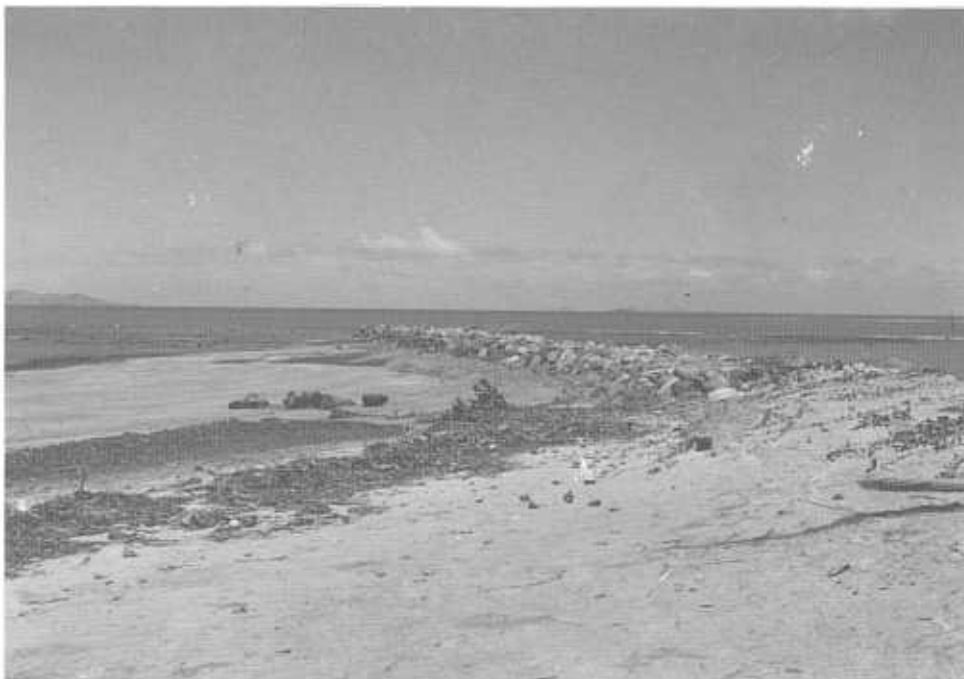
Figure 10.

December 1990: Sheraton groyne - after Sina. Note: sand and vegetation scoured.

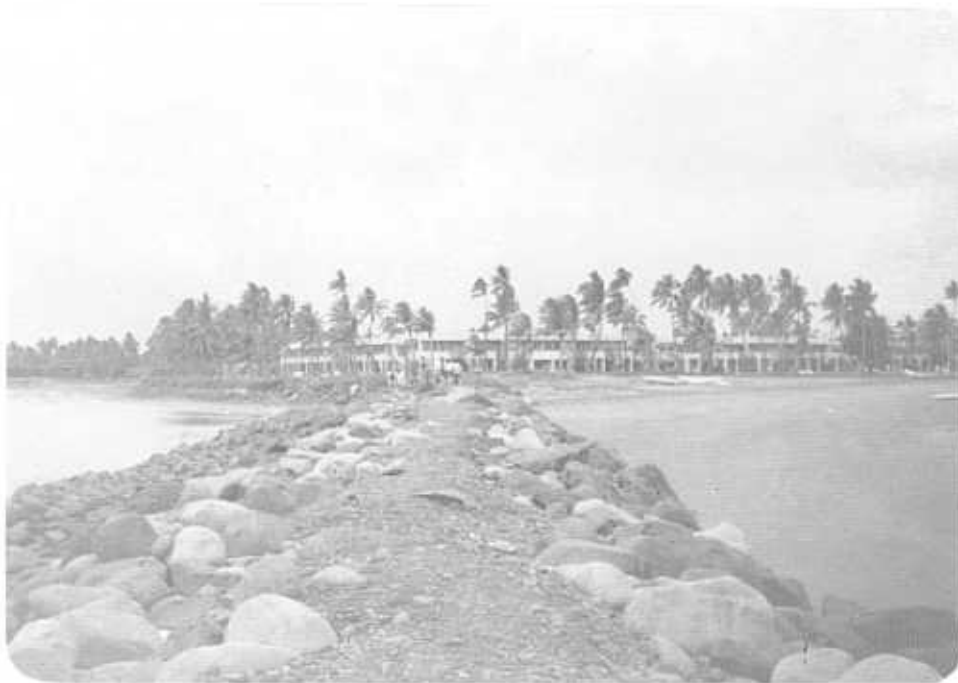
September 1990: Sheraton groyne - before Sina. Note: sand and gravel path on top of groyne.

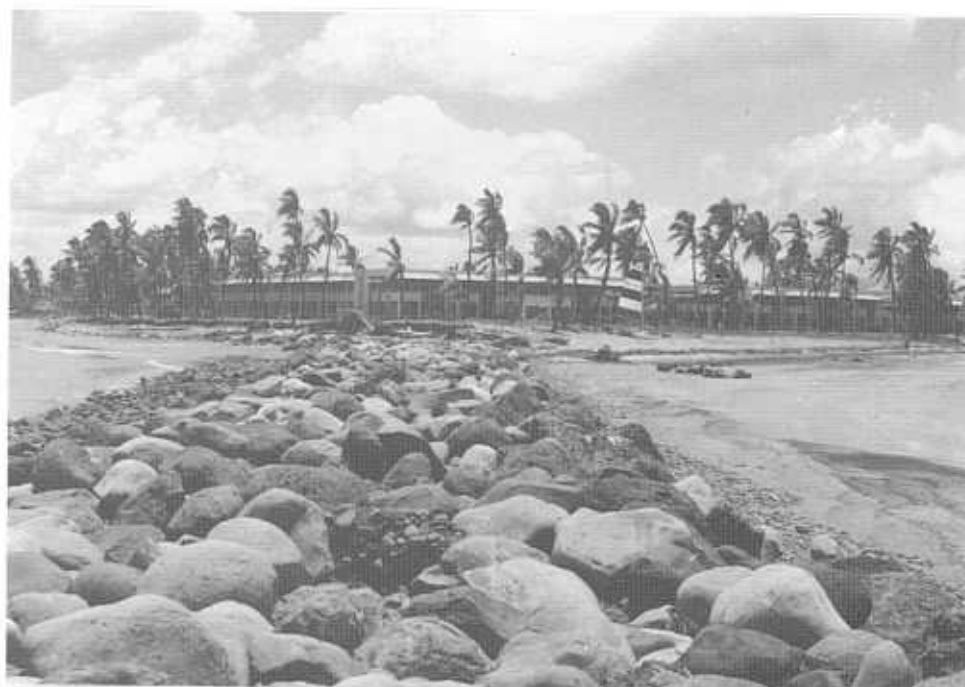
Figure 11.

December 1990: Sheraton groyne - after Sina. Note: sand and gravel path is gone.

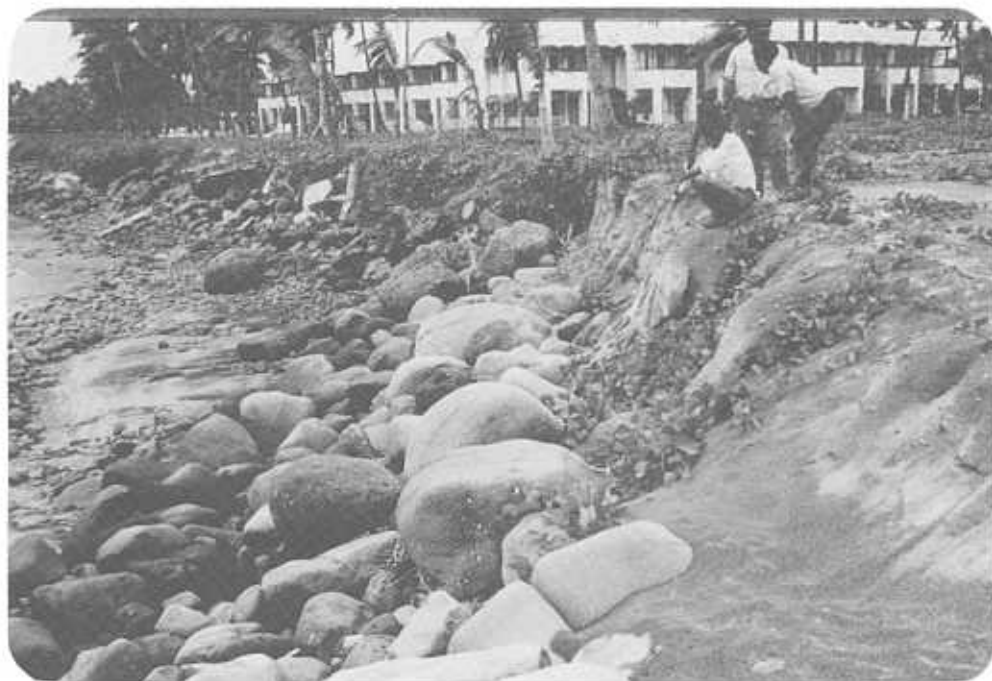
September 1990: Sheraton west side - before Sina.

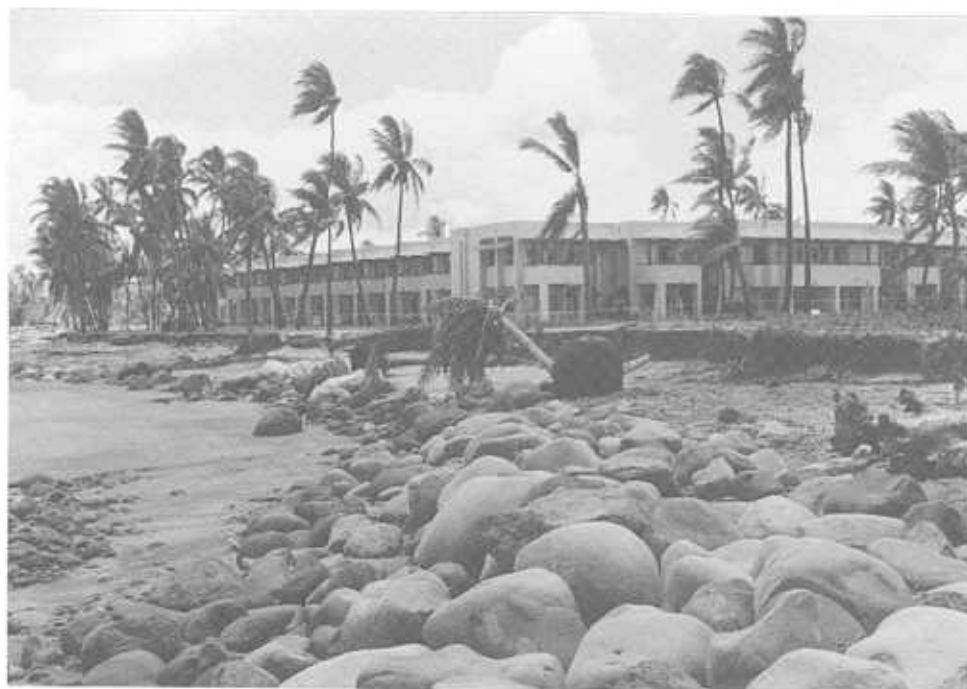
Figure 12.

December 1990: Sheraton west side - after Sina. Note: about 10 m of erosion.

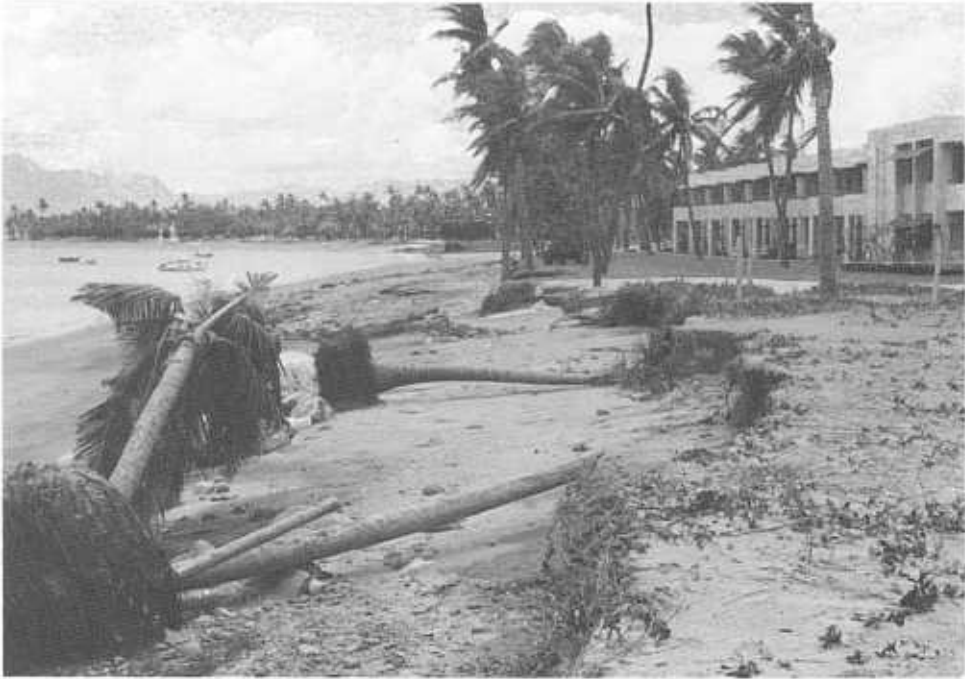
December 1990: Sheraton west side - after Sina. Note: erosion and sand thrown up on lawn.

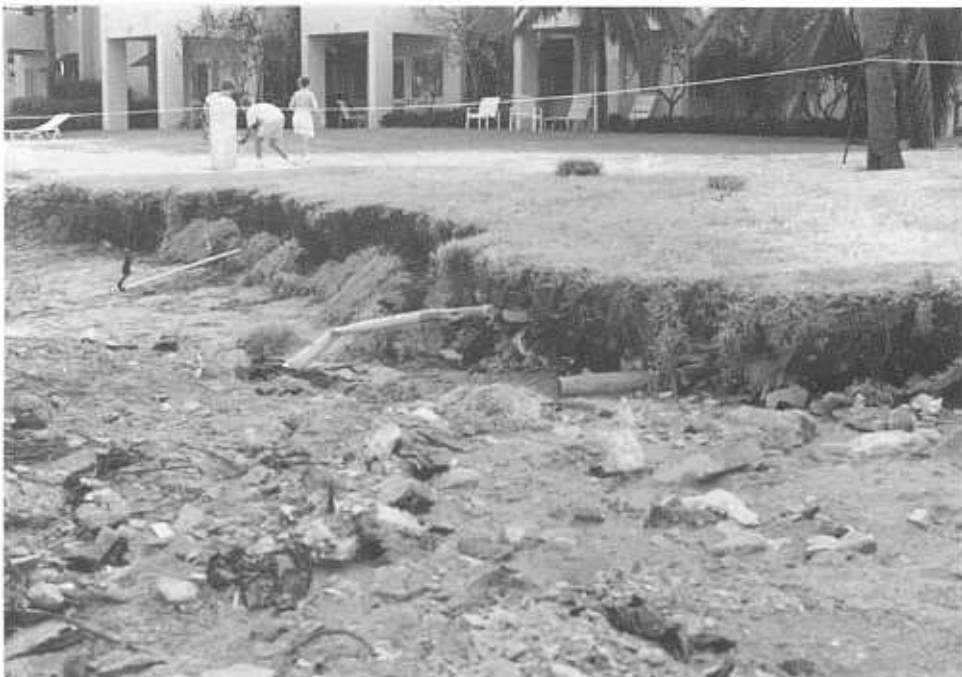
Figure 13.

December 1990: Sheraton west side - after Sina. Note: erosion of lawn exposing irrigation pipes. Debris in bank indicates that this was reclaimed land.

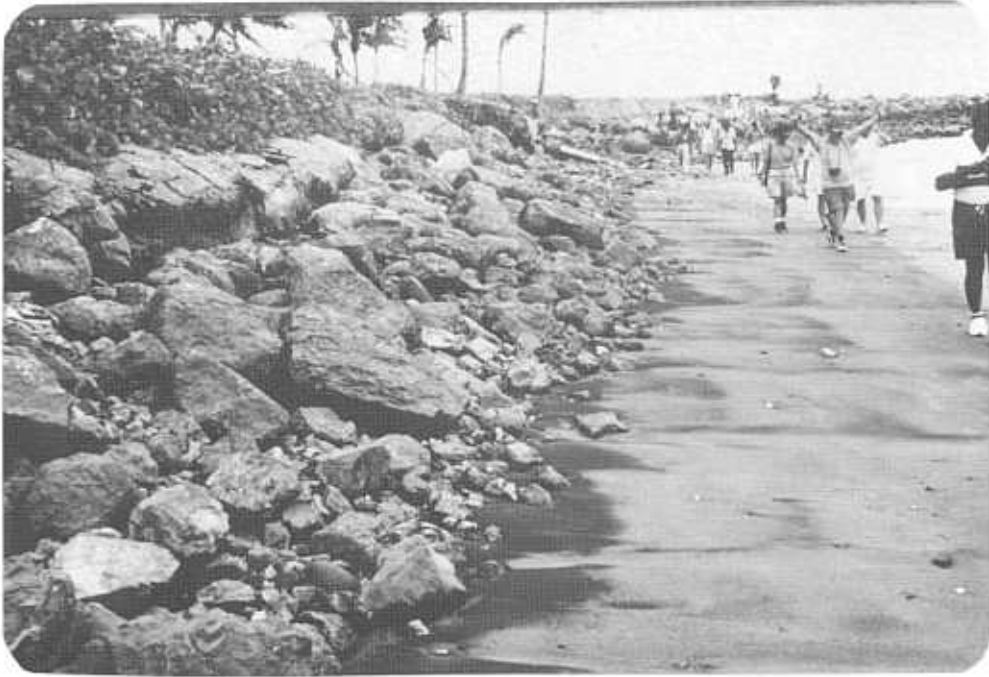
Properly designed rubble mound seawalls are generally the best method of coastal protection. Proper design means having appropriately graded filter layers and adequately sized armour stone. The rubble mound seawall on the west side of the Sheraton was obviously not designed properly because it disappeared completely (Figure 14). On this side of the Sheraton the storm waves appear to have hit the shore directly because the material was removed offshore.

September 1990: Sheraton west side - before Sina. Note: poorly designed rubble mound protection.

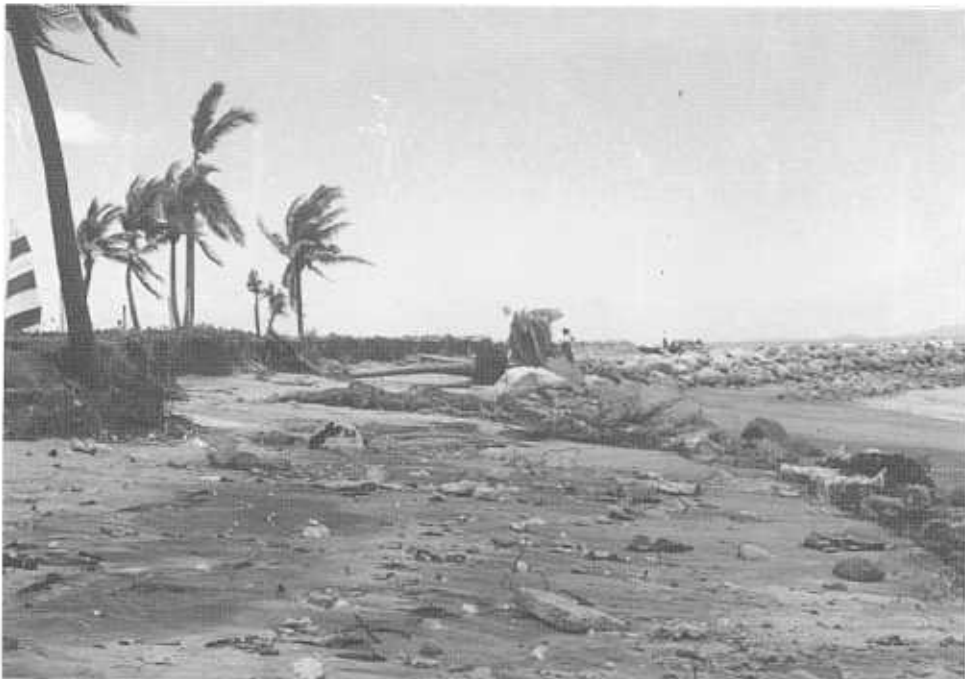
Figure 14.

December 1990: Sheraton west side - after Sina. Note: rubble mound protection is gone.

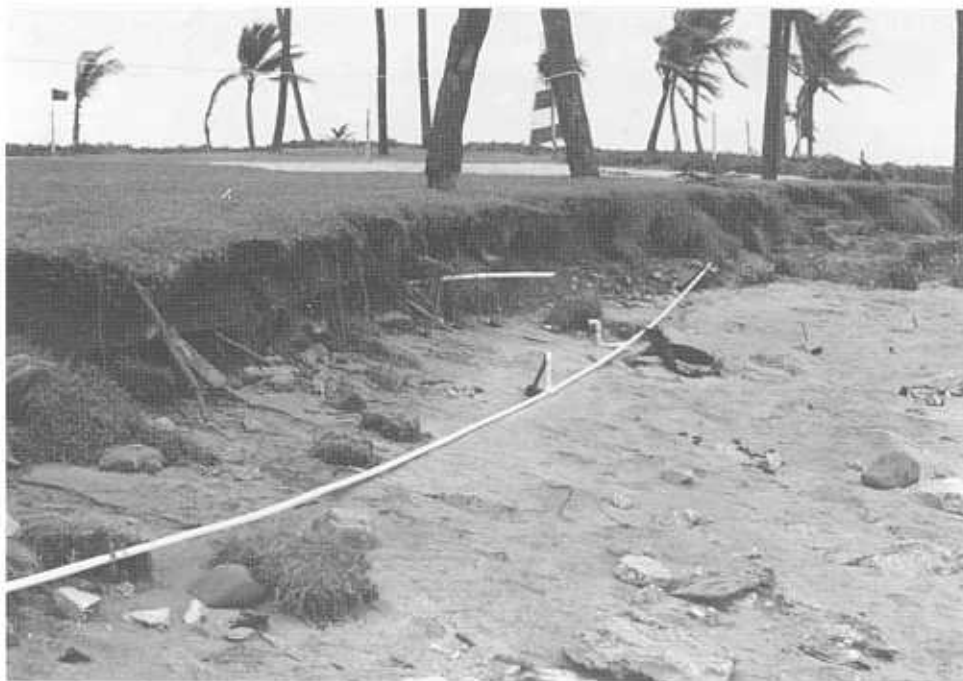
December 1990: Sheraton west side - after Sina. Note: irrigation pipes exposed and debris in bank indicating reclaimed land.

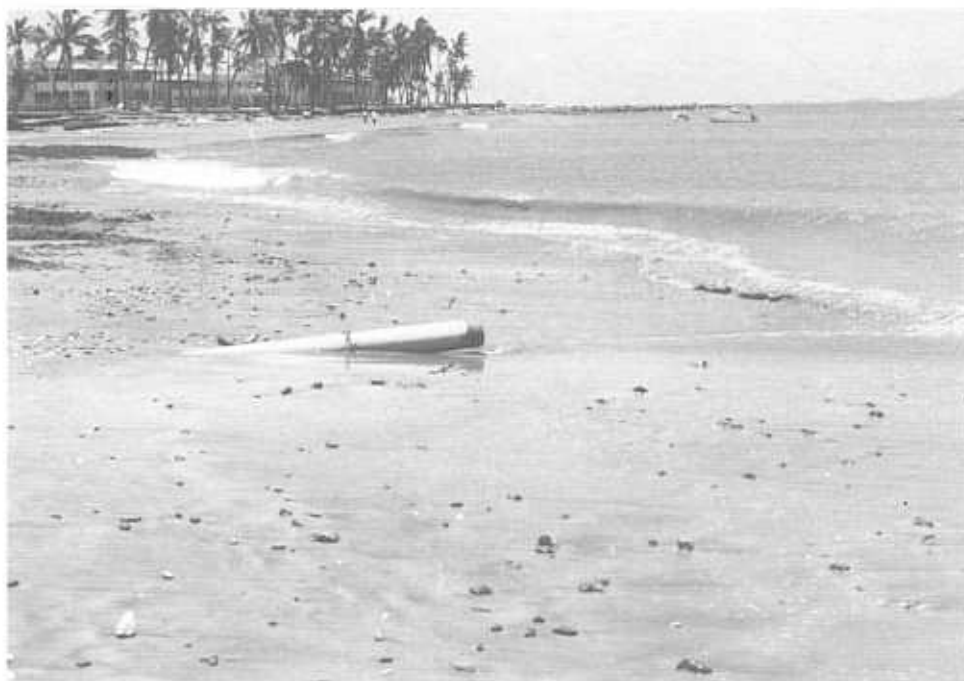
Figure 15.

The Regent Hotel has beach frontage, with no seawall, and is located immediately northwest of the Sheraton. It appeared that this beach had eroded badly, because sand had been dumped at the edge of the lawn and a bulldozer was grading the beach on 1 December. Since restoration work had already begun, it was not possible to see and photograph the state of erosion following Cyclone Sina. A 15 cm plastic outfall pipe, which was exposed on the beach in September, was now broken and spilling onto the beach (Figure 15).

December 1990: Sheraton west side - after Sina. Note: outfall pipe near Regent Hotel is broken and spilling onto beach.

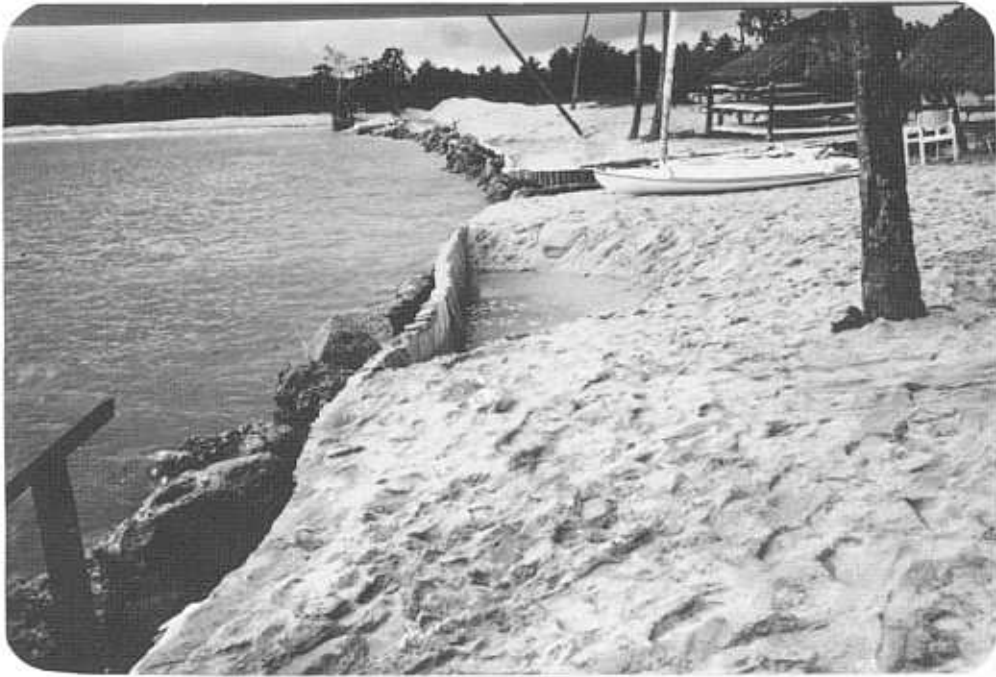
September 1990: Fijian Hotel - before Sina.

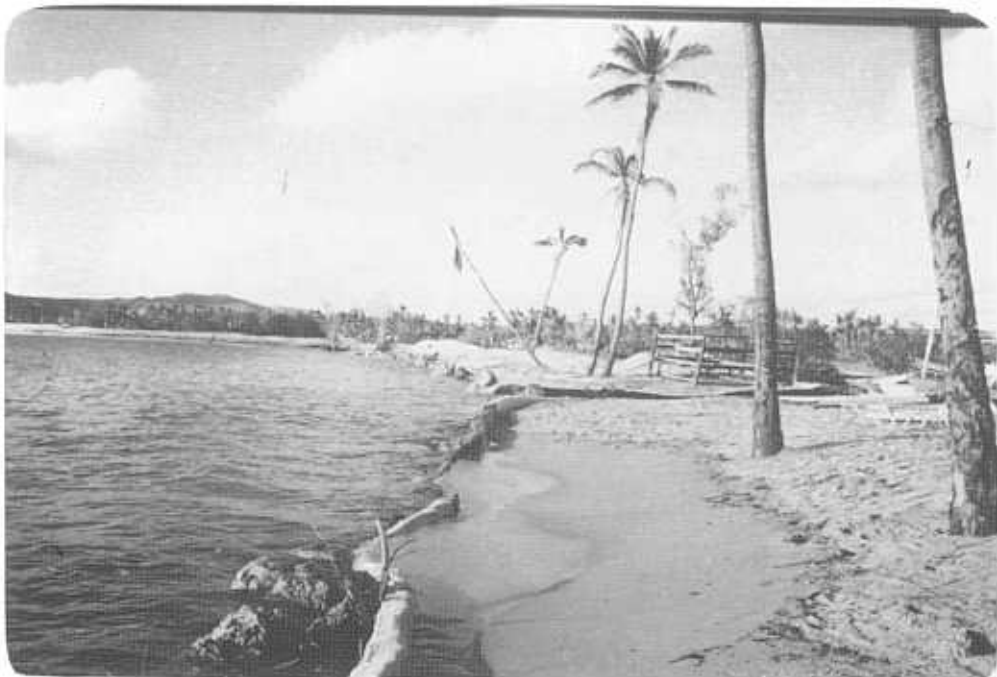
Figure 16.

The Fijian Hotel has a small vertical log seawall on the seaward side of a narrow sandy spit. This seawall is in a bay and is relatively sheltered from the open ocean. The top of the logs are only slightly above high water and the wall was backfilled with sand against a plastic sheet. After Sina, there was some sand washed out behind the wall and one set of wooden steps was gone. Most of the damage in this area seemed to be wind damage to recreation equipment and associated structures (Figures 16-18).

The vertical log seawall at the Fijian appears to have behaved in a similar manner to the vertical seawall at the Sheraton (Figures 16-18). An additional problem at the Fijian appears to be the mining of beach sand for use in developing the golf course. If sand is mined from a beach, the shoreline will try to adjust to achieve its original slope and profile.

December 1990: Fijian Hotel - after Sina. Note: more scouring behind log seawall.

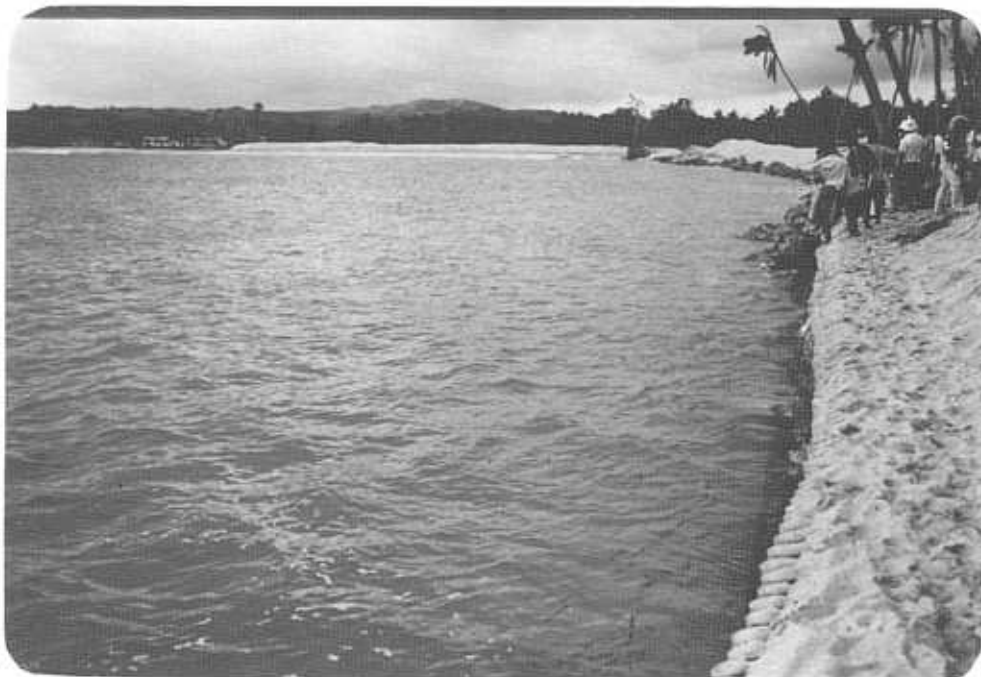
September 1990: Fijian Hotel - before Sina.

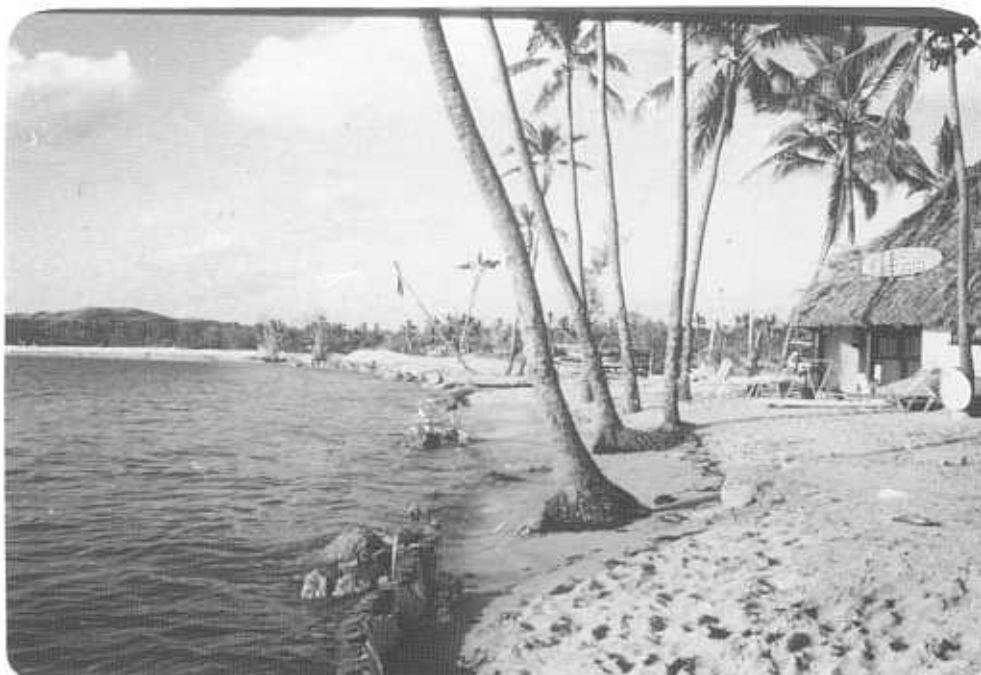
Figure 17.

December 1990: Fijian Hotel - after Sina. Note: scouring behind seawall.

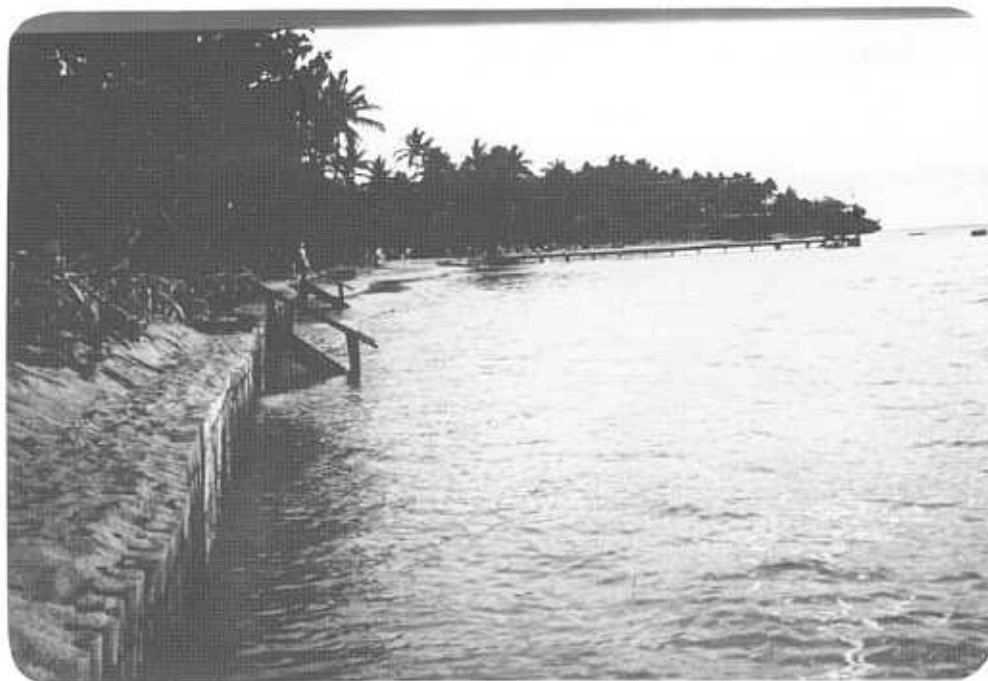
September 1990: Fijian Hotel - before Sina.
