**COASTAL DAMAGE INSPECTION  
SOUTHWEST VITI LEVU, FIJI  
AFTER CYCLONE SINA**

Brendan J. Holden  
SOPAC Technical Secretariat

*July 1992*

*SOPAC Technical Report 148*

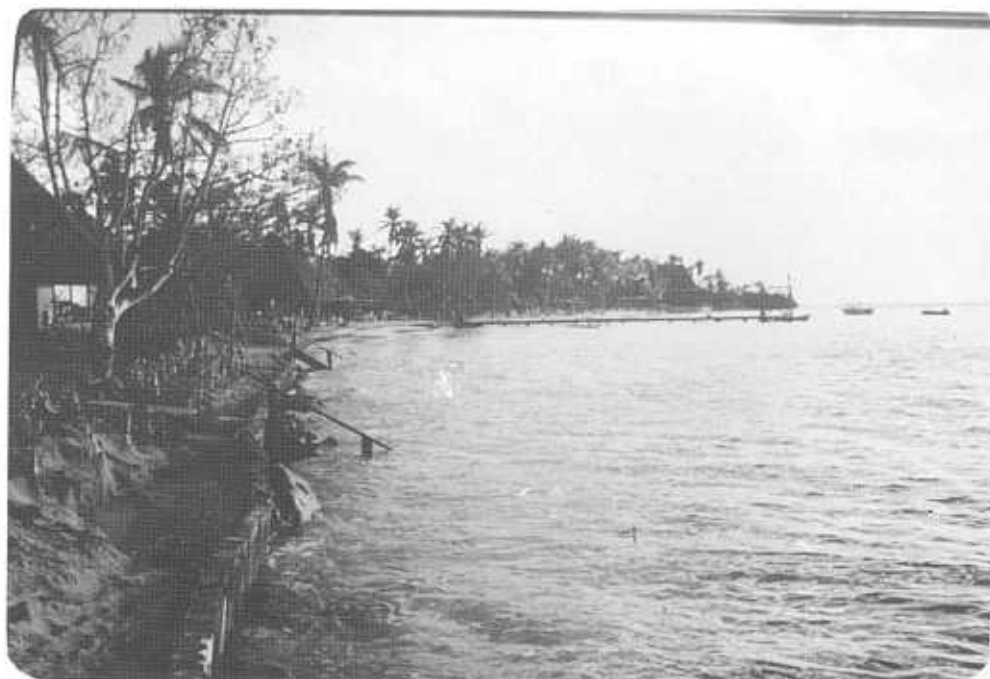
Figure 18.

December 1990: Fijian Hotel - after Sina. Note: sand scoured from behind wall.
