# EVALUATION OF THE IMPACTS OF HARBOUR ENGINEERING

## ANIBARE BAY REPUBLIC OF NAURU (RON)

May 2001

SOPAC Technical Report 316

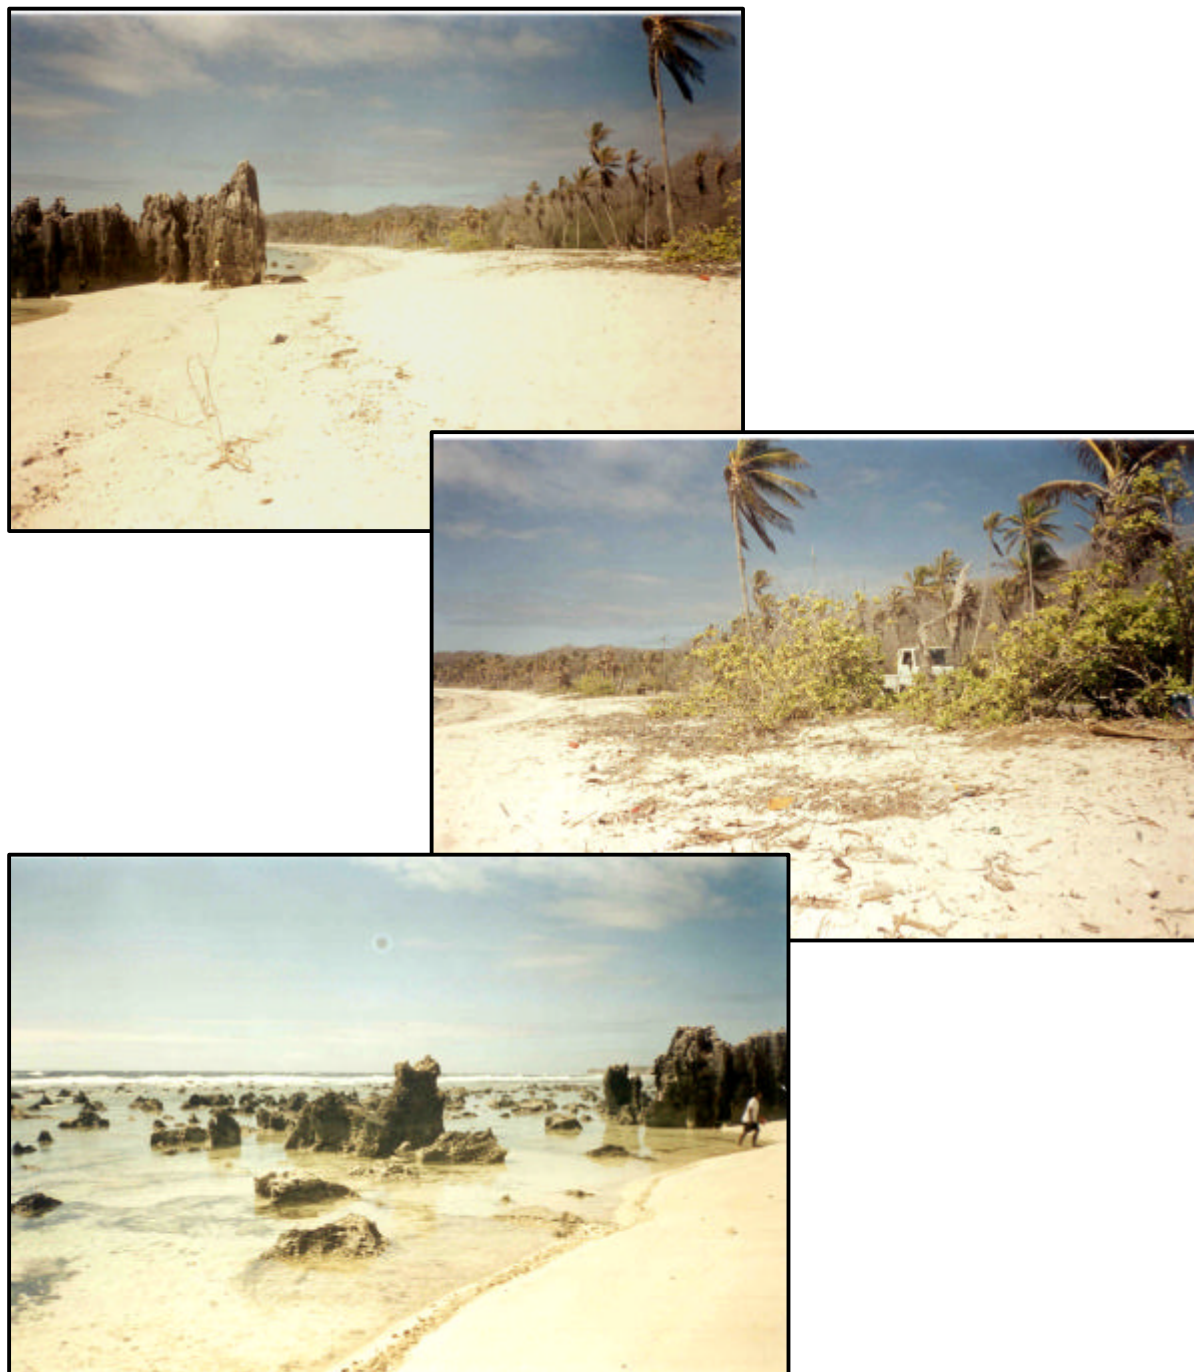
*Figure 11. Beach morphology. Top left – arcuate, coconut palm-fringed sandy beach, north Anibare Bay; middle photo – upper beach showing erosion, central Anibare Bay and lower left – dolomite limestone pinnacles in the surf zone, central Anibare Bay.*

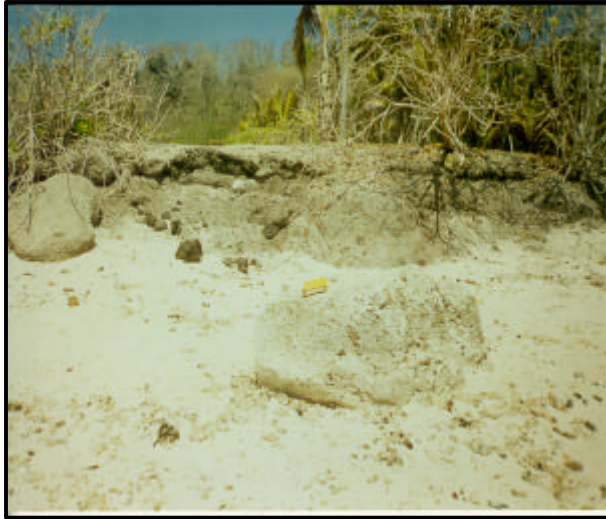
*Figure 13. Above – Exposed coastal soils at an erosion scarp near the development site.*

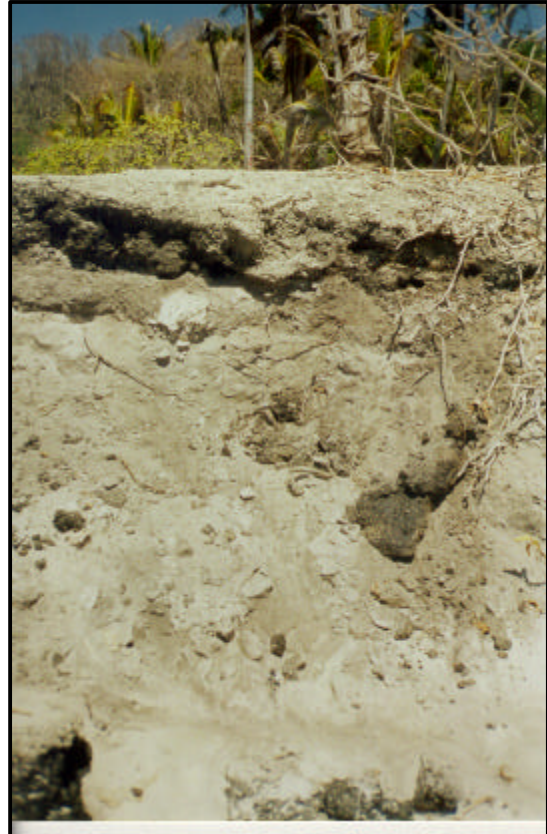
*Figure 14. Right – Details of the brown coastal soils and vertical erosion scarp from Figure 13.*

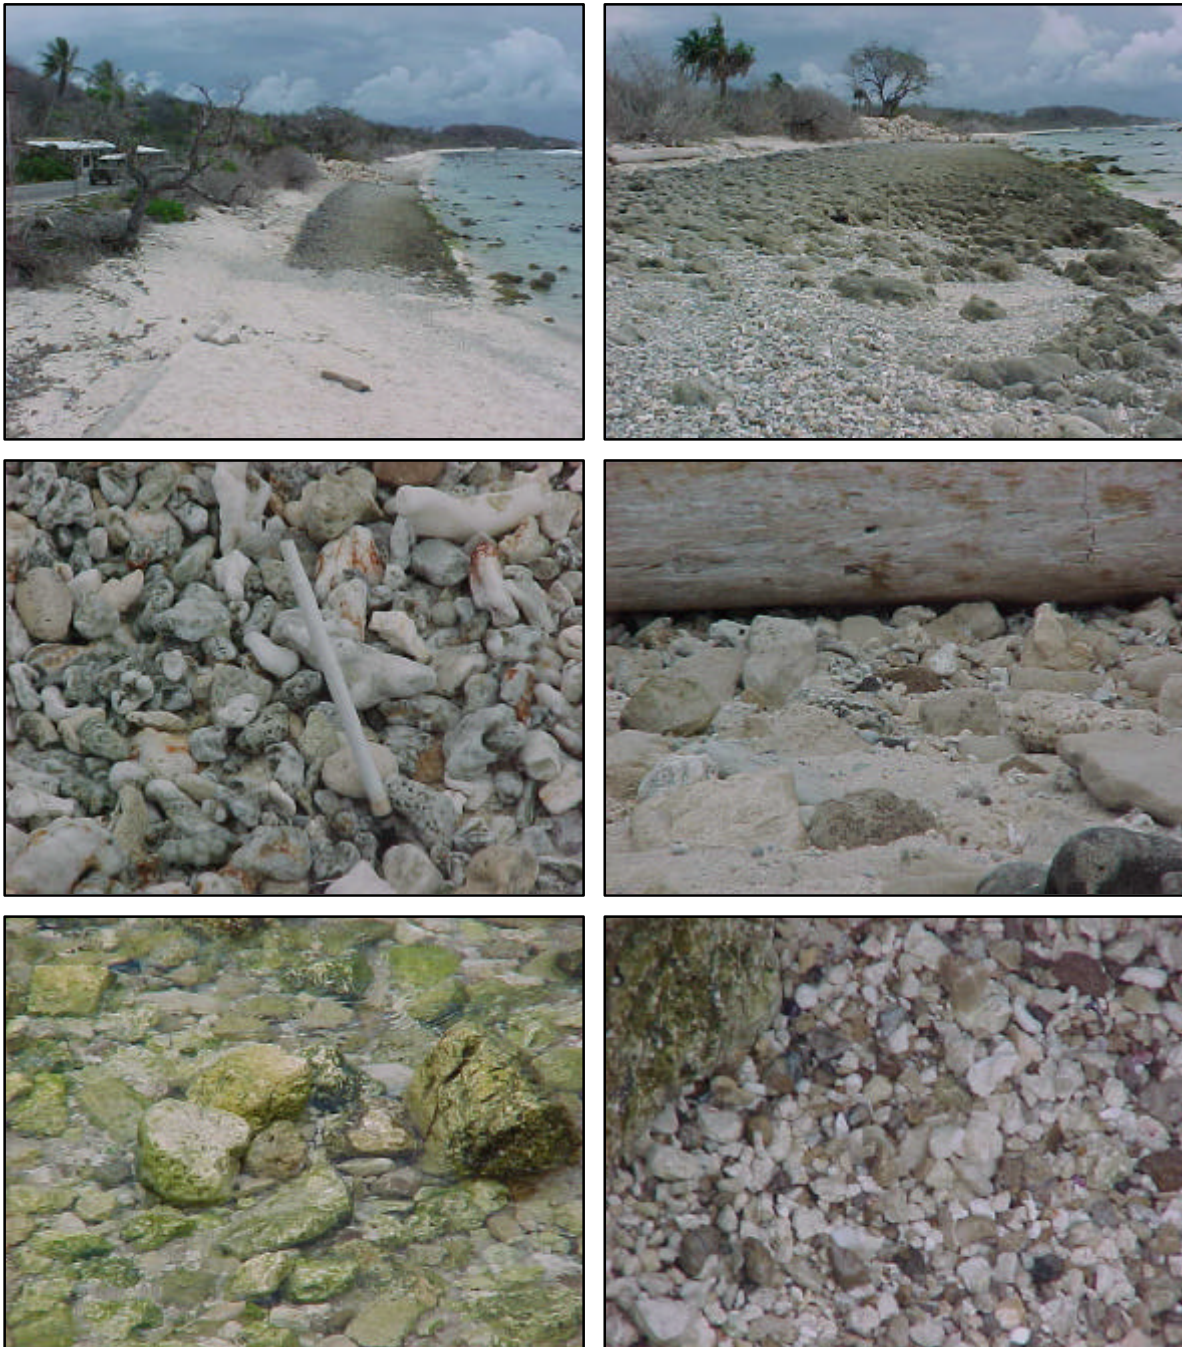
*Figure 18. Beach physiography (top photos) and sedimentology (middle and lower photos) at the development site. Note the coarse sub-rounded and well washed Mollusca and coral gravels on the lower beach in the middle left and top right photos; and the sub-angular boulders with sand on the mid-beach, in the middle right photo. The lower left photo shows filamentous green algae on angular boulders; while the lower right photo shows sub-rounded, medium gravel deposited between rip-rap boulders pockets on the lower beach at the site.*

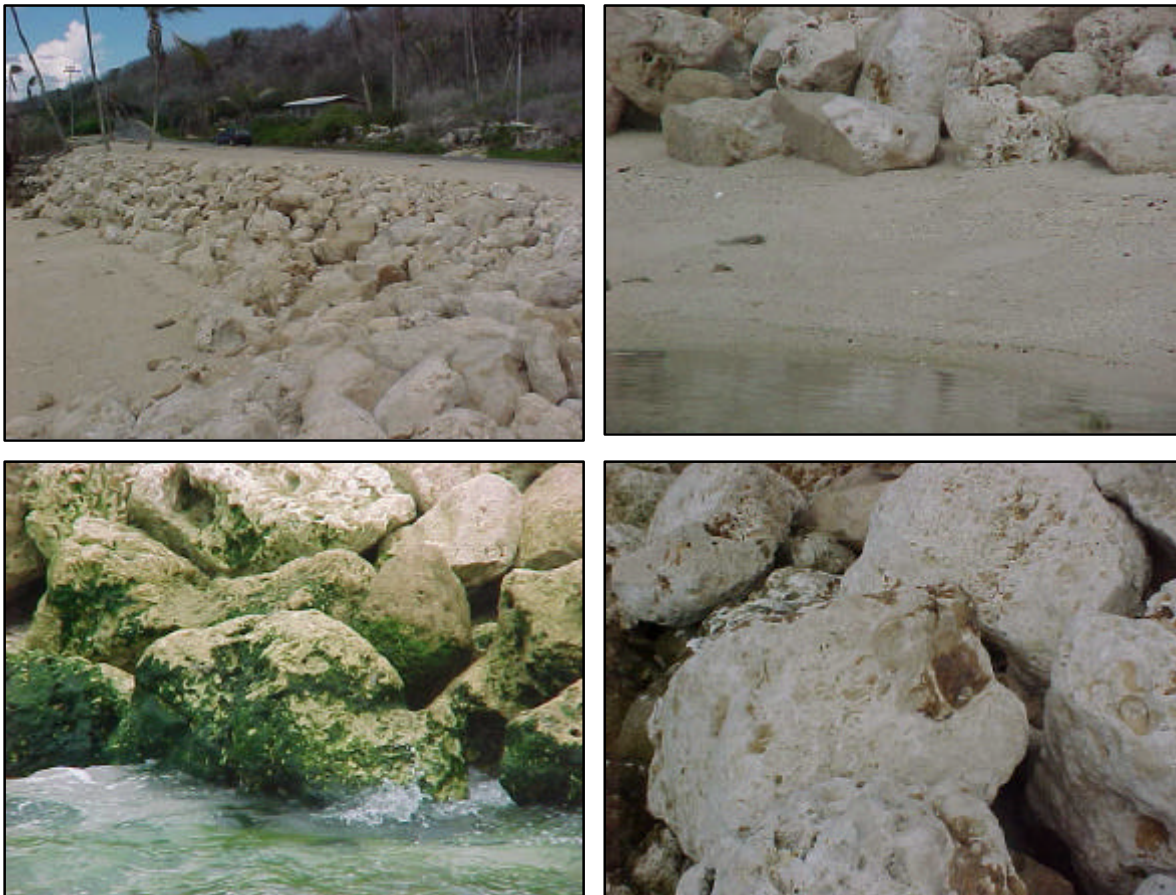
*Figure 22. Rip-rap characteristics at the harbour site. Top left – a single-layered rip-rap, protecting an eroded segment of road, on the Southern side of the harbour; top right – rip-rap at the toe of the groin; lower left – algae-covered rip-rap at the toe of the groin, alongside the mooring basin; and lower right – note rip-rap boulder shape, angularity and pits.*

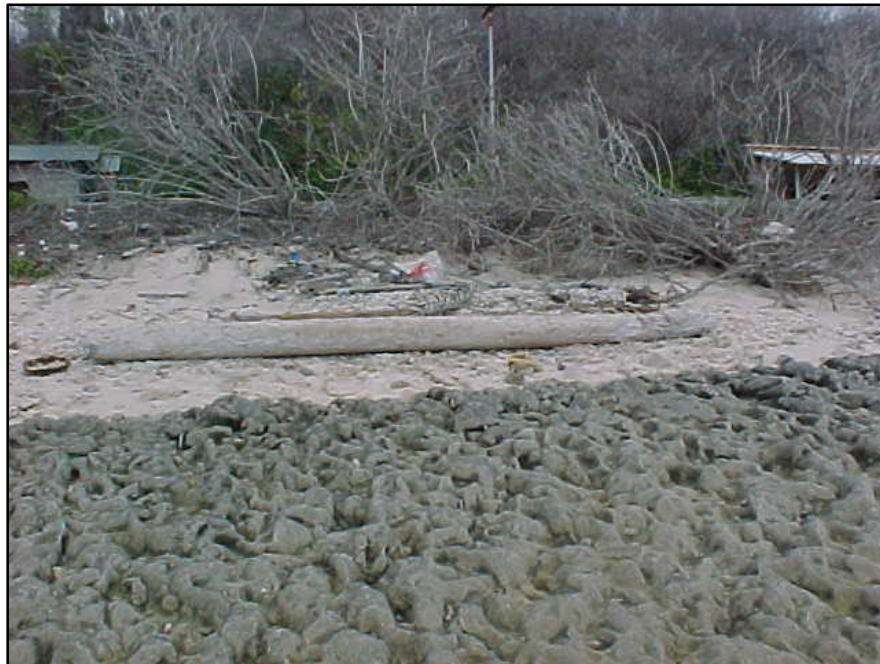
*Figure 23. Scouring and removal of beach sand on the mid and upper beach, exposing the underlying scoured and eroded dolomite limestone. Note the coastal shrubs which are have now collapsed on the upper beach. This site is just North of the harbour facility.*

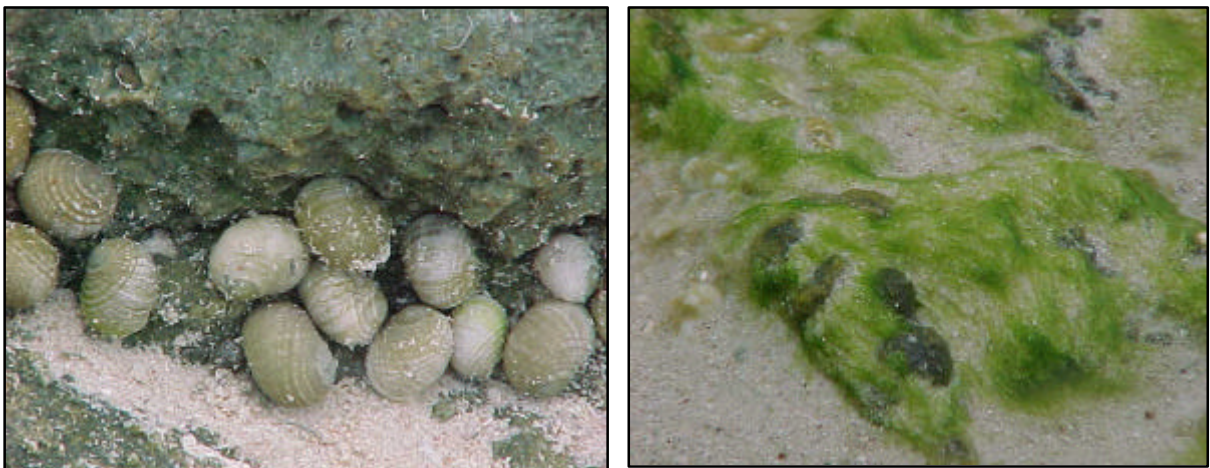
- ✓ the lower beach and backreef areas are 50 % covered with green, filamentous algae (Figure 22);
- ✓ abundant green algae indicates that there is eutrophication (nutrient enrichment) in the coastal waters;
- ✓ macrobenthic species are common on the lower, rock part of the beach area and backreef; including green and brown algae, red algae, sea cucumbers; crabs; sea urchins and a variety of Molluscs (Figure 22) attached to rock substrate;
- ✓ as mentioned previously, the bay is fringed by a coral reef, which contain several species of coral; and
- ✓ the reef is narrow and averages 15 m in width.

Figure 24. Examples of benthic biota. Left - mollusc fauna on the dolomite limestone substrate. These feed on green algae. Right – filamentous green algae attached to limestone rock on the lower beach at Anibare Bay.
