**SURVEY OF CYCLONE OFA DAMAGE
TO THE NORTHERN COAST OF UPOLU,
WESTERN SAMOA**

by
Douglas M. Rearic*
Techsec

Prepared for: South Pacific Applied Geoscience Commission (SOPAC)
Western Samoa Project: WS.13

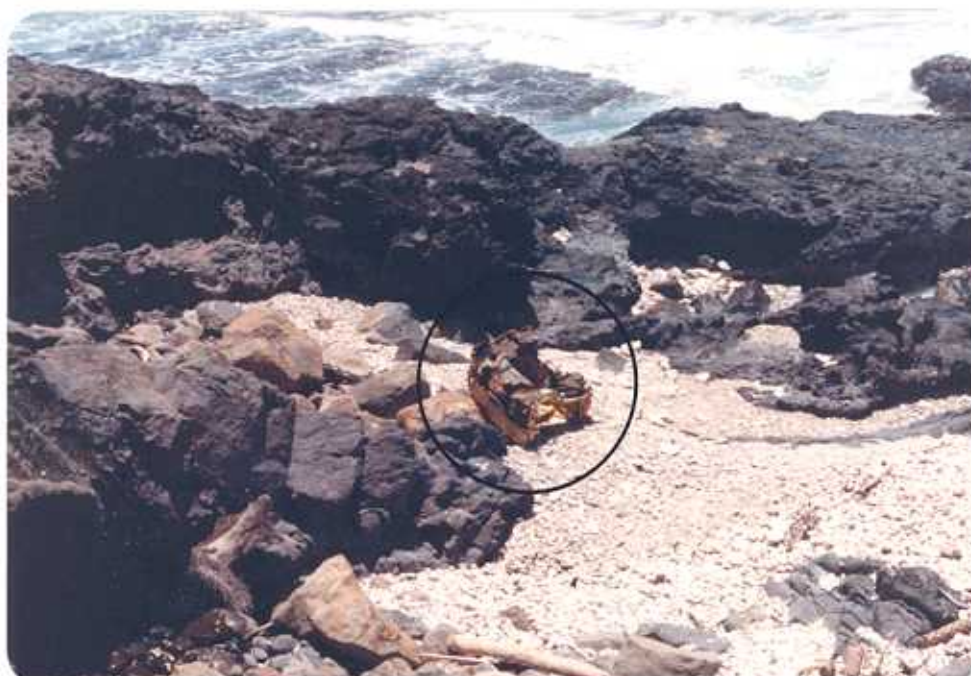
The final count of lives lost due to the cyclone in Western Samoa stands at 7. The causes for the deaths are varied and range from drowning due to large seas and waves (Figures 2 and 3) to being struck by flying debris in the high winds of the storm.

Figure 2. Remains of truck that was hit by a large wave and washed from the road above. Two people were killed in this accident.

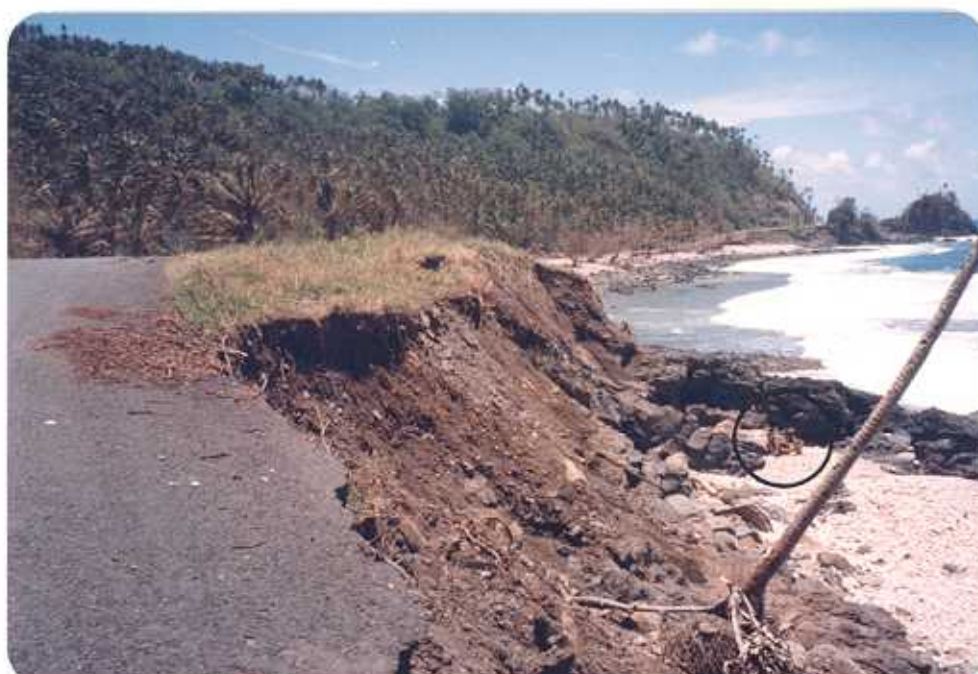
Figure 3. Cliff erosion at edge of road where truck in Figure 2 was washed from road. Truck remains are circled.

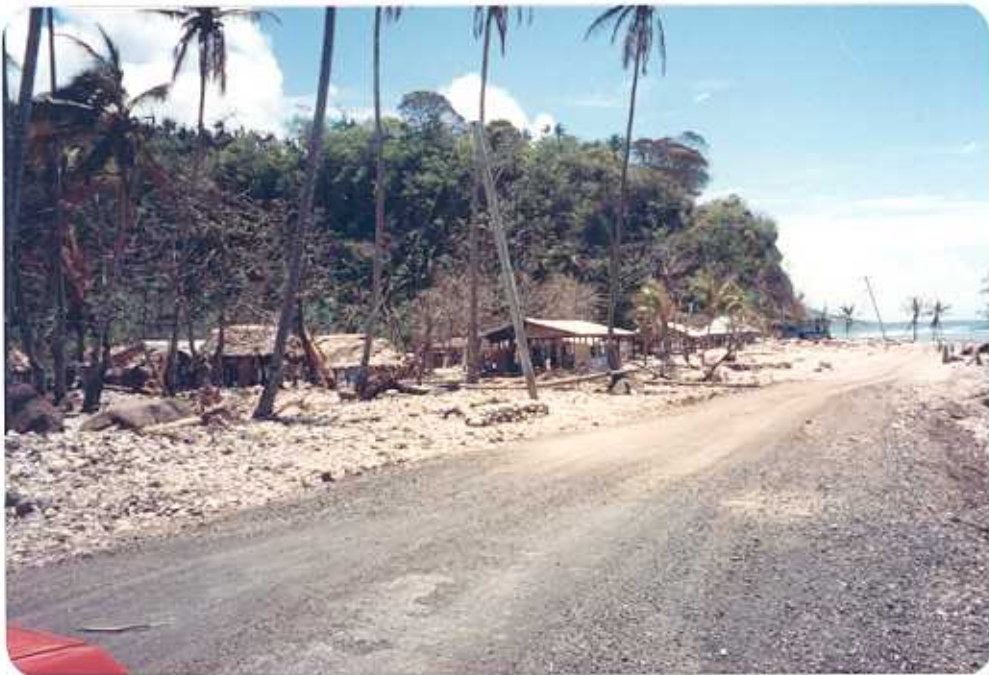
Damage to dwellings, businesses and social facilities was extreme and generally caused by either large waves which inundated the coastal zone (Figures 4, 5 and 6) or high winds which reached further inland (Figures 7, 8 and 9). Wave and wind damage was particularly severe to the coastal villages east of Apia where coastal protection is minimal. In these areas, the sea moved inland through the villages, removing homes from their foundations and distributing coral rubble over the village grounds. In the areas lying to the west of Apia, the coastline is more protected and most damage resulted from high, sustained winds which removed the roofs of many homes and facilities.

Figure 4. Destroyed homes and power lines at Lautuanuu Village. The road lies next to the coastline. Coral rubble now covers areas that were carefully tended lawns and gardens.

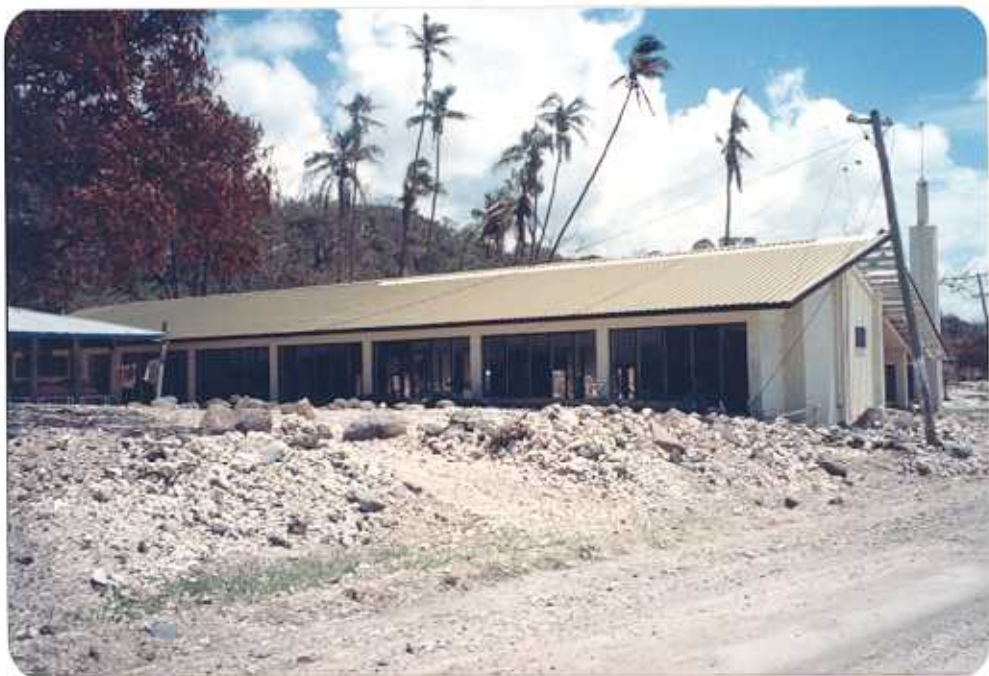
Figure 5. Church at Lautuanuu Village which suffered internal damage from waves and roof damage from high winds. Note the large amount of coral rubble surrounding the church grounds.

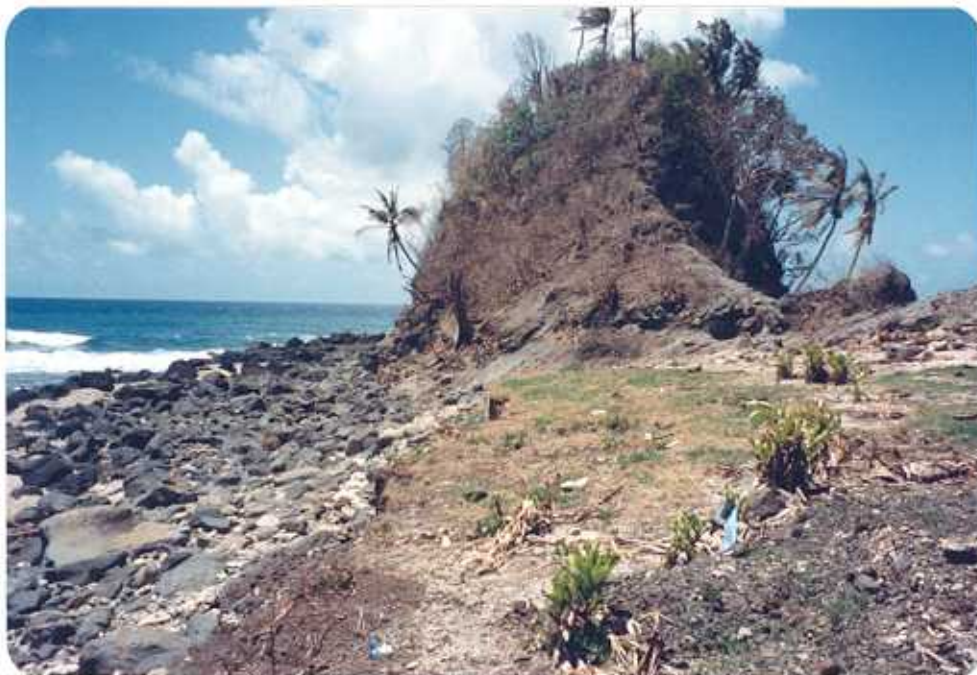
Much of the reclaimed land along the coast was lost to the sea (Figure 32). In many cases, homes that had been built on this type of land were destroyed and the land washed away so that it is now impossible for these families to rebuild even if they have the resources to do so (Figure 6).

Figure 6. Site of house at Lautuanuu Village which was destroyed during the cyclone. Note that much of the land that the house was built on has been eroded from the coast.

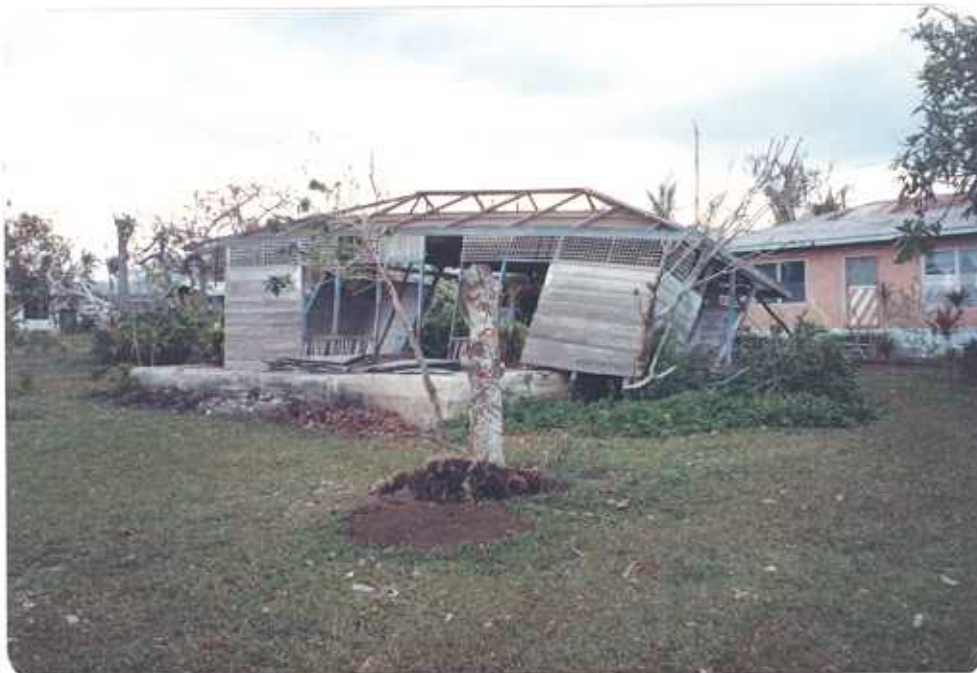
Figure 7. Destroyed house knocked from its foundation by strong winds. The house lies to the west of Apia and is away from the coastline.

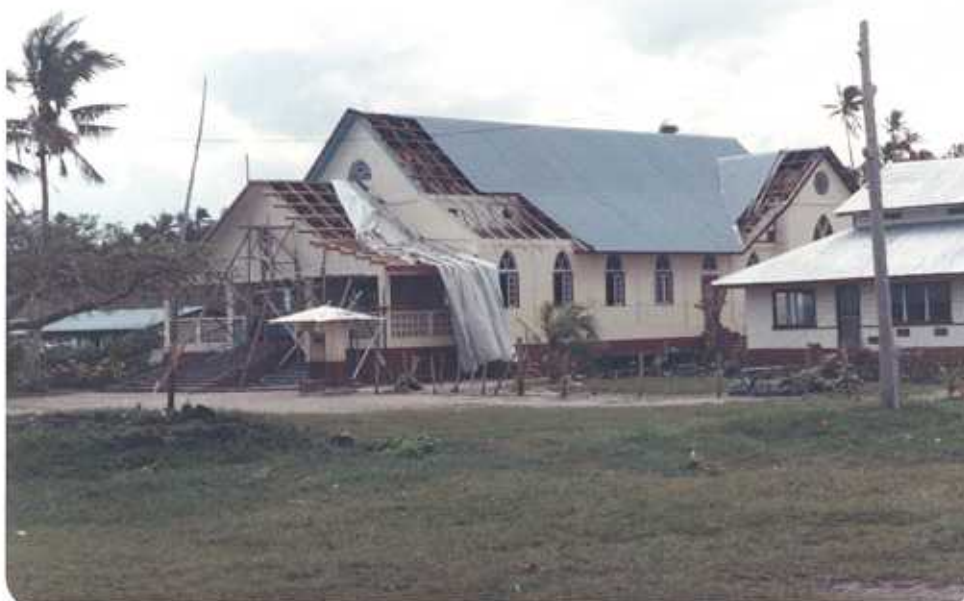
Figure 8. Much of the damage to structures to the west of Apia was caused by strong winds. This church is at Mulifenua Village.

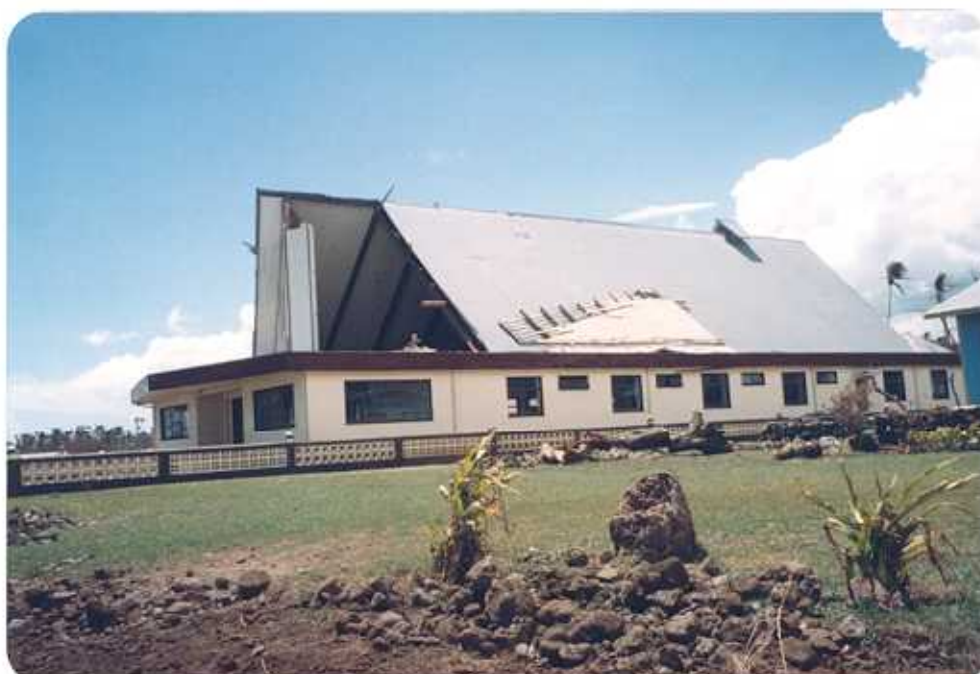
Figure 9. This church at Faleasiu Village suffered damage to its roof. Most structures that lost their roofs also suffered considerable water damage to interior furnishings.

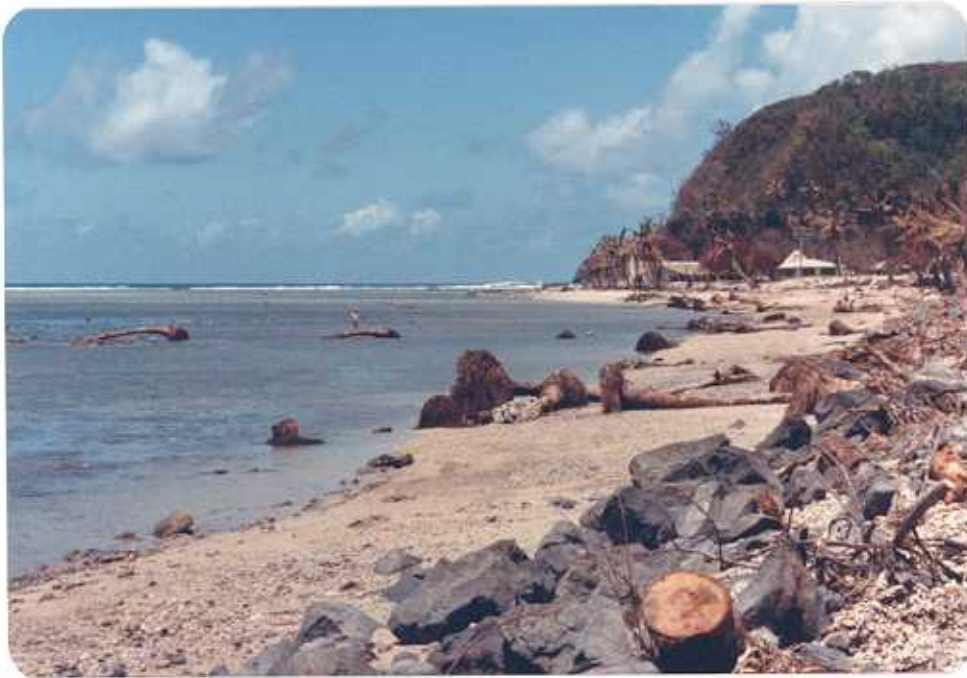
Because there is a subsistence economy in many of the coastal villages, the loss of family gardens means a loss in the production of food crops for some time to come (Figure 10). The people of Samoa take pride in their village appearance and spend many hours tending to the upkeep of their land. The inundation of the sea caused a widespread ground cover of coral debris which destroyed lawns, gardens and trees (Figures 11 and 12). Saltwater poisoning of the trees which survived the high winds is a common occurrence along the northern coast of Upolu (Figure 13). There is also a fear of food shortages as present supplies are used up and there are none available to replace them.

Figure 10. Many of the coconut palms that were uprooted during the storm now litter the coastline of Upolu.

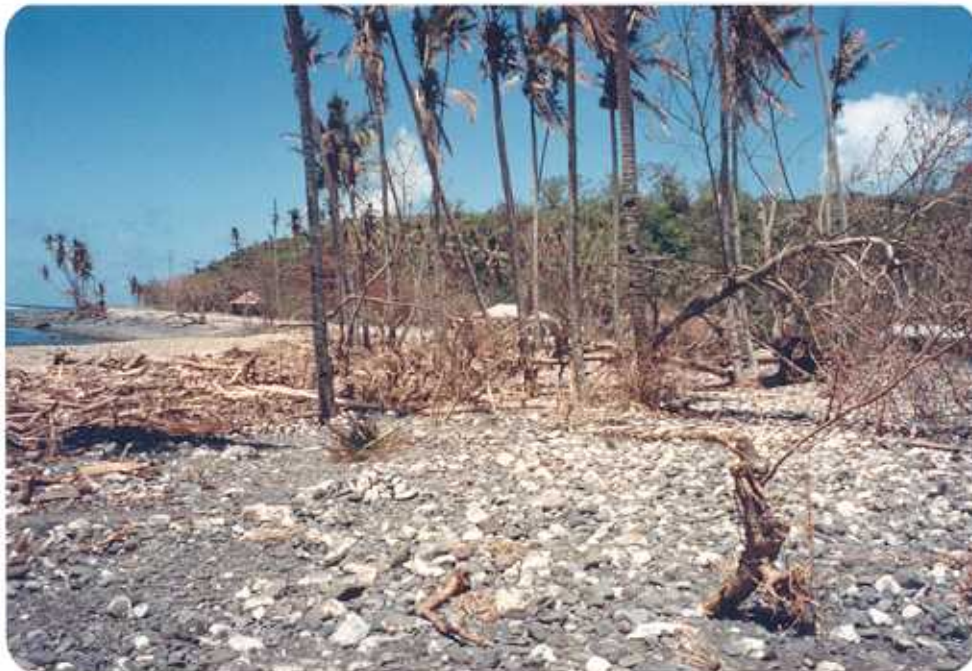
Figure 11. The area in this photograph was a grassy, park-like area near the coastline of Lautuanuu Village prior to *Cyclone Ofa*.

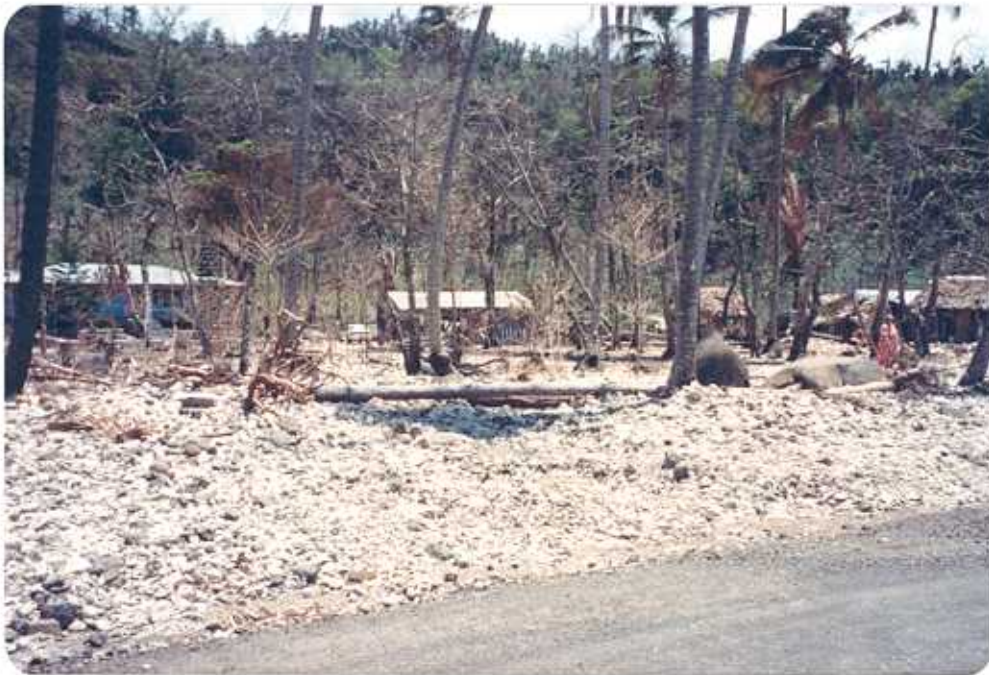
Figure 12. Lautuanuu Village was one of the hardest hit areas by the storm. Because relatively little rain accompanied the storm most of the trees were poisoned by salt from seawater intrusion. A vast amount of coral rubble covers areas that were once grass.

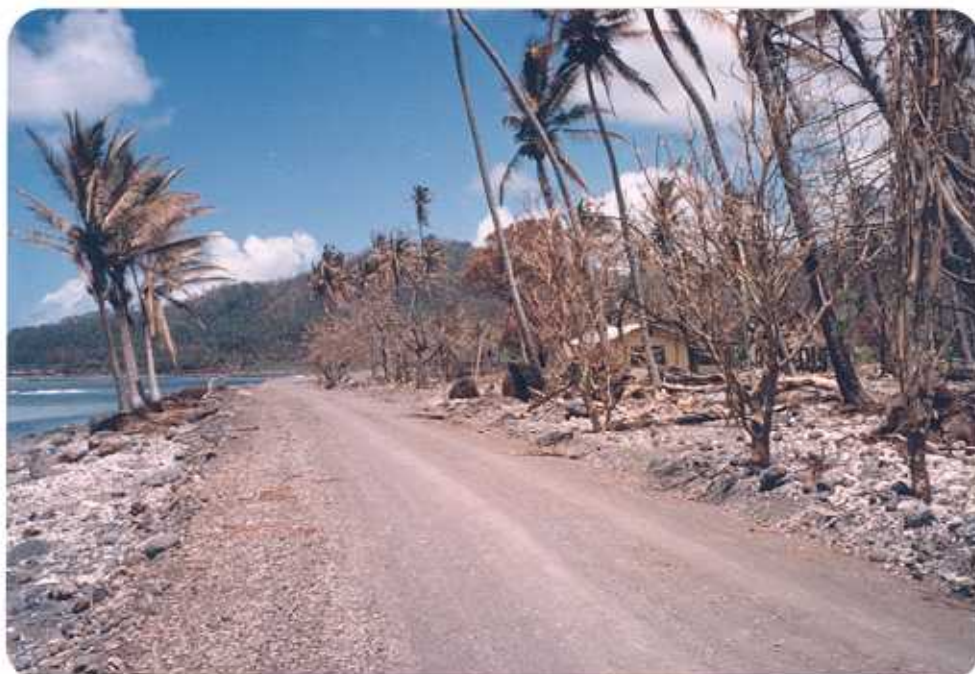
Figure 13. Trees along the road at Solosolo Beach survived the high winds but were poisoned by saltwater intrusion from the sea.

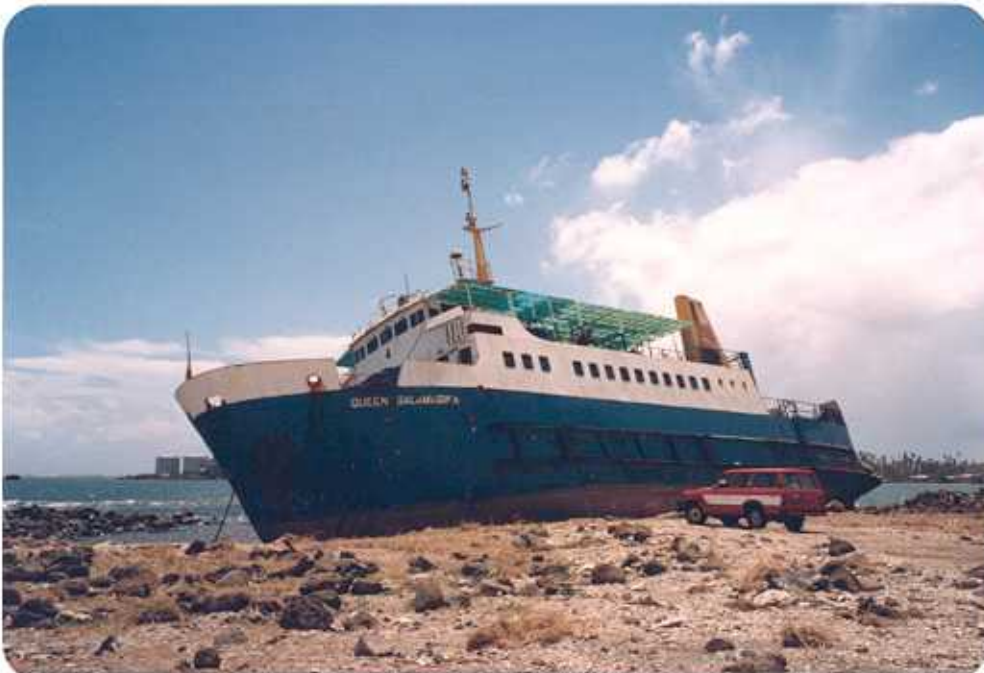
Shipping was disrupted in several ways. The most destructive was the beaching of the passenger/cargo ferry Queen Salamasina in Apia. The ferry broke away from the main wharf during the storm and drifted across the harbour finally coming to rest on an area of reclaimed land (Figures 14 and 15). Wharf facilities at Apia Harbour suffered damage from the battering of boats against the facility. Strong currents and waves at the harbour facilities at Mulifanua, the main ferry terminal between Upolu and Savai'i, caused shoaling of the harbour which has disrupted transportation between the islands.

Figure 14. The passenger/cargo ferry *Queen Salamasina* broke away from the main wharf during the cyclone and was beached at the landfill area directly off the main part of the city of Apia. During low tide the area beneath the ferry is completely dry.

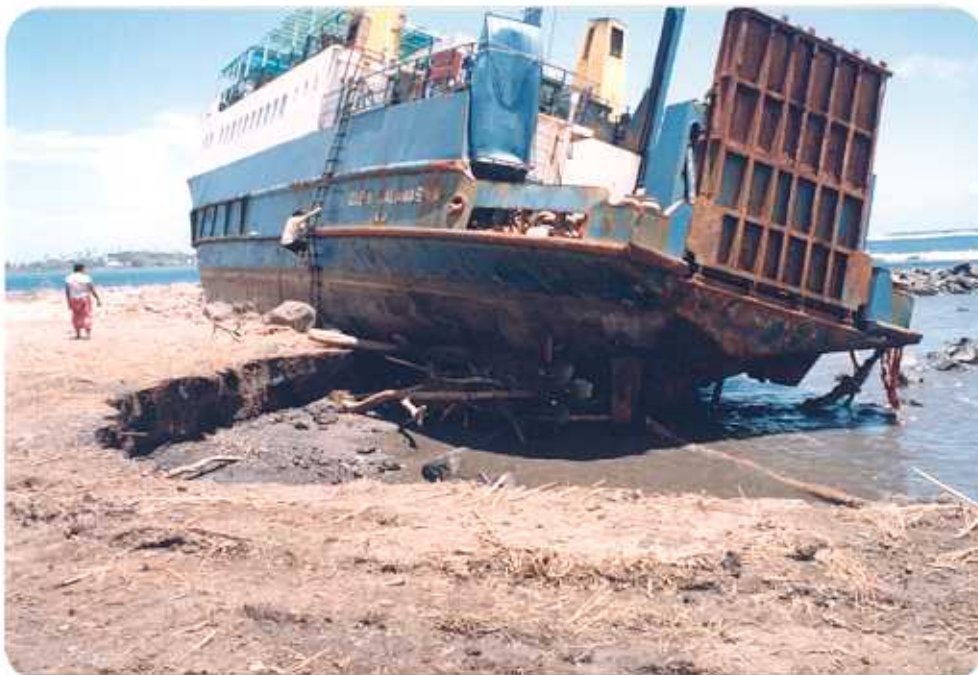
Figure 15. The landfill on which the *Queen Salamasina* was beached has been severely damaged, losing about 20 meters of fill to the strong waves that attacked the inner harbour area of Apia.

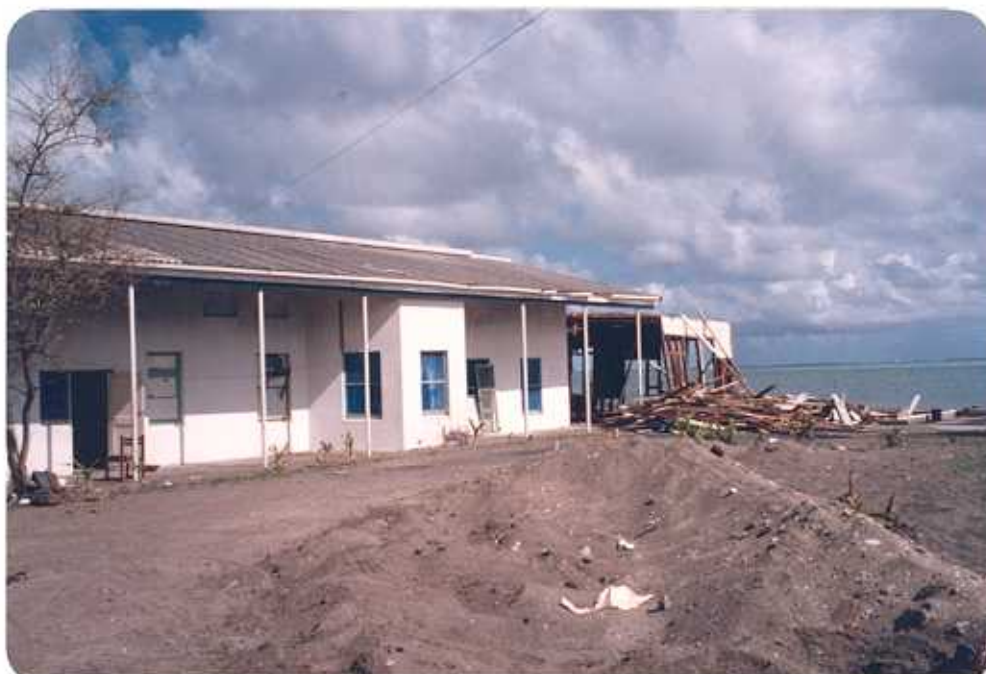
Government buildings suffered considerable damage during the cyclone. Possibly the hardest hit by the full force of the cyclone was the Apia Observatory, where many of the older structures were destroyed (Figures 16-19). The Department of Lands and Survey building, on the main road fronting the harbour was also damaged severely (Figure 20). Other structures were destroyed. A grave monument (considered by Carter in 1987 to be at high risk during a cyclone) on Mulinu'u Peninsula survived the cyclone with little additional damage (Figure 21). It had been protected by a rock fill placed in December 1989, just prior to the storm. The importance of this type of protection to coastal structures can not be over emphasised. The western side of Mulinu'u Peninsula suffered little or no damage because it was sheltered from the more severe effects of the storm. Carter (1987) had noted that there would be little damage from a cyclone to this side of the peninsula and that coastal protection (a seawall) would not be necessary for this part of the peninsula.

Figure 16. The Apia Observatory suffered considerable damage both to buildings and the effects housed there. A large amount of sand was deposited during the storm on the end and east side of Mulinu'u Peninsula.

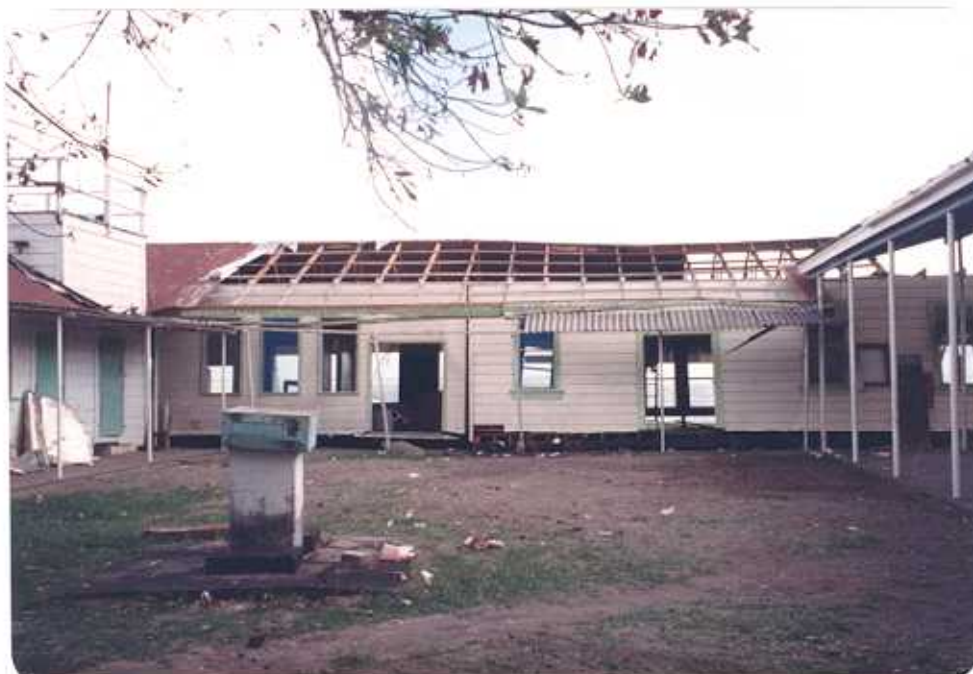
Figure 17. Most of the wooden structures at the Apia Observatory were damaged beyond repair.

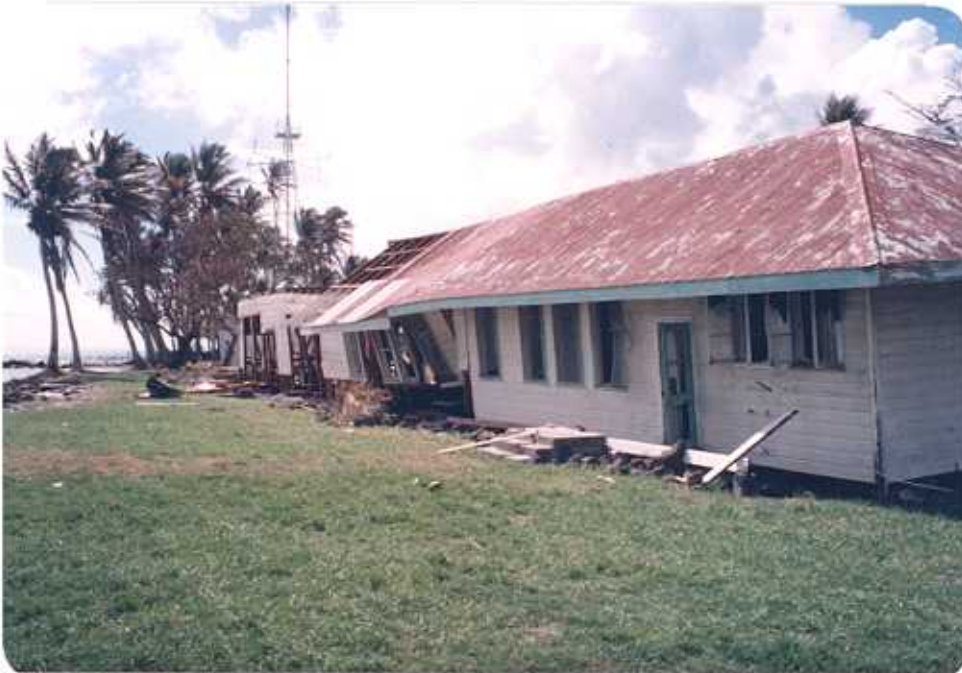
Figure 18. Observatory buildings facing the lagoon felt the full onslaught of the cyclone. Interior, as well as exterior, damage was almost total and the buildings are structurally unsafe for use of any type at present.

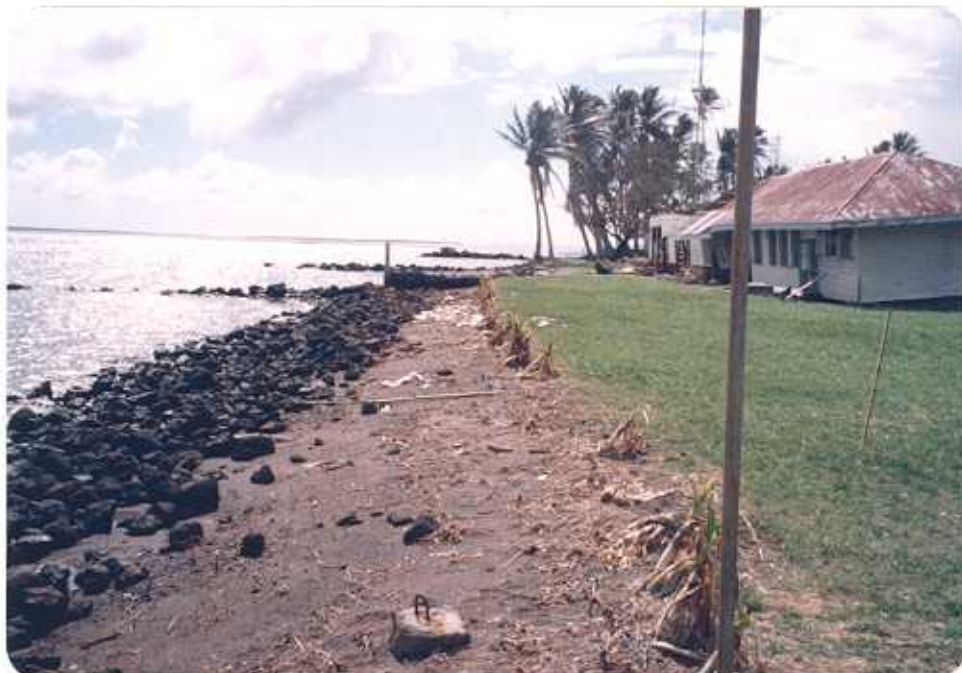
Figure 19. Coastal erosion on the lagoon facing, northern point of Mulinu'u Peninsula was significant.

2. The end of Mulinu'u Peninsula will continue to be at risk during severe storms and, therefore, a detailed study of the peninsula and the coastal processes affecting it is suggested. Other areas of the coast, particularly areas of reclaimed land, are also at high risk and should be included in the study. The study should include an interpretation of both historical and recent aerial photographs to determine coastal changes to the area over time. This information can be utilized by engineers in determining the type of coastal protection works appropriate for the conservation of land and facilities.

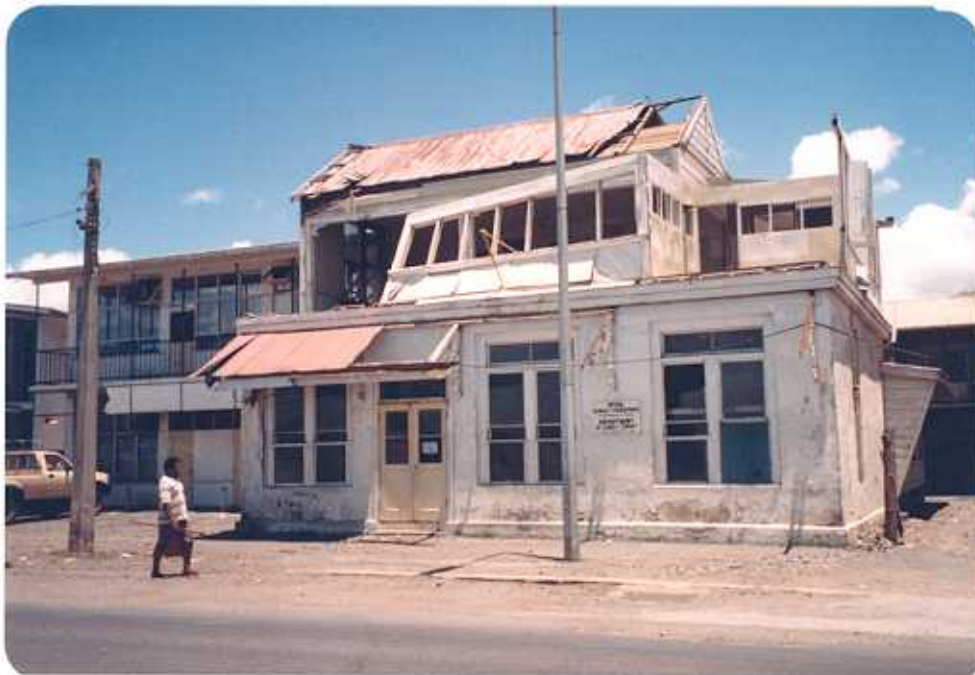
Figure 20. The Department of Lands and Survey building suffered considerable damage. The building lies on the main road fronting the harbour at Apia.

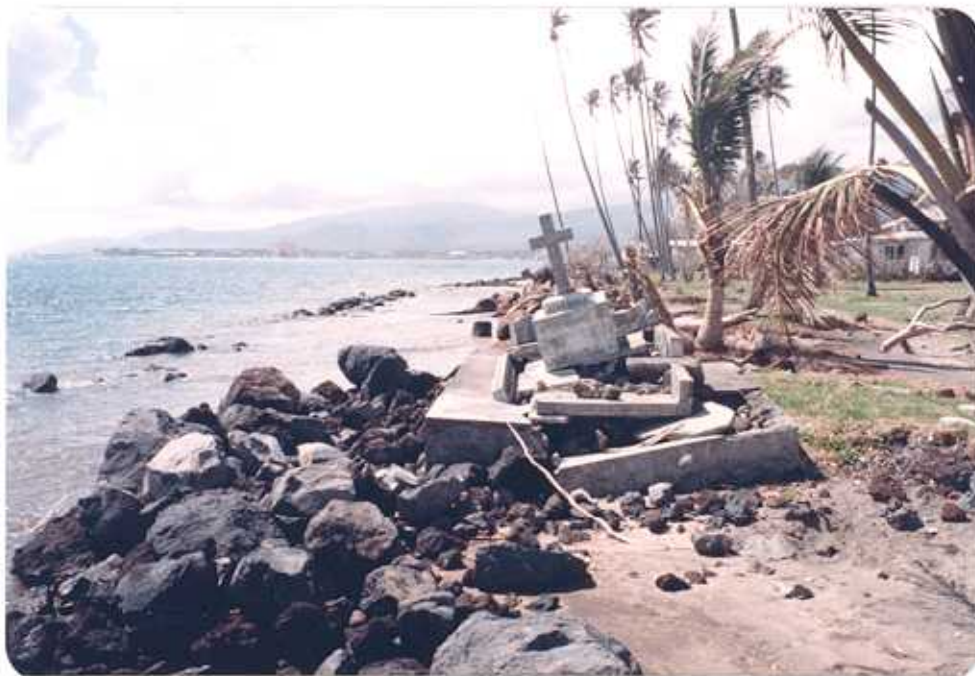
Figure 21. A grave site lying along the coast on the east side of Mulinu'u Peninsula survived the cyclone with little additional damage due to the placement of a protective rock fill in December, 1990 which absorbed much of the wave energy expended on the coastline. The rocks from the fill can be seen scattered around the site. These coastal monuments were considered by Carter (1987) to be at high risk during a cyclone.

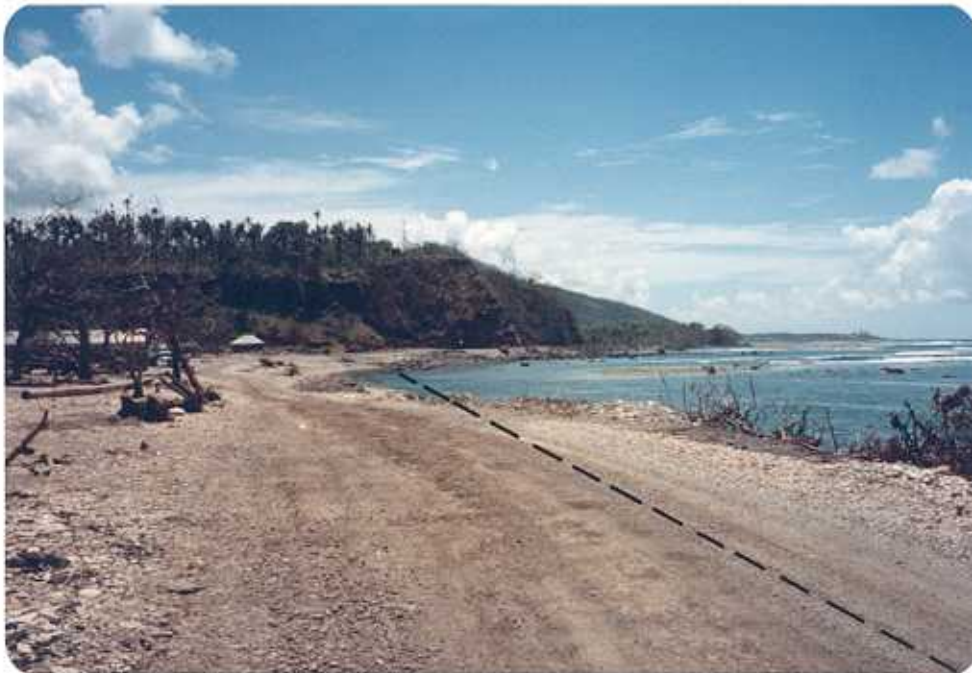
The coastal roads, in particular, received a lot of damage from the force of the waves breaking on them and overtopping them (Figures 22-26). Damage ranged from erosion of the seaward sides to complete removal of the road and its foundation (Figure 22). Some of the coastal roads lie at the high tide level (Figure 26) and are at great risk even during normal seasonal storms. The cyclonic storms that strike the coastal zones bring unusually high tides, such as might be experienced in the future if mean sealevel rises, and highlight the need to build roadways and dwellings away from the

Figure 22. At Lautuanuu Village the road was completely washed away disrupting travel to the east of Apia and hindering rescue operations after the cyclone. The original road lay along the dashed line in the photograph.

1. Detailed coastal mapping and site surveys should be conducted of areas where coastal roads were damaged to provide information for planning and design of coastal protection works.

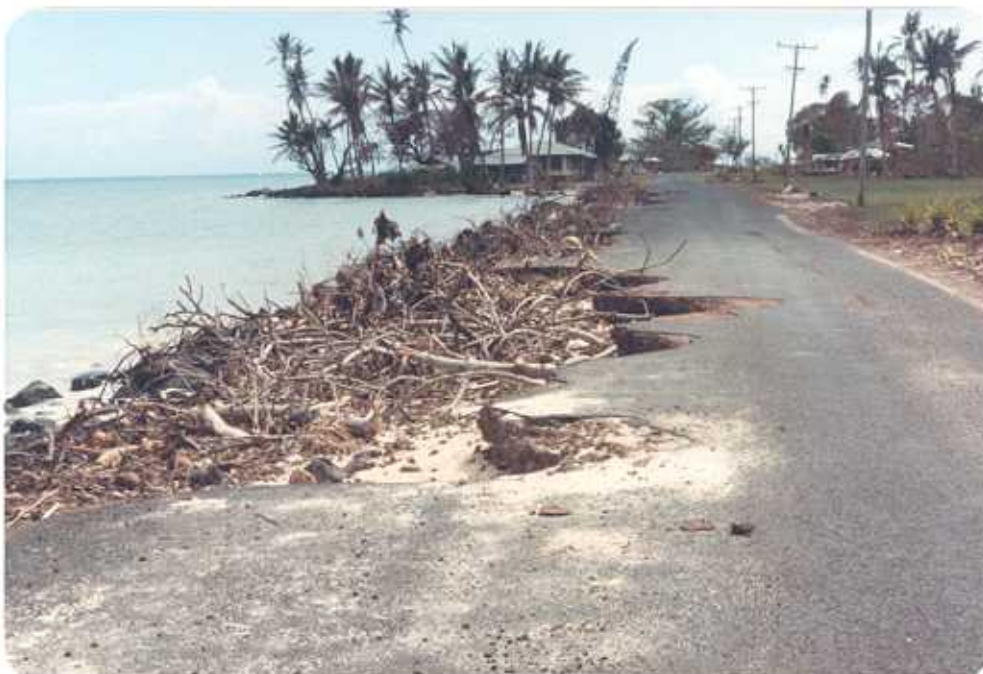
Figure 23. Roads to the west of Apia also suffered considerable damage.

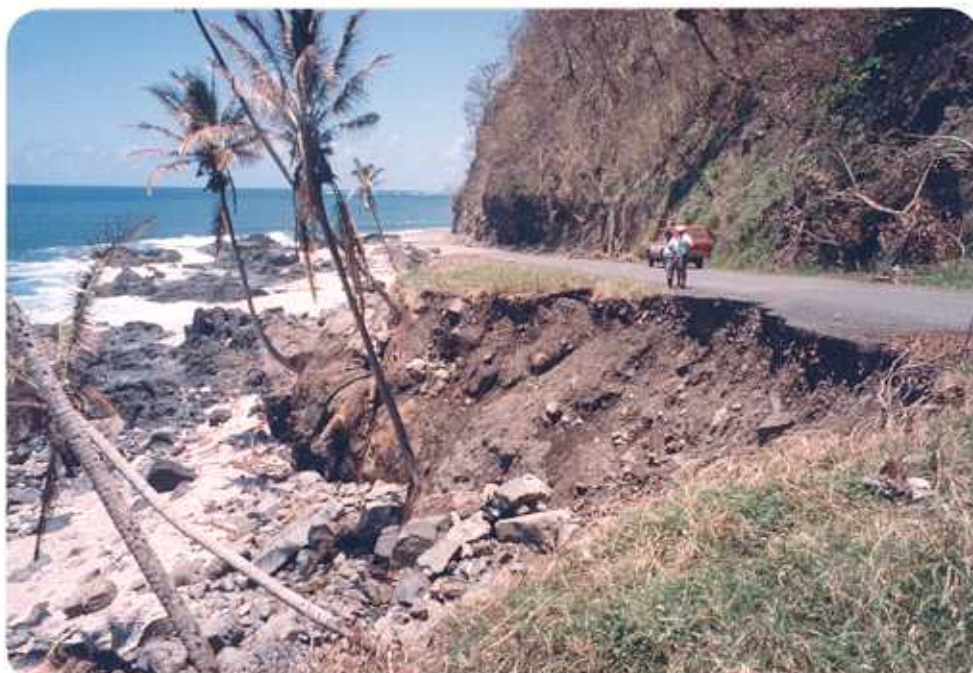
Figure 24. Storm waves to the east of Apia were particularly destructive due to the lack of reef protection in some areas. This photo is of the same area as Figures 2 and 3 and shows the height that storm waves were able to reach during the cyclone.

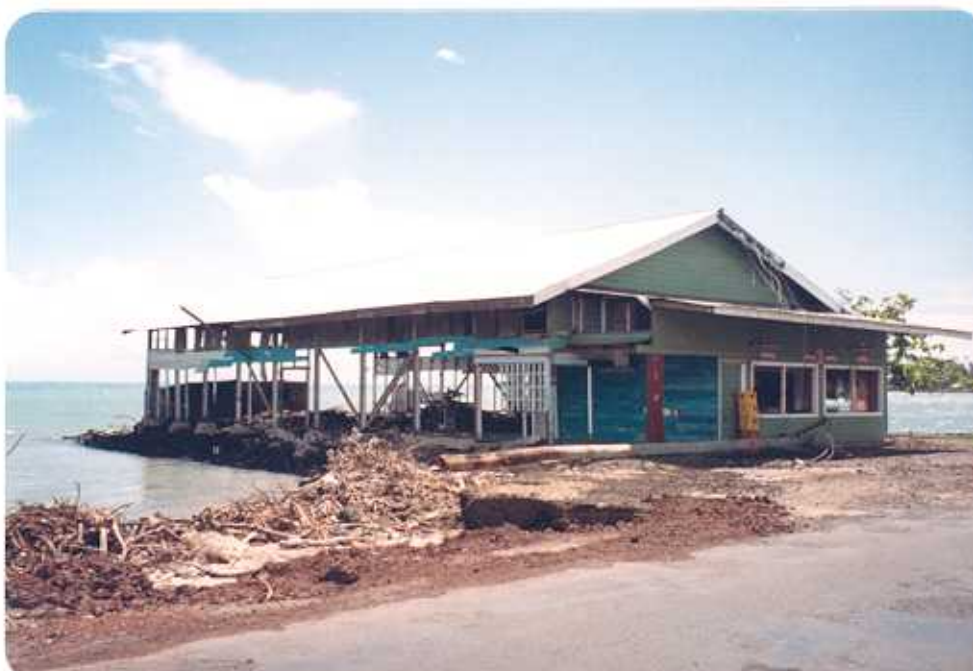
Figure 25. Although roadways suffered damage, some coastal homes on reclaimed land to the west of Apia survived the storm, however the damage sustained was severe in many cases.

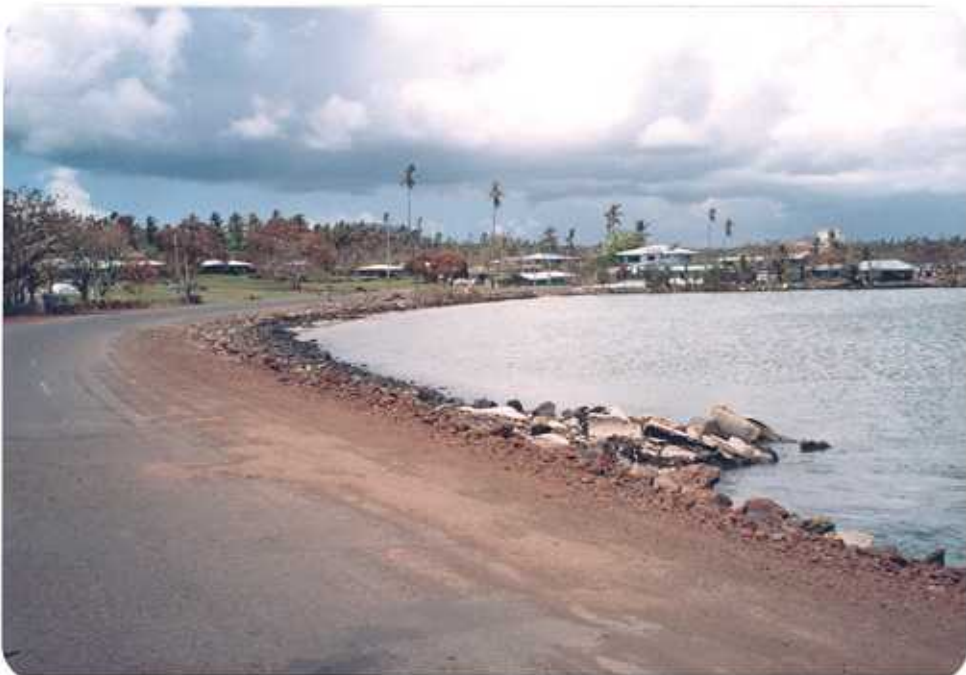
Figure 26. The road at Salcimoa Village lies at the high tide level and even during normal seasonal storms may be awash. Any future increase in sea level will put this area of the coast at high risk from flooding by average tidal fluctuations.

Roads and municipal services, such as electrical and water, were damaged or destroyed during the cyclone. In some places, roads lie at the present high tide level and may be inundated from extremely high tides or normal yearly storms.

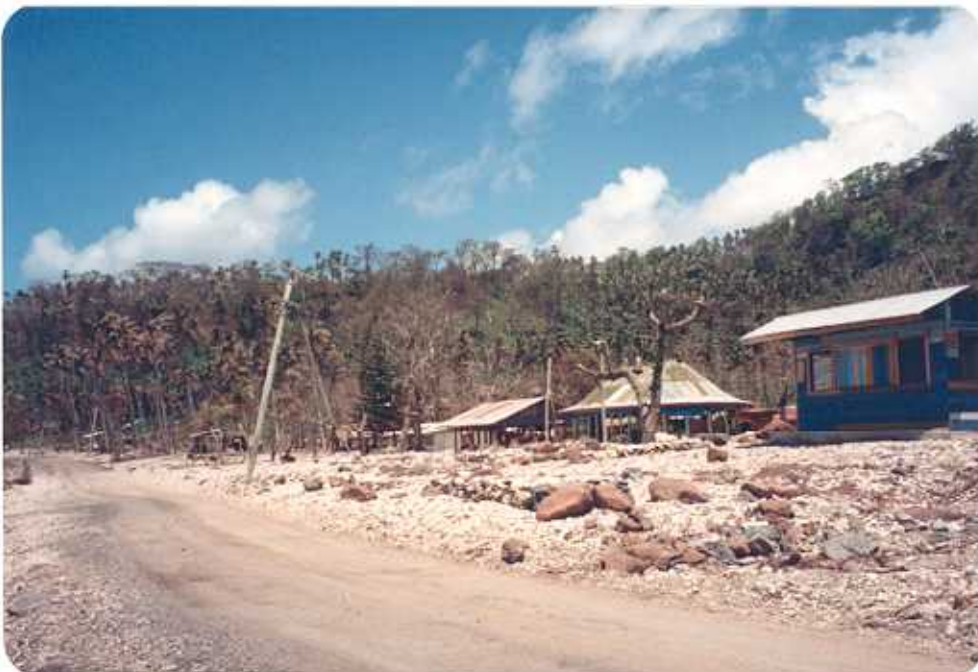
immediate coastline. Electrical power (Figure 27) and water facilities were cut to most of the villages along the coast.

Figure 27. Power lines at Lautuanuu Village were severed when waves knocked the poles from their foundations and high winds severed the electrical lines.

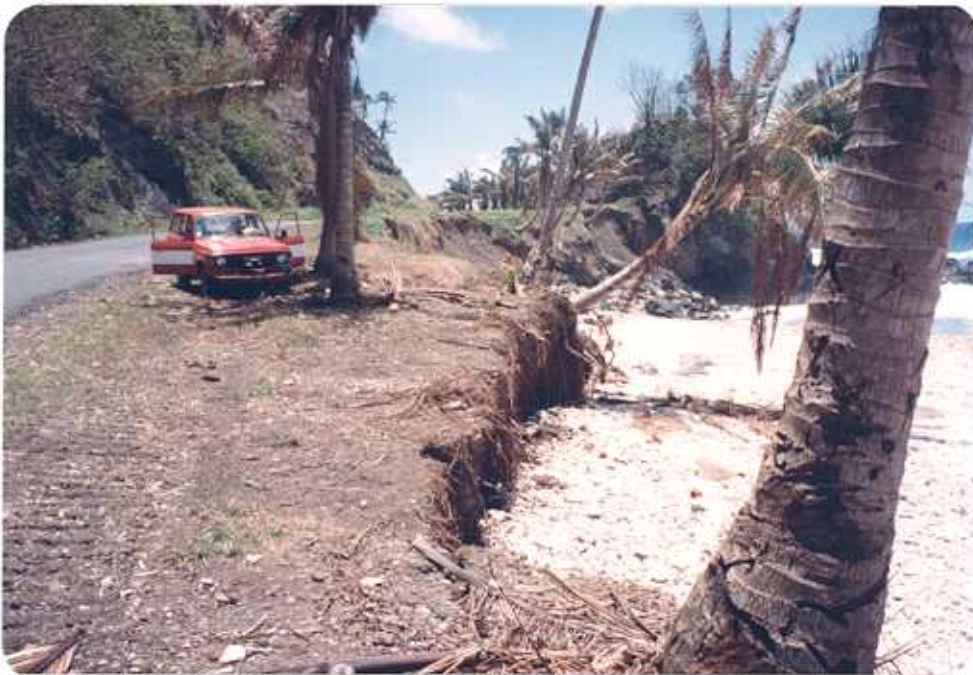
Figure 28. Coastal erosion was severe during the cyclone as waves attacked the coastline and large areas of the coast were washed into the sea.

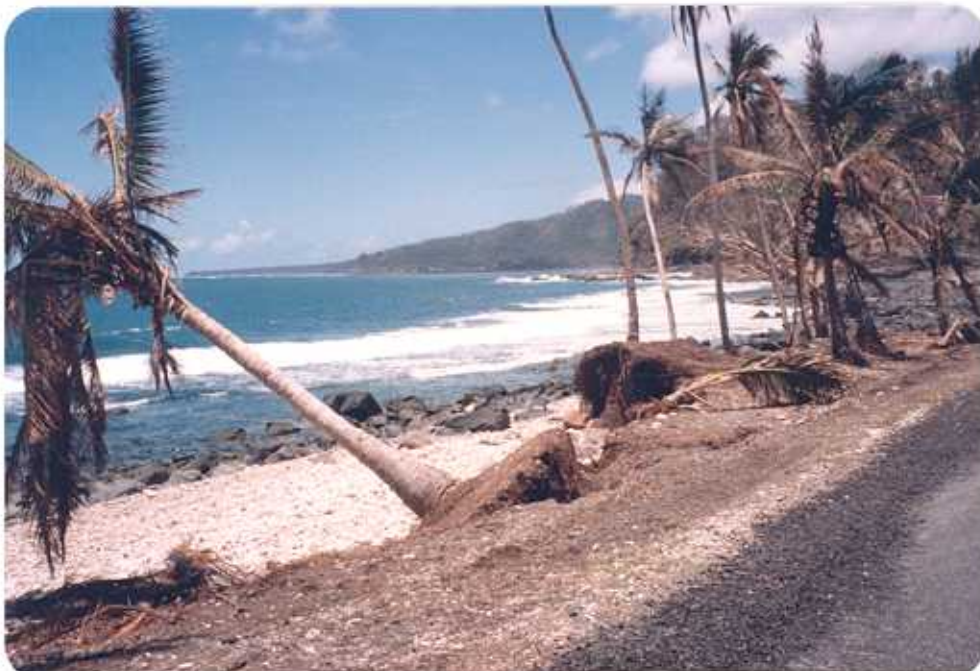
Figure 29. Wave attack on the coastline uprooted many of the coastal palms, washing many out to sea. They were later to be deposited along the coast after the storm (Figure 10).

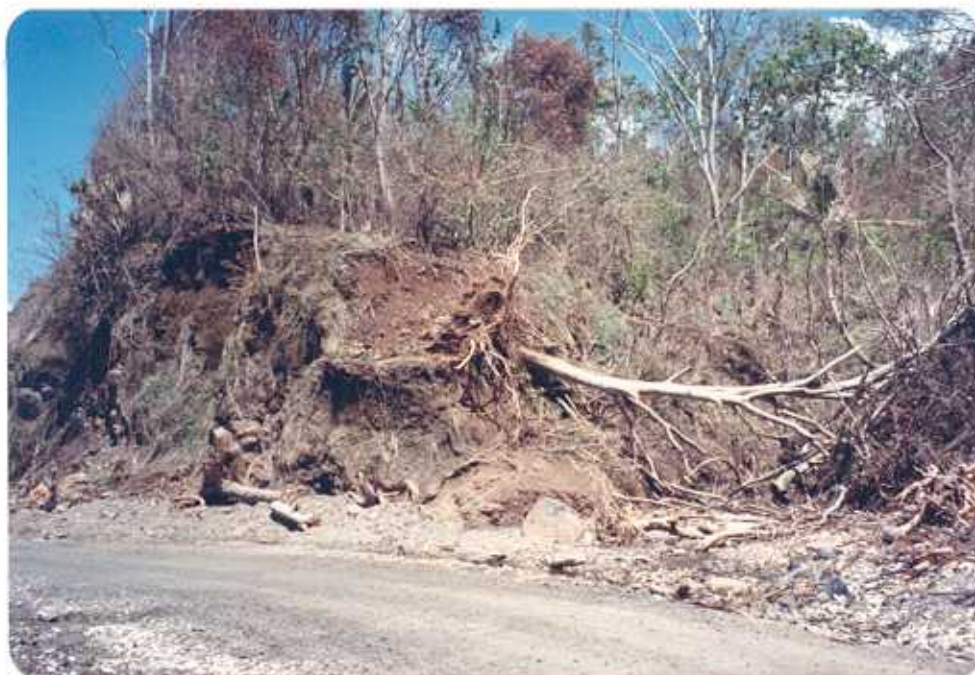
Landslides were common on the slopes of cliffs and mountains (Figures 30 and 31). Trees were uprooted due to strong winds and the land was destabilised. Heavy rains accompanying the cyclone worked to saturate the soil. Gravity, working on this mixture, was able to force the movement of soil downslope often covering roads and disrupting transportation to the outer parts of the coast. This tended to hinder rescue and relief efforts immediately after the cyclone.

Figure 30. Rainfall and high winds damaged many trees on the hillsides, uprooting them and causing landslides.

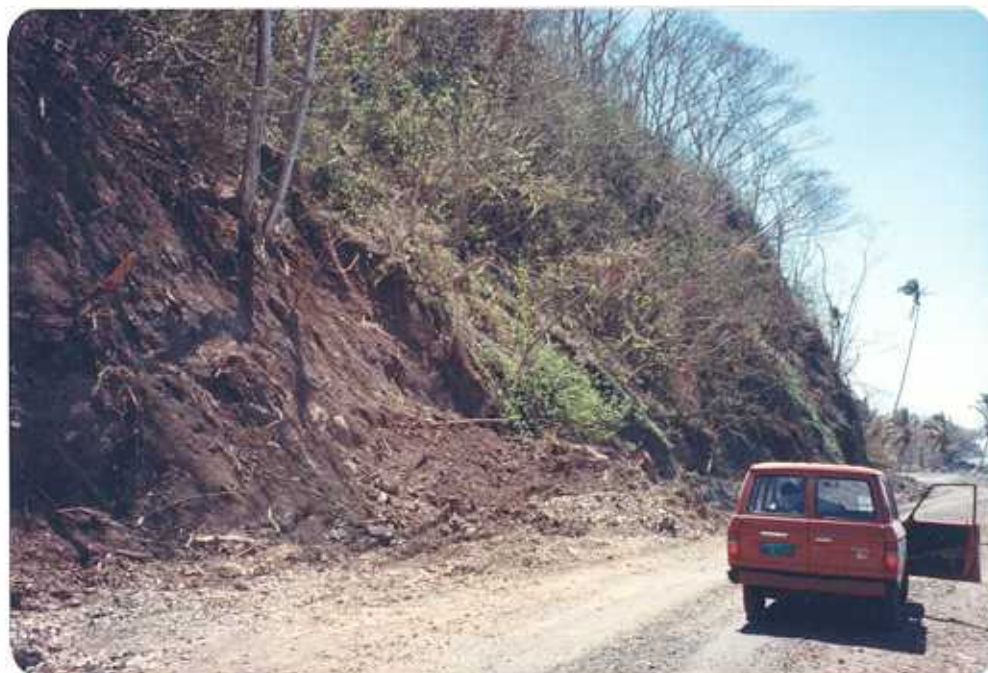
Figure 31. Many of the landslides blocked the roads hindering rescue efforts to the outlying areas of Upolu.
