**SURVEY OF CYCLONE OFA DAMAGE
TO THE NORTHERN COAST OF UPOLU,
WESTERN SAMOA**

by
Douglas M. Rearic*
Techsec

Prepared for: South Pacific Applied Geoscience Commission (SOPAC)
Western Samoa Project: WS.13

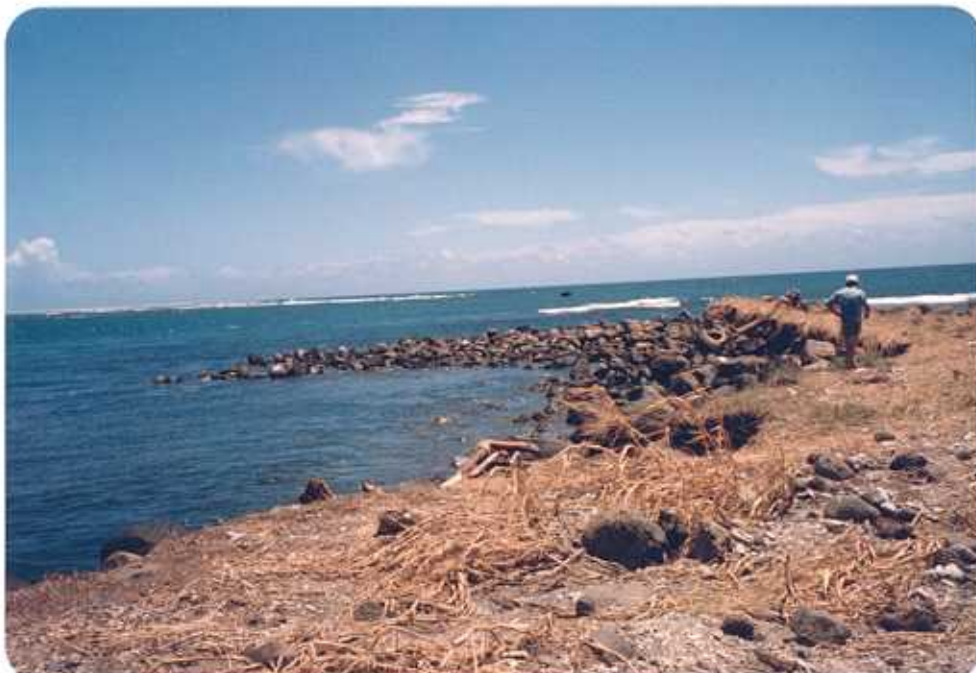
Much of the reclaimed land along the coast was lost to the sea (Figure 32). In many cases, homes that had been built on this type of land were destroyed and the land washed away so that it is now impossible for these families to rebuild even if they have the resources to do so (Figure 6).

Figure 32. The loss of reclaimed land was significant along the entire northern coast of Upolu. The landfill area in this photograph lies directly off the city front in Apia and about 20 meters of the ocean fronting portion was lost to wave attack during the cyclone.

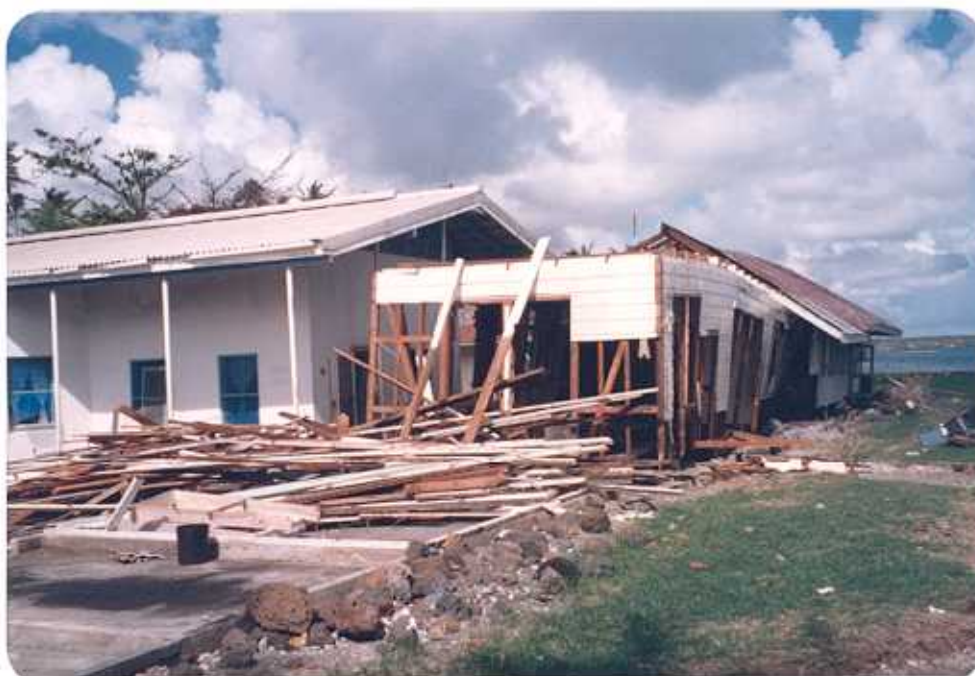
Because of the destruction of many of the buildings at Apia Observatory, historical meteorological and scientific records were lost forever (Figure 33). Some of these records date back to 1904 and the beginning of the Observatory. Most of the contents of the library were also destroyed or severely damaged during the cyclone.

Figure 33. Many of the historical meteorological and scientific records were lost at Apia Observatory. The library contents were also either destroyed or damaged during the cyclone as approximately 0.5 metre of water washed across the tip of Mulinu'u peninsula.
