# Assessment of the Port Vila Earthquake Vanuatu 2nd January 2002

By:  
Eslie GARAEBITI  
Graham SHORTEN  
Marc REGNIER  
Purnima NAIDU  
Monika SWAMY

March 2002

*A DGMWR/IRD/SOPAC Joint Publication*

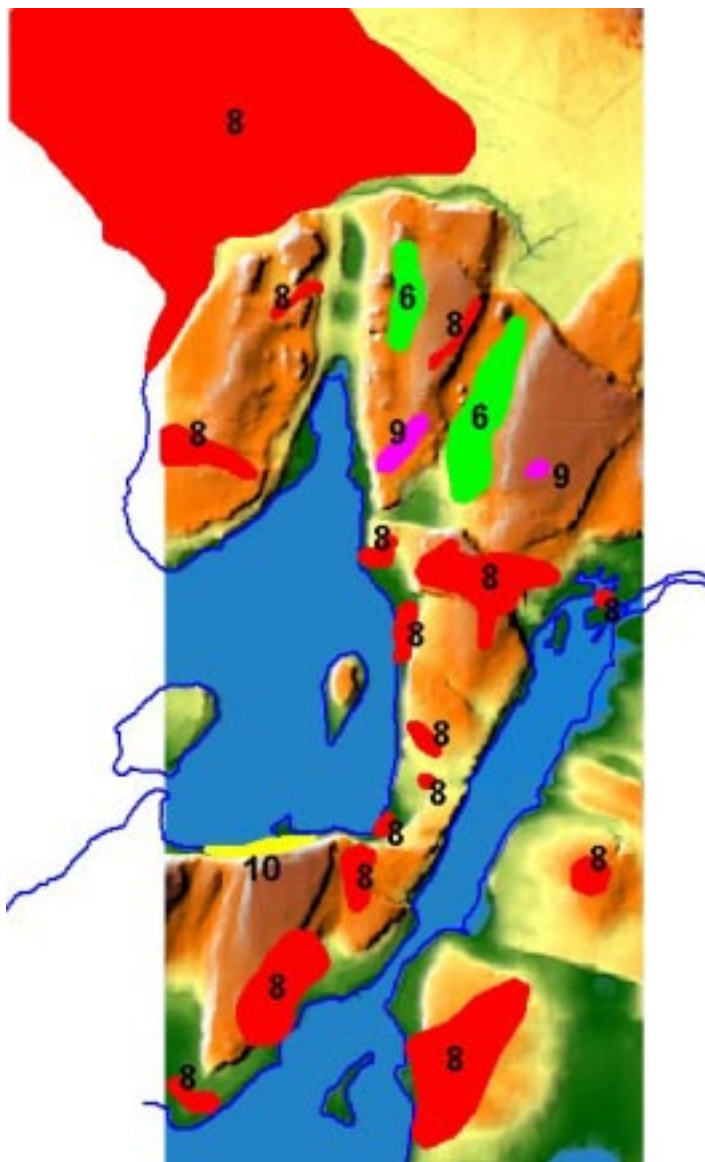
The intensity levels above or below intensity MM 7 are grouped in Figure 11 as anomalously-high and anomalously-low areas respectively, set against a general background of intensity MM 7. These areas are draped over a digital terrain model to demonstrate their relationship to the physiography of Port Vila.

Figure 11: Zones of anomalous intensity overlain on digital terrain model of Port Vila.

Only two anomalously-low (MM 6) areas have been delineated and these lie in the northern part of the city, both matching closely with deeply weathered physiographic troughs developed on grabens in the limestone bedrock.

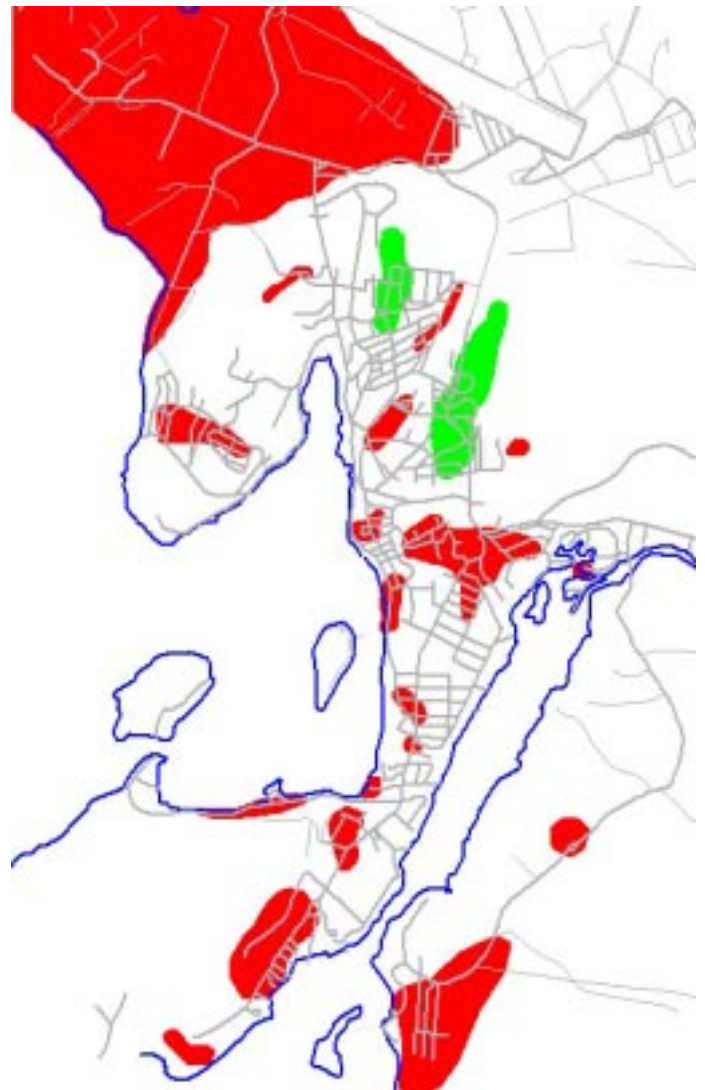
Anomalously-high (red zones) and anomalously-low (green zones) zones of observed intensities are plotted for ready reference against the road map of Port Vila in Figure 13 as basis for further investigations of the city area.

Figure 13: Map of anomalously-high (red) and anomalously-low (green) zones of intensity.

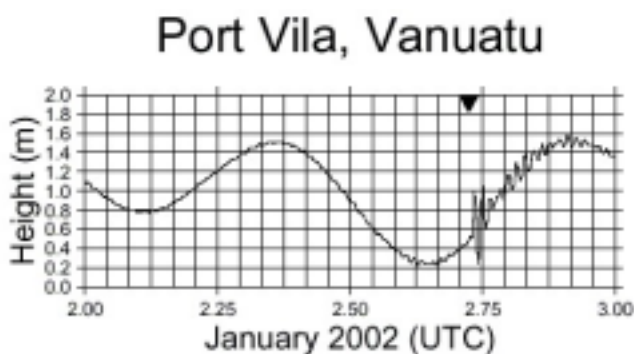
Figure 15: NTF Tide gauge record at Port Vila Star Wharf showing tsunami event.

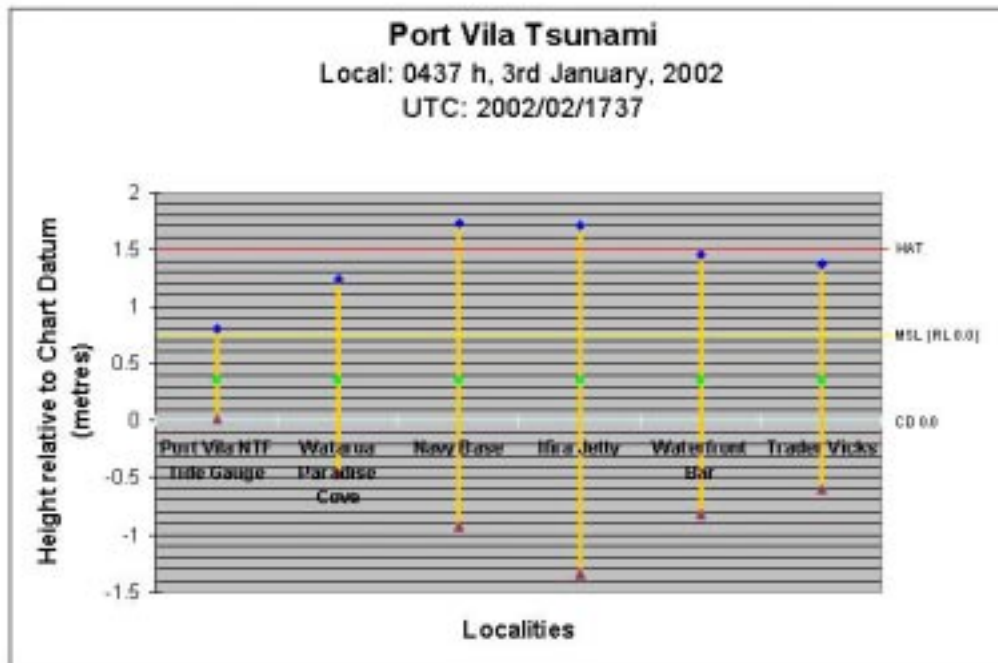
measurement. The results of the measurements are summarised and displayed together in Figure 18.

Figure 18: Eyewitness accounts of the tsunami effects around Port Vila Harbour.

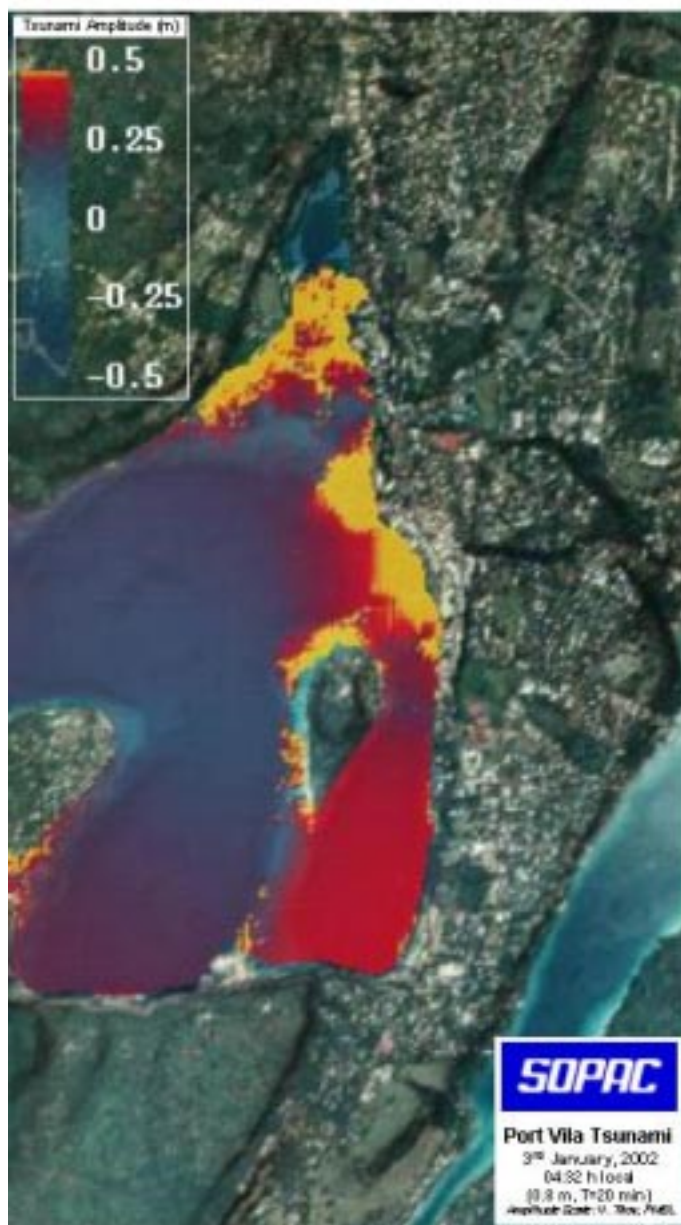
Figure 19: Model of tsunami heights in Port Vila Harbour based on tide gauge record.

The tsunami model appears, on the face of it, to have successfully predicted the amplification effects of the latest tsunami (Figure 19) and is currently being re-checked using the actual earthquake parameters and the eyewitness accounts for verification.

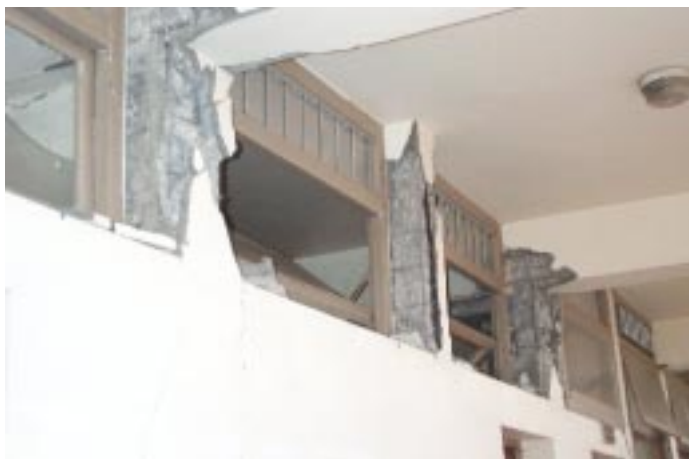
Figure 21: Short columns spalled and failed, ground floor, Lycee Bougainville.

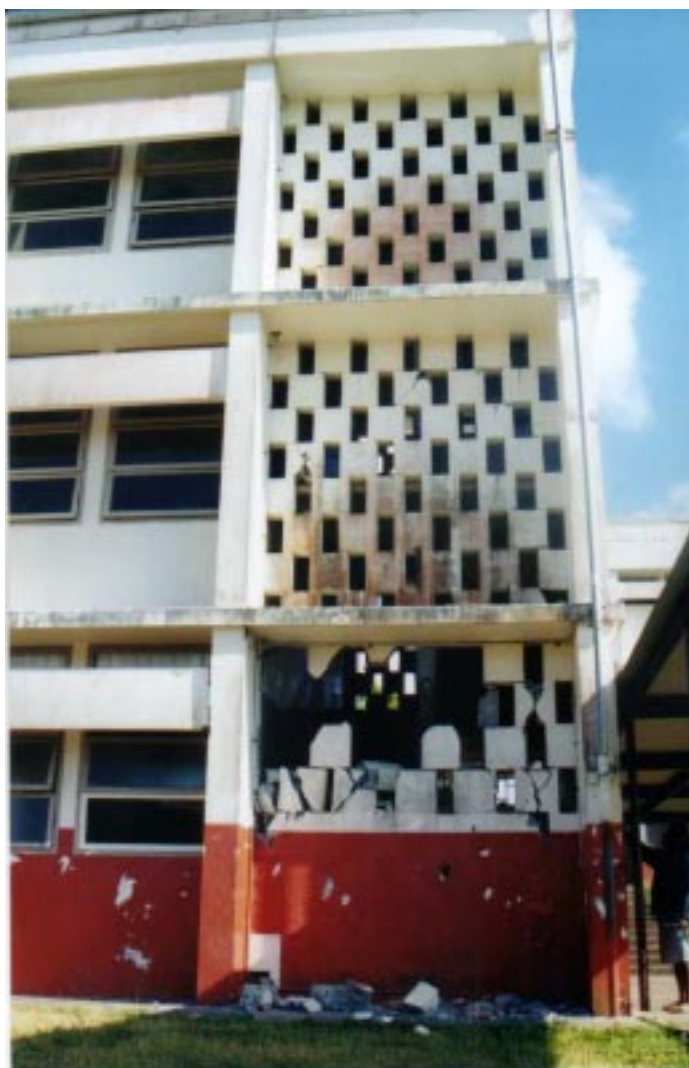
Figure 22: Differential damage between upper and lower floors of the Lycee Bougainville.

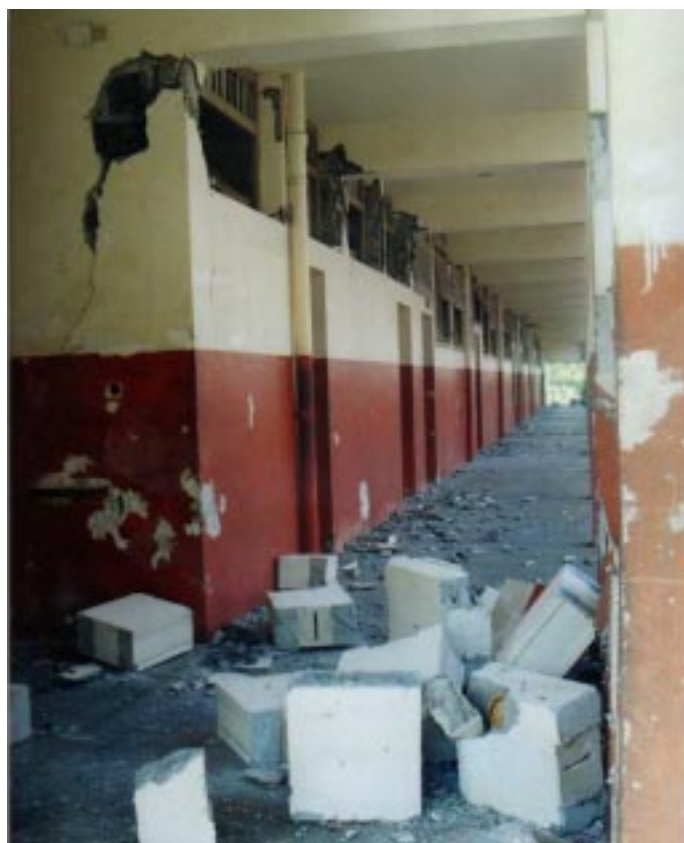
Figure 23: Damage to ground-floor classrooms of the Lycee Bougainville.

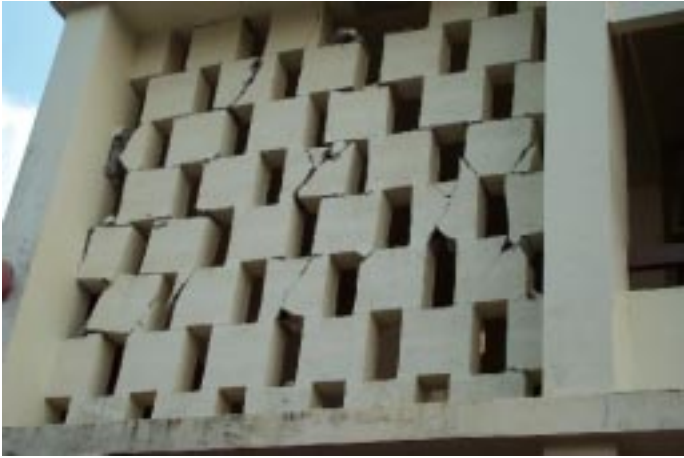
Figure 24: Infill block-work in stairwells of the Lycee Bougainville sheared and collapsed.

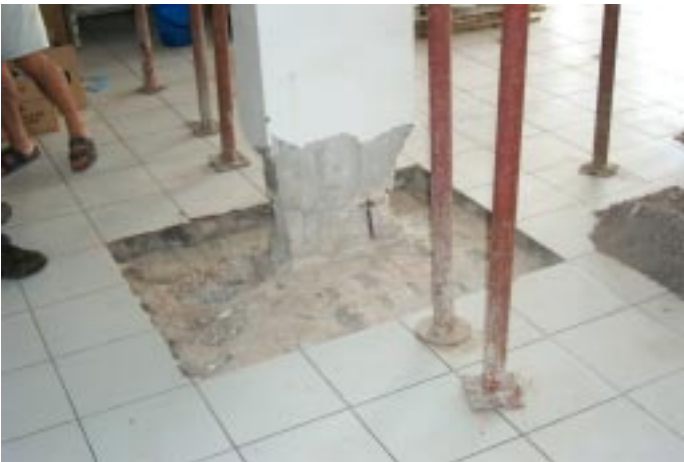
The 3-storey Au Bon Marche in No.2 district was badly damaged (Figure 25) through column failure, probably due to inadequate foundation floor beams.

Figure 25: Damage around ground-floor columns at Au Bon Marche.

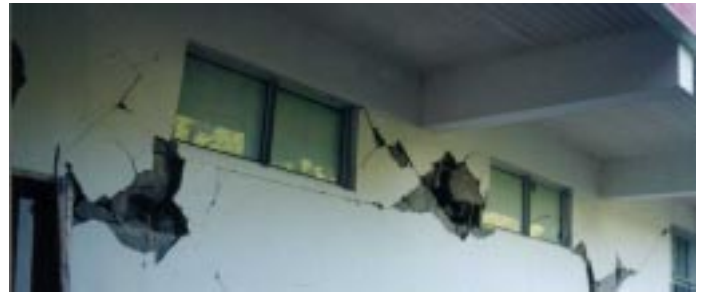
Figure 26: Damage at the Imford Museum.

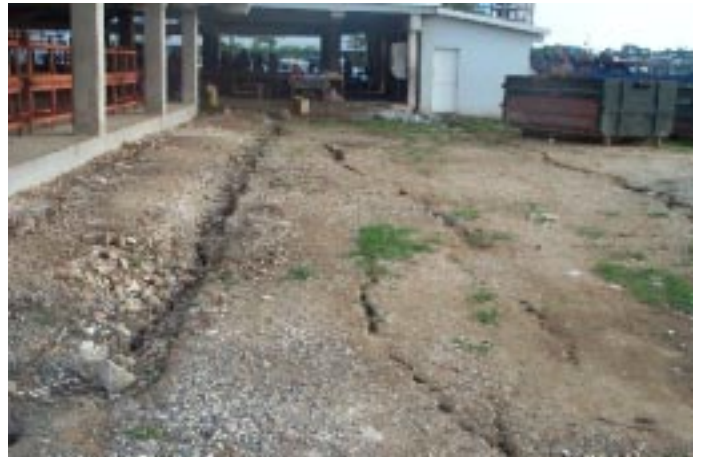
Movement of the sea wall during the main shock has led to some permanent deformation to seaward and subsidence of the foreshore in reclaimed areas around the Central Business District. The worst affected area runs for some 150 m from the open park area north of the main public Market (Figure 27), southward through the seaward end of the Market building and car park and then through the seaward end of the Sea View Restaurant/Bon Marche in a 25 m-wide zone adjacent to the sea wall.

Figure 27: Fissuring in back-fill behind sea wall, north of Market.

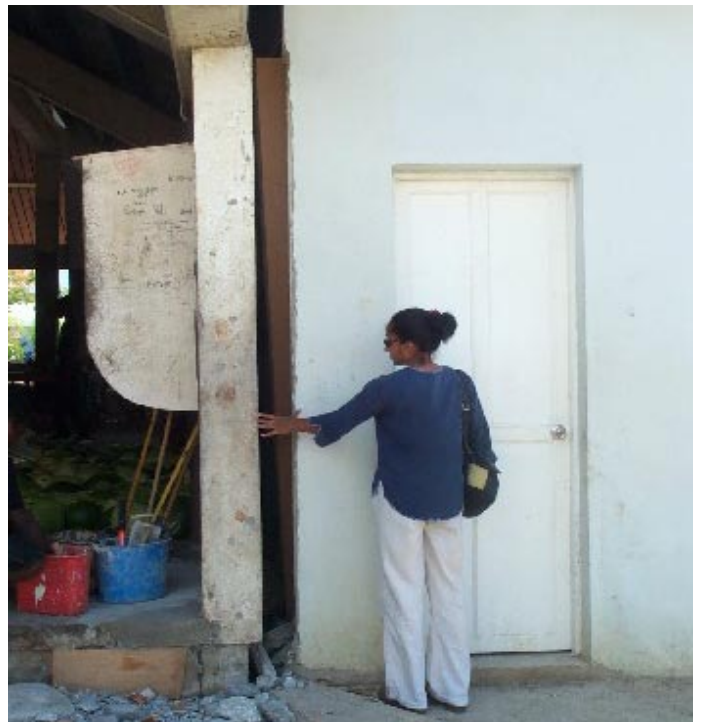
Figure 28: Detached Market toilet block.

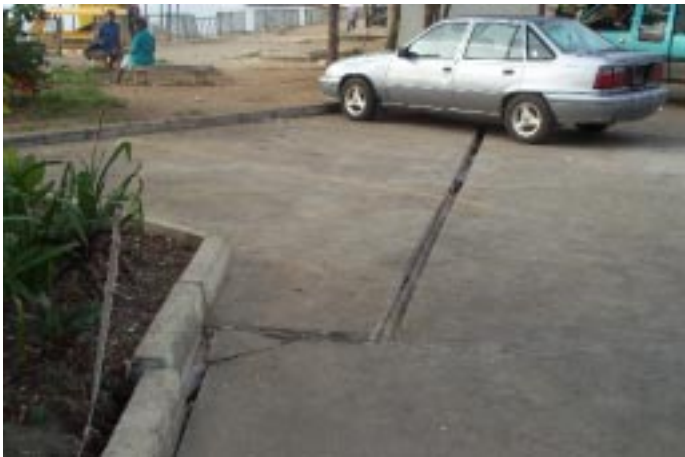
Figure 29: Car park slabs opened on construction joints south of Market.

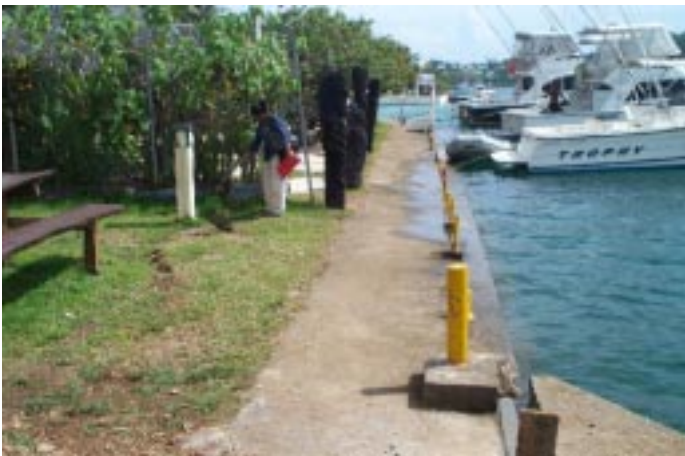
Figure 30: Ground fissures and tilted sea wall near Waterfront Bar.

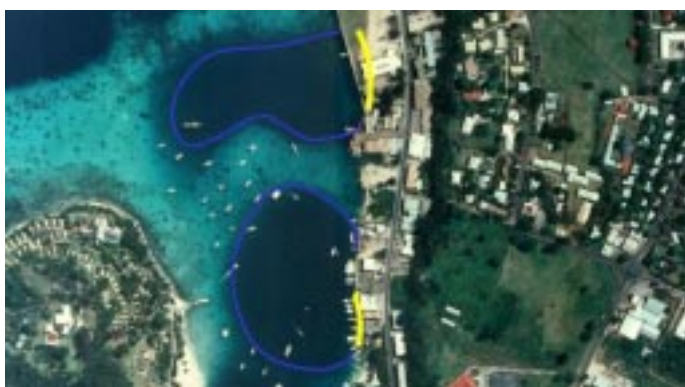
Figure 32: Areal extent of damage to sea wall in Port Vila.

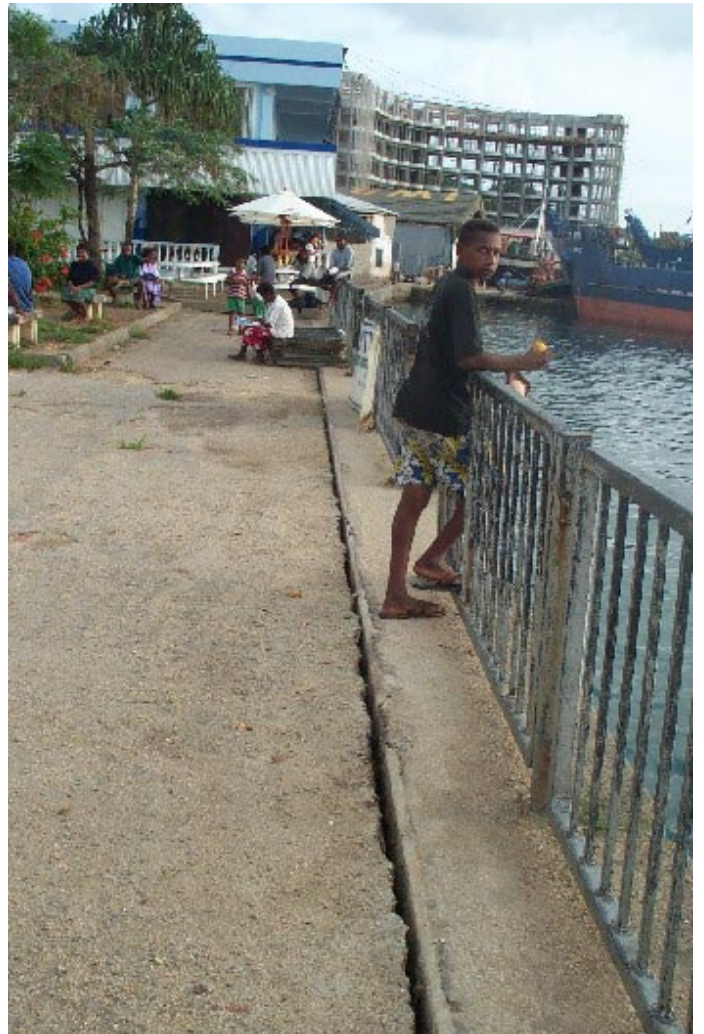
Figure 31: Gap between sea wall and back-fill.

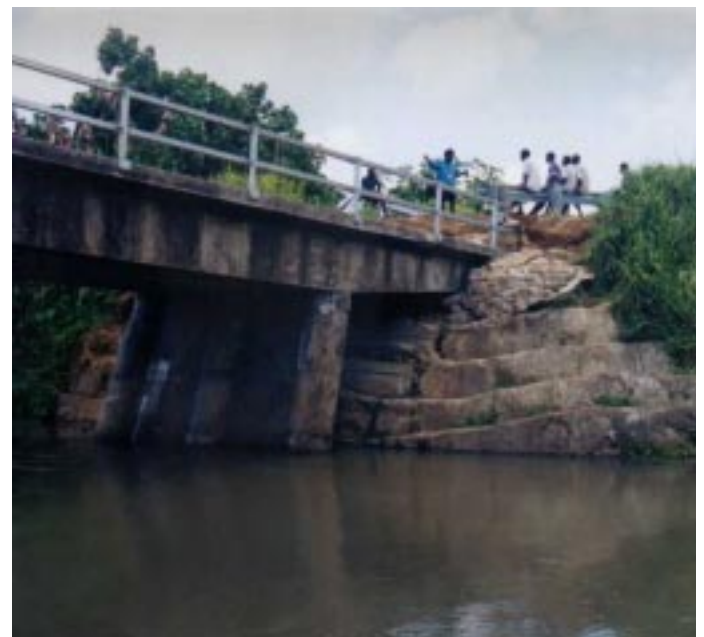
Figure 33: Damaged Teouma Bridge, eastern abutment.

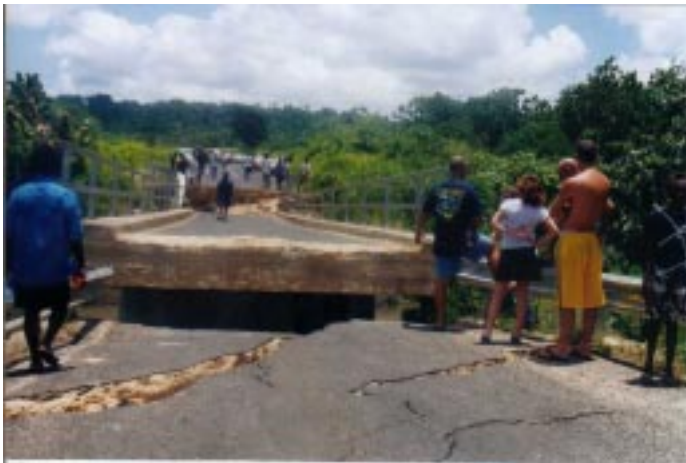
Figure 34: Damaged Teouma Bridge, western abutment.

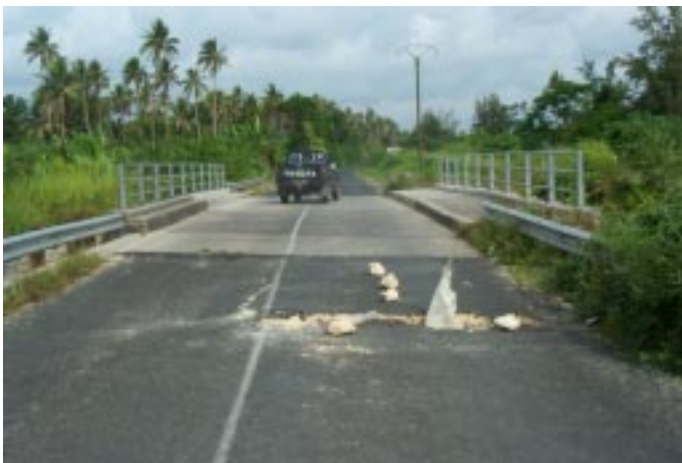
Both the Mele (Figure 35) and Prima Bridges to the northwest of Port Vila have been affected by failure of their approach embankments and abutments due to liquefaction in the underlying alluvial soils (Figure 36), although the main bridge structure in both cases is considered by the PWD to be sound. Fissures

Figure 35: Embankment failure, Mele Bridge.

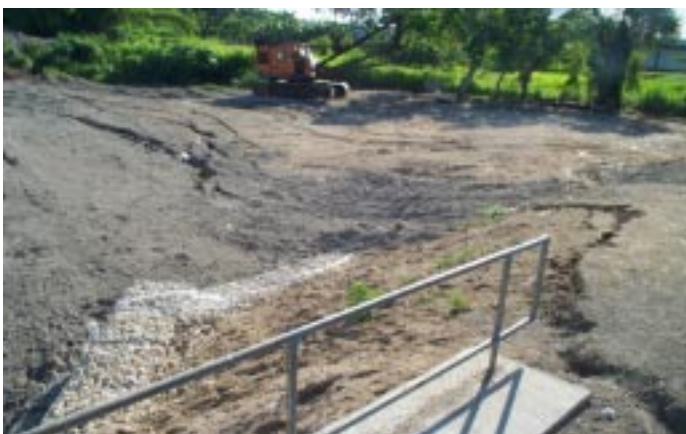
Figure 36: Slumping due to liquefaction, Prima Bridge.

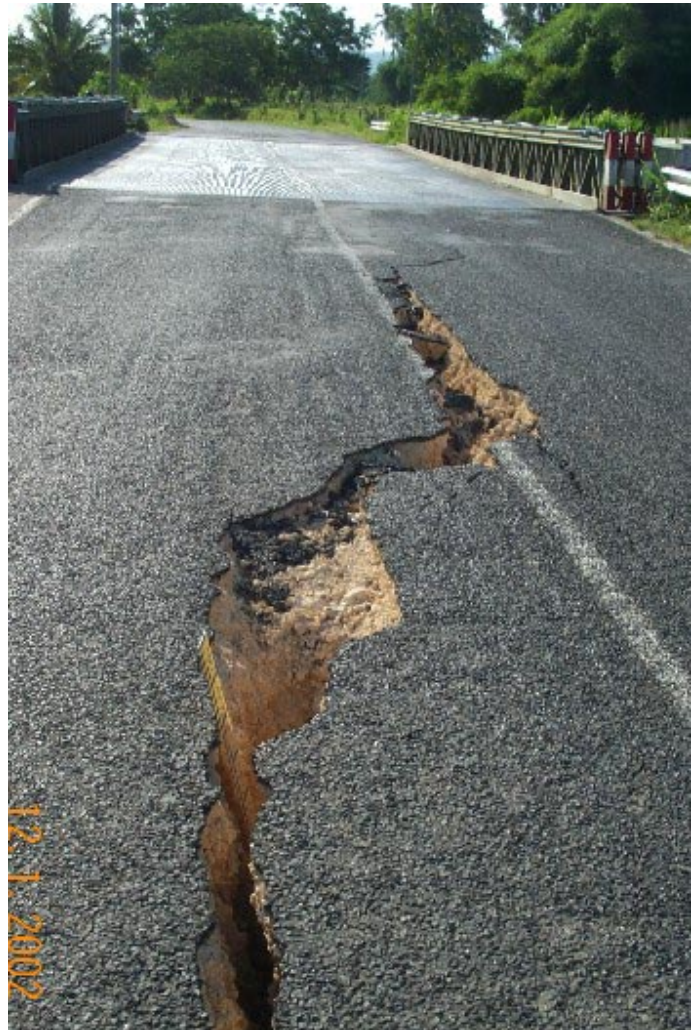
in the roadway and underlying embankment fill (Figure 37) opened up to 500 mm wide with depths in excess of a metre in places.

Figure 37: Embankment failure, Prima Bridge.

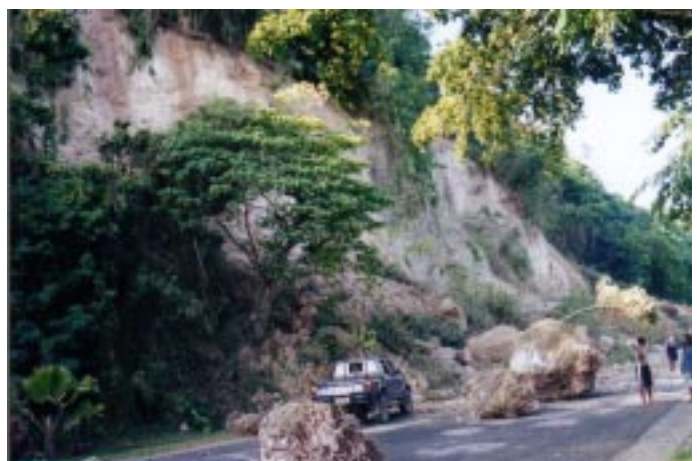
Figure 38: Blockage of Star Wharf access road by landslide.

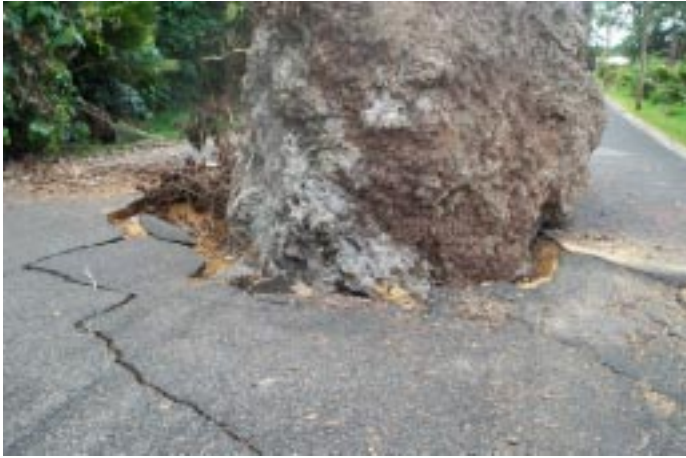
Figure 39: Toppled limestone boulder puncturing surface of the main Star Wharf access road.

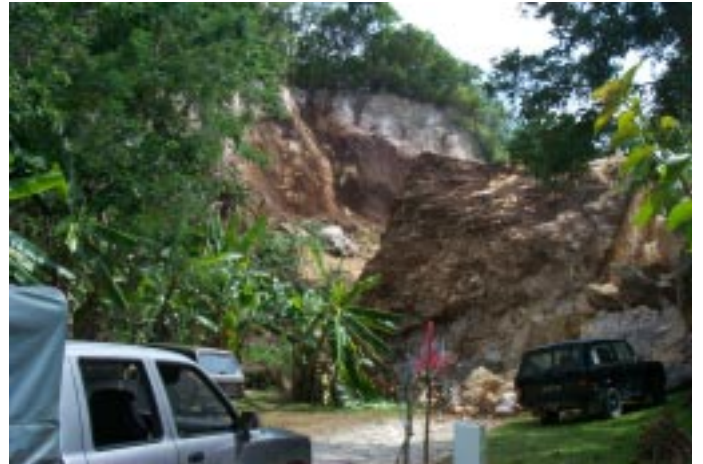
Figure 42: Toppling failure from the cliff face near Pango Resort.

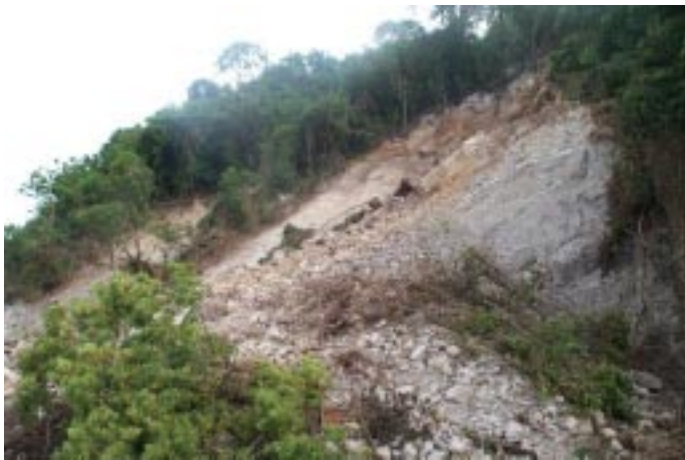
Accordingly, the slope failures have been concentrated in the tuff composing the cliff face above the southeastern part of the harbour with very few in the southwest where the cliff face is almost entirely composed of limestone (Figure 40).

Figure 40: Massive slope failure in tuff above Star Wharf access road.

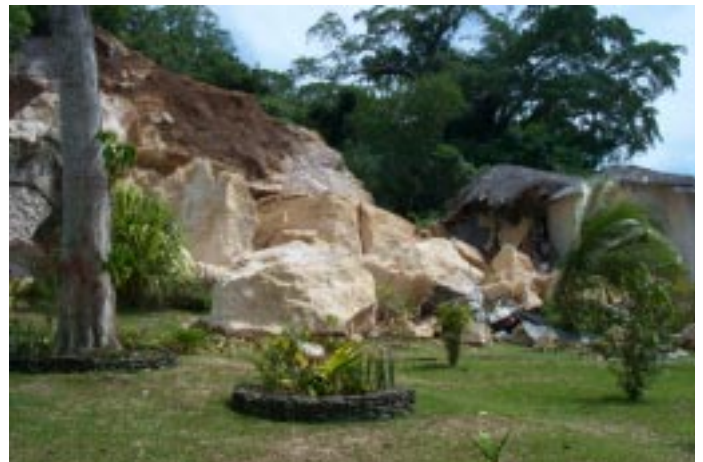
Figure 43: Rock debris behind Pango resort.

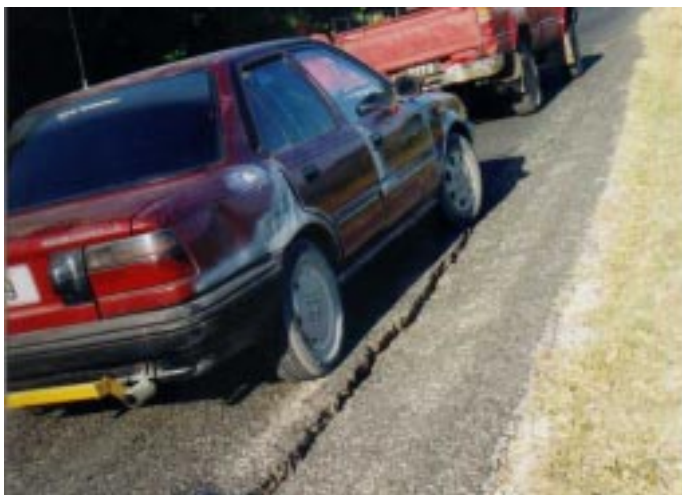
Figure 41: Road embankment collapse, Star Wharf road.

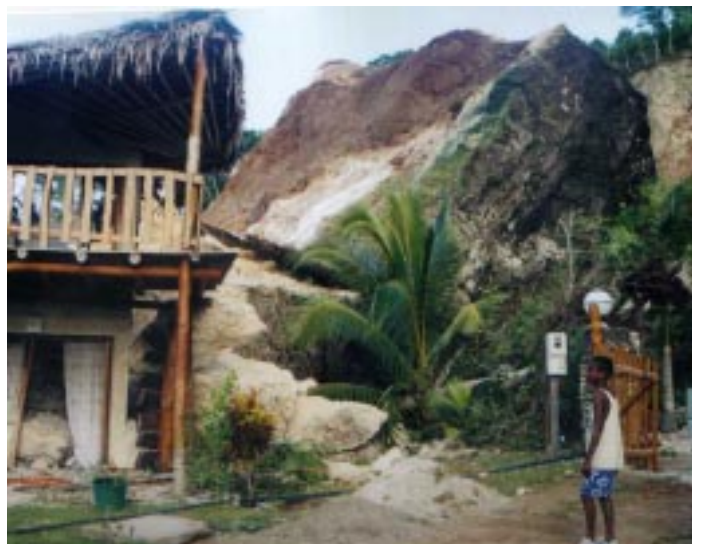
Figure 44: Bungalow damaged by rock-fall at Pango resort.

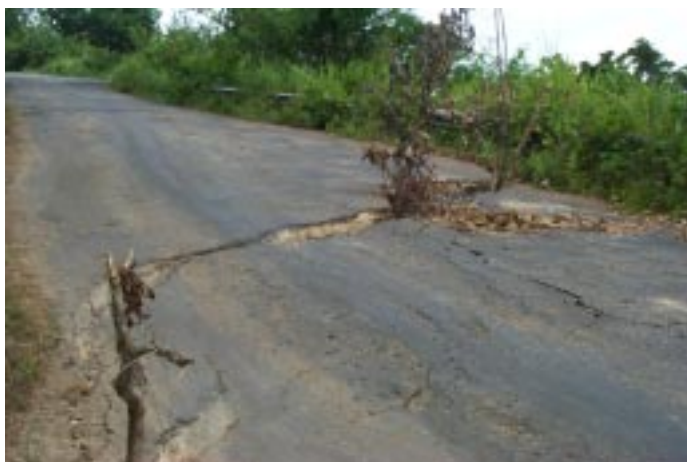
At Klem's Hill, a significant slope failure occurred both within the Efate Ring Road roadway fill (Figure 45) and in the tuff forming the cut slope above.

Figure 45: Transverse fissures on Efate ring road at Klem's Hill.

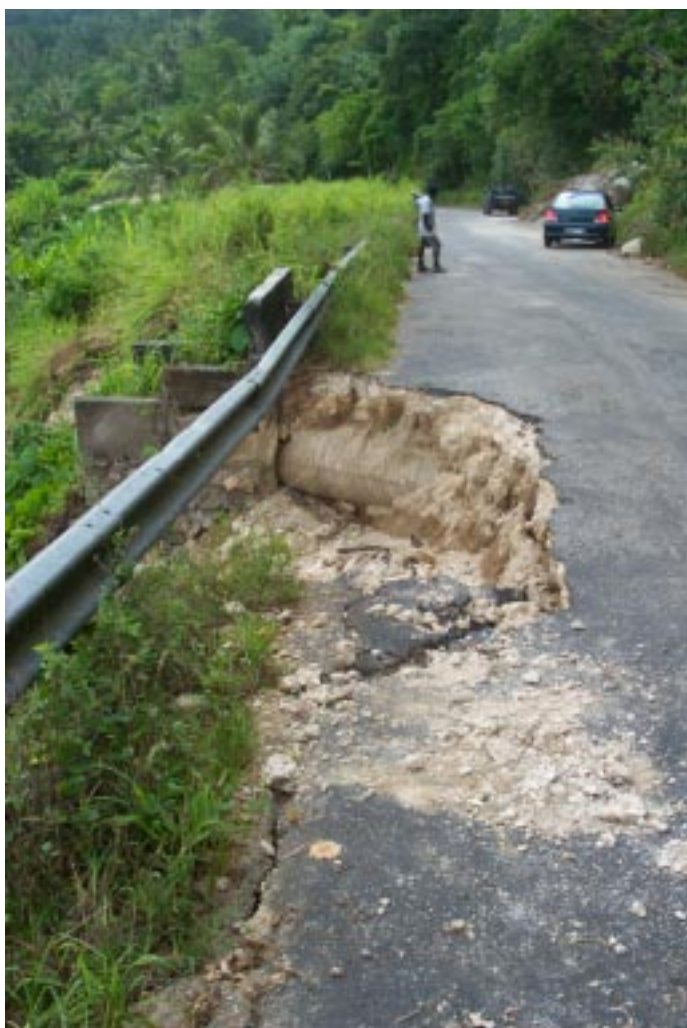
Inspection of other, smaller failures nearby suggest that shear planes dipping out of the face may have led to the failure in this area. The road is excessively steep and remains vulnerable to such failures in the future. Transverse and longitudinal cracks in the roadway were related to collapse of the main embankment (Figure 46). The length of the damaged area on this road is about 200 m.

Figure 46: Landslide on Efate ring road at Klem's Hill.
