BUILDING DAMAGE ASSESSMENT SUVA, FIJI ISLANDS

Geraldine Teakle & Litea Biukoto
SOPAC Hazard Assessment Unit

January 2001

SOPAC Technical Report 315

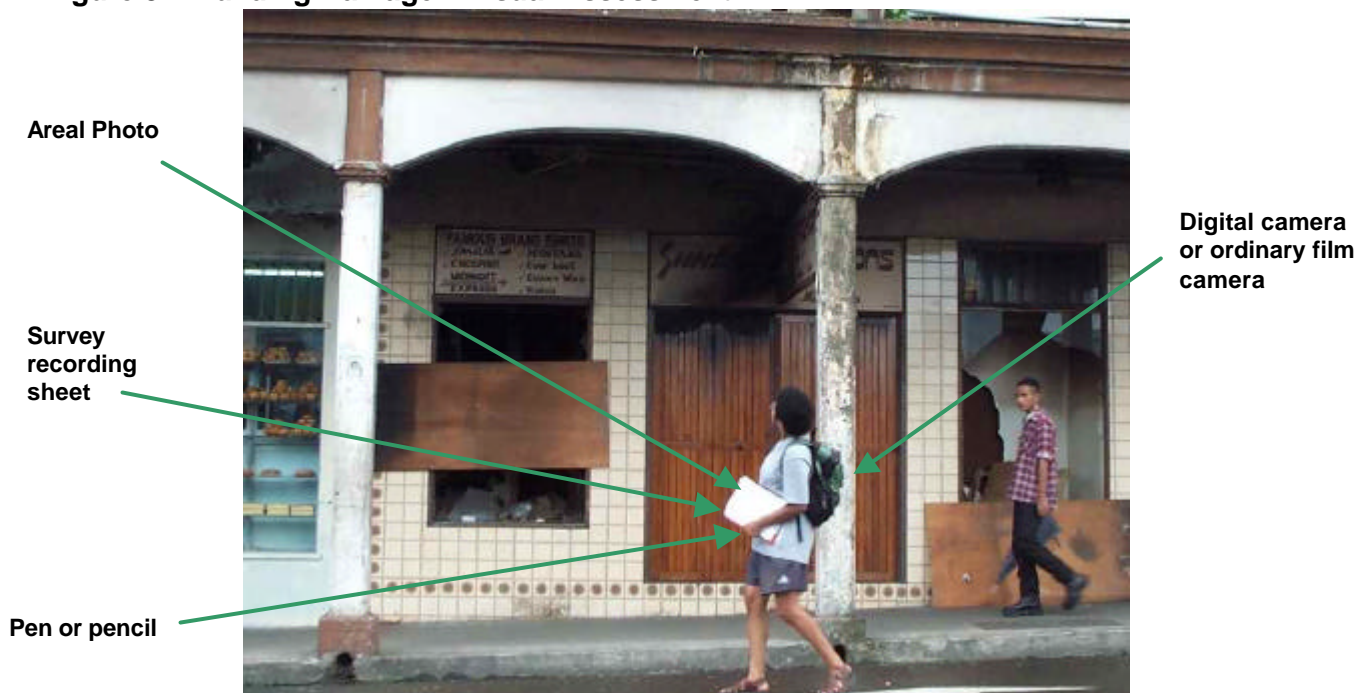
Figure 3. Building Damage – Visual Assessment

The same-sidewalk survey approach is used in identifying building materials and assigning a basic structural-hazards flag based on the observed building characteristics. Application of the methodology to seismic hazards identifies buildings that are potentially hazardous and should be analysed by a professional engineer after the initial shock.

Damage flags were determined by gauging the extent of damage using several building attributes. The overall damage to the building had to be considered even though most of the shops impacted were located on the ground floor. The building attributes examined included mainly

- windows and size of impacted area;
- wall and roofing material; and
- the integrity of the walls and roofing (that is, degree or extent of damage).

Each damaged building was flagged red, orange or green depending on the extent of damage (see Table 1). Where possible, the damaged buildings were photographed for incorporation into the Suva event database. More than 50% of the damaged buildings, including those most seriously damaged, were photographed.

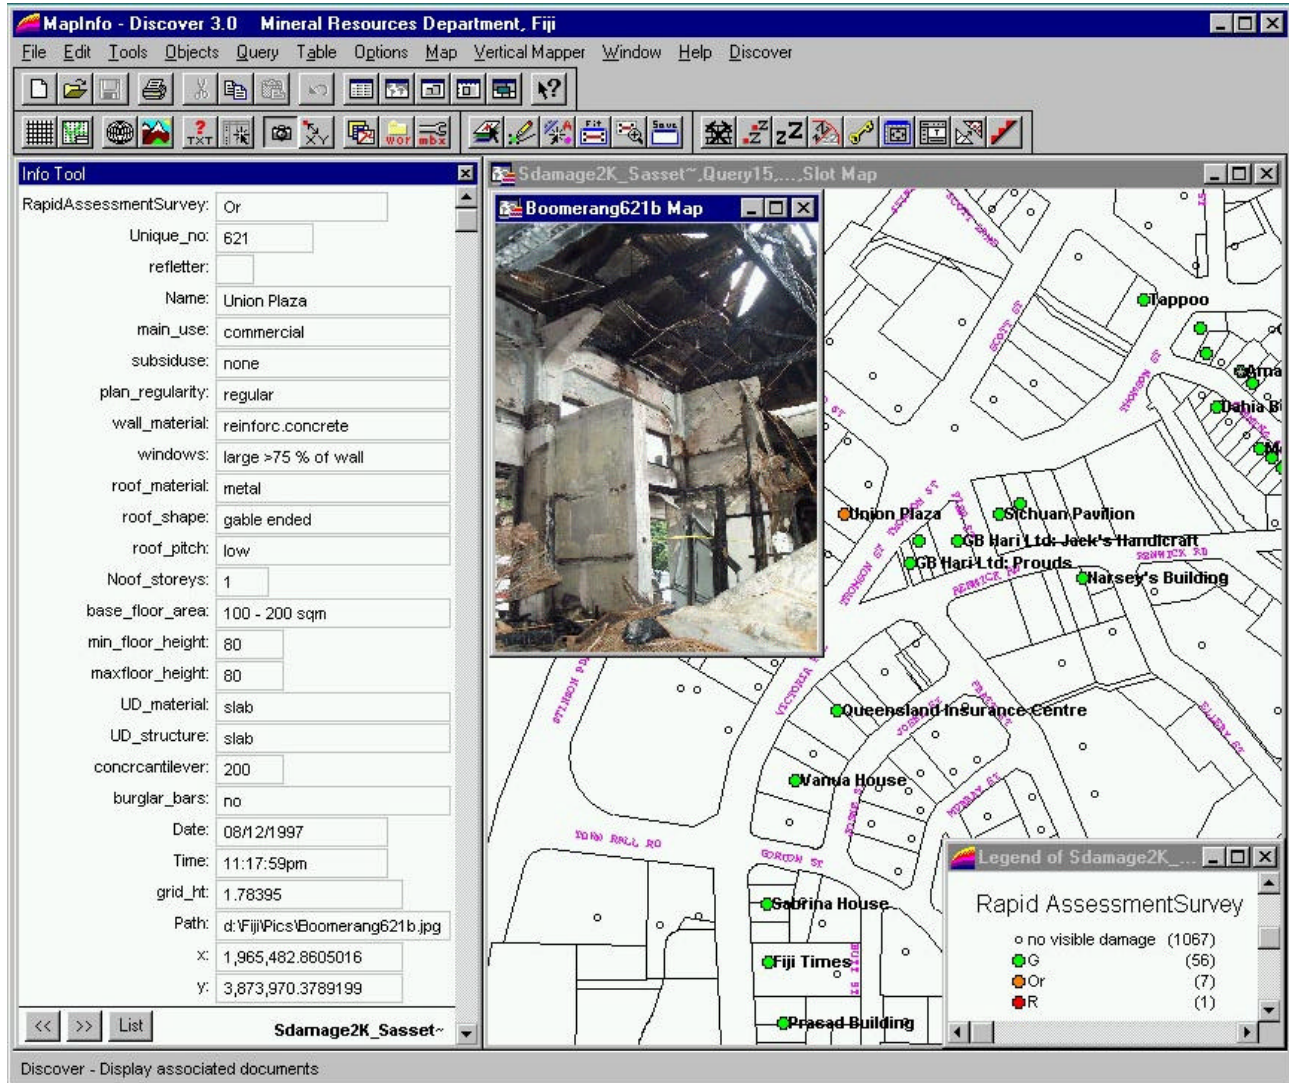
Figure 5a. A pop-up display of the burnt interior of Boomerang Duty-free, Union Plaza Building.

The results of the survey can be displayed by MapInfo “thematic-map” option, Figure 5a, to show buildings that were severely damaged (red) as opposed to those that were not visibly damaged (black circle). Of the 64 buildings flagged 54 were flagged green, 7 orange and 1 red; see the orthophotograph² and flagged buildings in Figure 5b.

A damage flag is assigned to a whole building. Hence, despite 3 of the businesses in the Plaza being burnt, an orange flag was assigned to represent total building damage. The Discover display images button (🖼️) brings up any images linked to the selected map object.

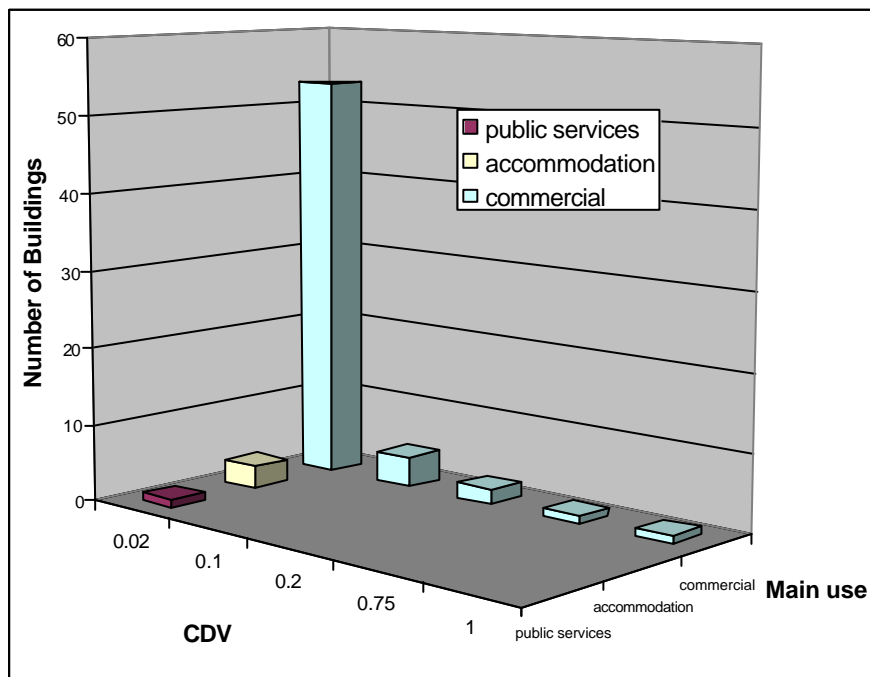
Figure 6a. Number of Buildings Assessed and Central Damage Values (CDV).

The column chart depicted in Figure 6a represents a summary of the CDVs assigned to each building assessed in the survey. The CDVs were assigned to the buildings after the damage flags (red/orange/green), field comments and digital photographs were assessed and analysed. A total of 64 buildings were assessed in the survey, with CDVs ranging from 0.02 (negligible damage) to 1.0 (complete destruction). It is interesting to note that the main use of the majority of the buildings damaged in the Suva event was “commercial”; while the remaining were “accommodation” and “public services” (see Figure 6a). There is an inconsistency with the number of buildings assessed in the damage-assessment survey and those assessed by all the insurance agencies combined (well exceeding 100 buildings, pers. comm. Tower Insurance). This inconsistency is discussed further below as a component of calculating the damage. Photographic images showing the CDVs assigned to buildings that sustained different levels of damage can be seen in Figure 6b.

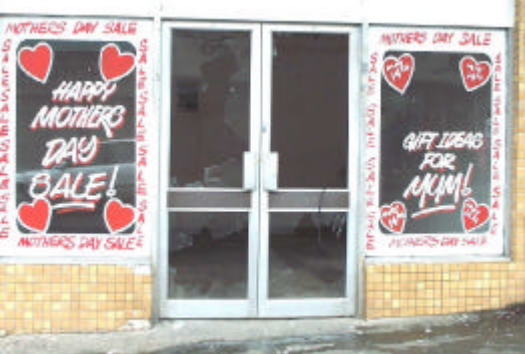
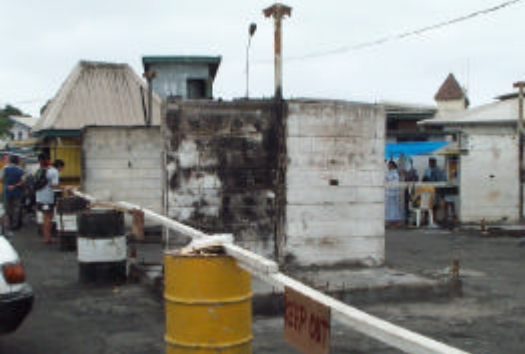
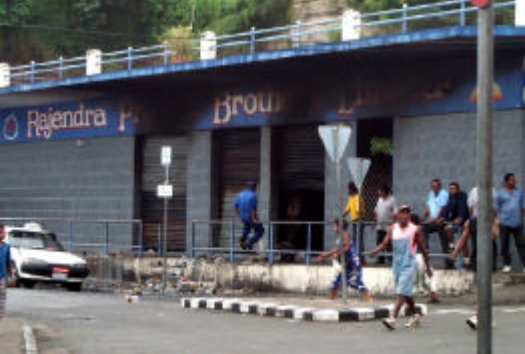
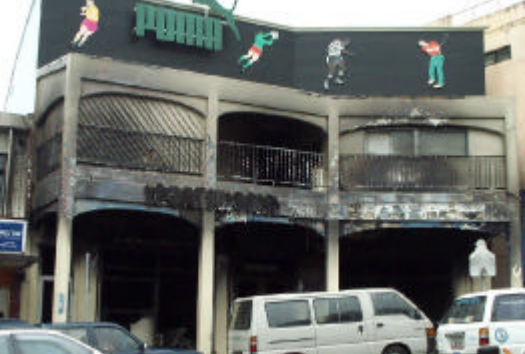
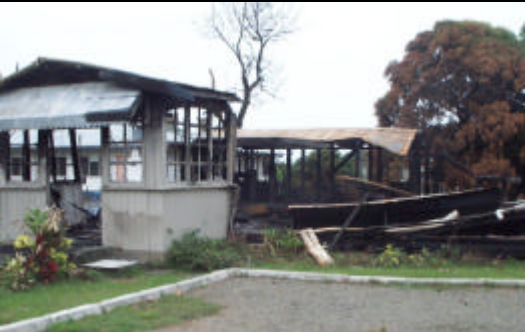
Figure 6b. Central Damage Values (CDVs) Assigned to Damaged Buildings.

CDV	Example
0.02

0.1

0.2

0.75

1.0

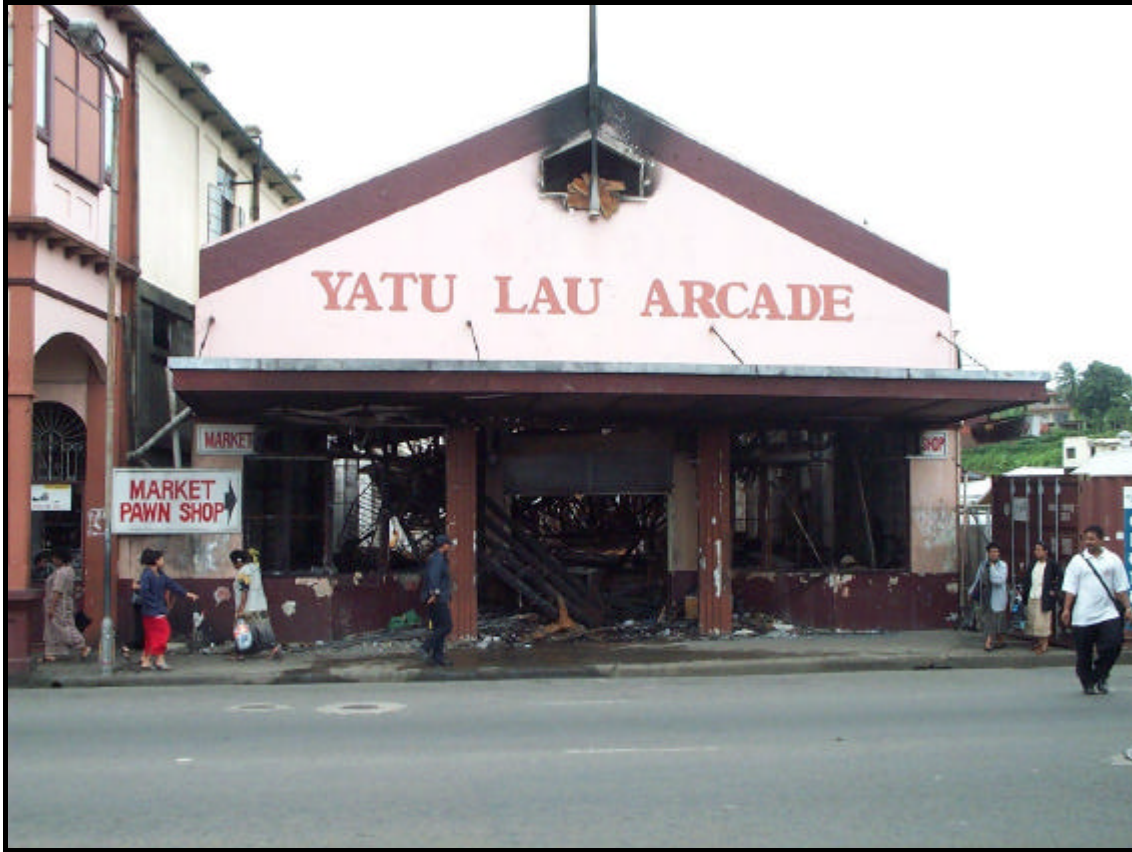
Figure 7a. Yatu Lau Arcade – A severely Damaged Building

Once the RR has been calculated, the Damage [HE] for a specific building in the selected study area can be calculated. To demonstrate this, the Damage [HE] is calculated for Yatu Lau Arcade, a single building with a commercial main use (Rawlinsons’ Classification Office 1-2 Stories). Yatu Lau Arcade was severely damaged (see Figure 7a, 7b and 7c) by fires during the Suva event. After visual inspection, it was assigned a red damage flag and subsequently a CDV of 0.75 as it most likely suffered greater than 60% damage by fire and is likely to be condemned (demolished) (see Table 3). The RR is 2.2 (from Table 4) and resultant Damage [HE] is calculated to be 2.2 x 0.75 (from Equation 2) which equals 1.65 [HE].

The floor area of Yatu Lau Arcade is approximately 400 m² (obtained from the Suva building-assets GIS database). Thus the total estimated cost of damage to the building only (not including contents, interior fixtures, or business values) is:

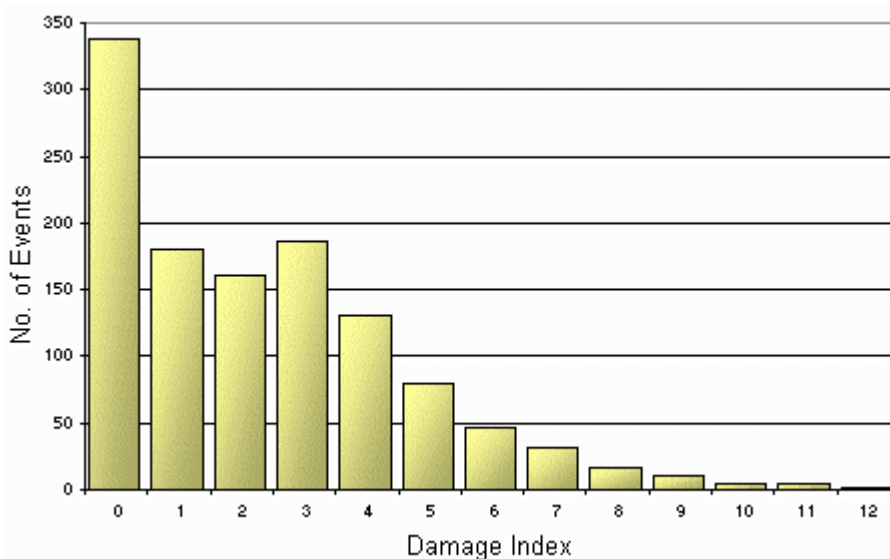
Figure 8. Frequency Distribution of Australian Damage Indices 1900 - 1999
(Blong 1999 Figure 1)

To compare number of events and degree of damage resulting from multiple events, damage indices calculated for Australian hazard and disaster events have been plotted in Figure 8. DIs were calculated for 1191 events from all parts of Australia for the period 1900 to 1999, and include tropical cyclones, floods, severe thunderstorms, bushfires and earthquakes (Blong 1999). Note that 92% of the indices calculated have DI values less than 7 (equivalent to the complete destruction of just over 120 houses). What is more, approximately 16% of events have a damage index lying between 3 and 4, which is equivalent to the complete destruction of about 10 houses. Although speculative, if the trend in frequency of events of a certain magnitude impacting Fiji were the same as in Australia, then one could expect 16% of events each century completely destroying 10 houses in Fiji.
