EU EDF 8/9 – SOPAC Project Report 53  
Reducing Vulnerability of Pacific ACP States

## TECHNICAL REPORT ANALYSIS OF COASTAL CHANGE AND EROSION – TEBUNGINAKO VILLAGE, ABAIANG, KIRIBATI

March 2006

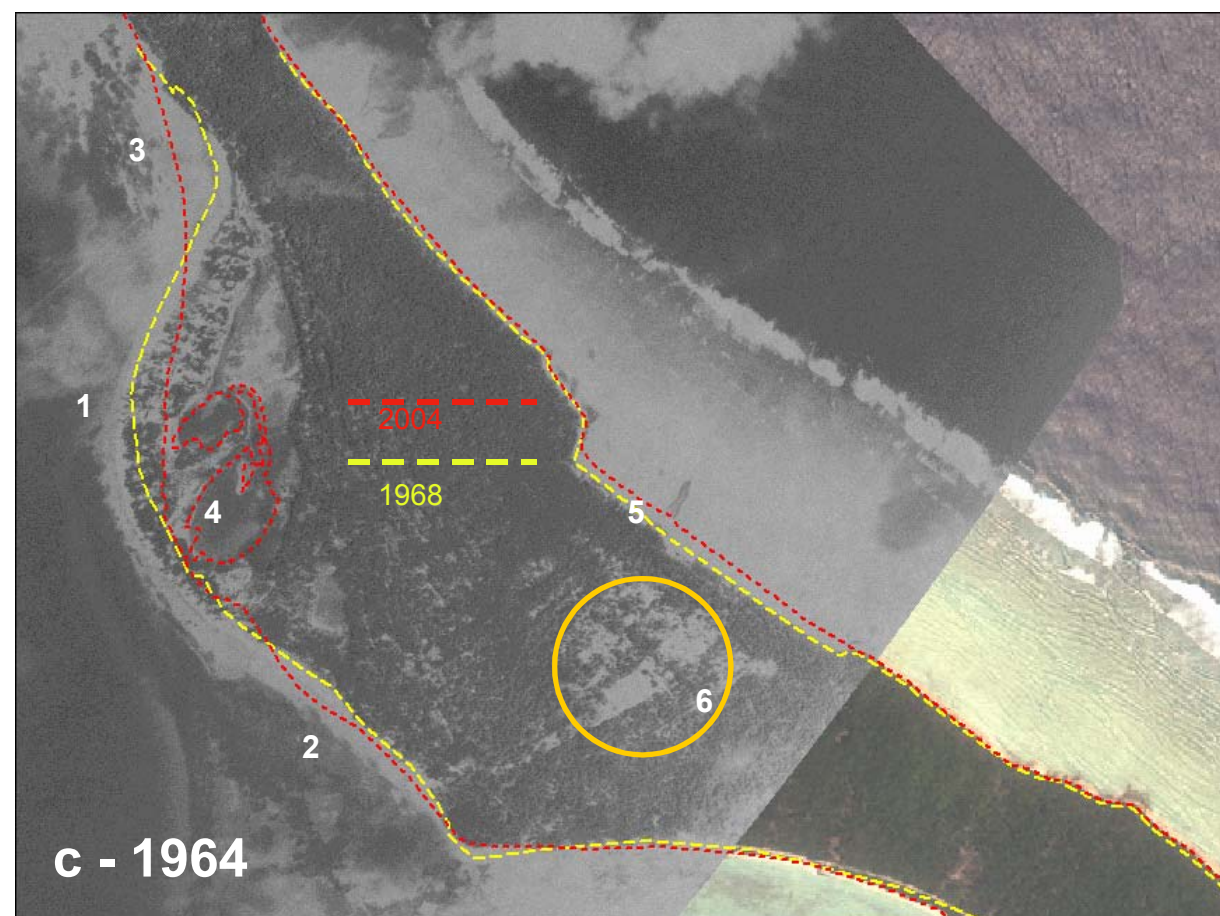
#### Historical coastline changes (multi-temporal comparisons)

These figures show a comparison of the Tebunginako Village area in 2004 (a), 1968 (b) and 1964 (c). The superimposed shorelines shows the large degree of shoreline change particularly on the lagoon coast (note all images are of identical scale and orientation and the black and white historical aerial photo boundaries can be seen where they over lay the base satellite colour image).

In 2004 (a) the position of the 1964 (red) and 1968 (yellow) coastlines show that approximately 2.73 Ha (6.7 acres) of land has been lost in area (1). However about 2.56 Ha (6.3 acres) of land has also accreted (built up) in areas 2 and 3. This shows that whilst there has been erosion at some locations (e.g. 1) the sediments are being redeposited in other locations. At location 3 the shoreline has accreted by nearly 100 m since 1964, overall there has only been a net loss of 0.165 Ha (0.41 acres) of land over the last 40 years.

Of particular concern to the village community however, has been the recent break through of lagoon waters into the freshwater ponds south of the village (4). In this area the shoreline has eroded about 50 m since 1964.

The historical aerial photographs (b and c) show some additional important information which gave clues as to what processes have been at work in this area during the last 100 years or so. Location 5 shows that a section (about 650 m long) of the ocean-side coast has also prograded (moved out) by some 20 m since the 1960's. The area in 6 (orange circle) shows a persistent feature in the vegetation of this area. Note the poor / sparse vegetation (whitish area) and the persistent curving boundary to the south of this feature. This is thought to be a prograding shoreline of the now in-filled channel and similar line features (running approximately parallel) can be detected over much of Tebunginako.

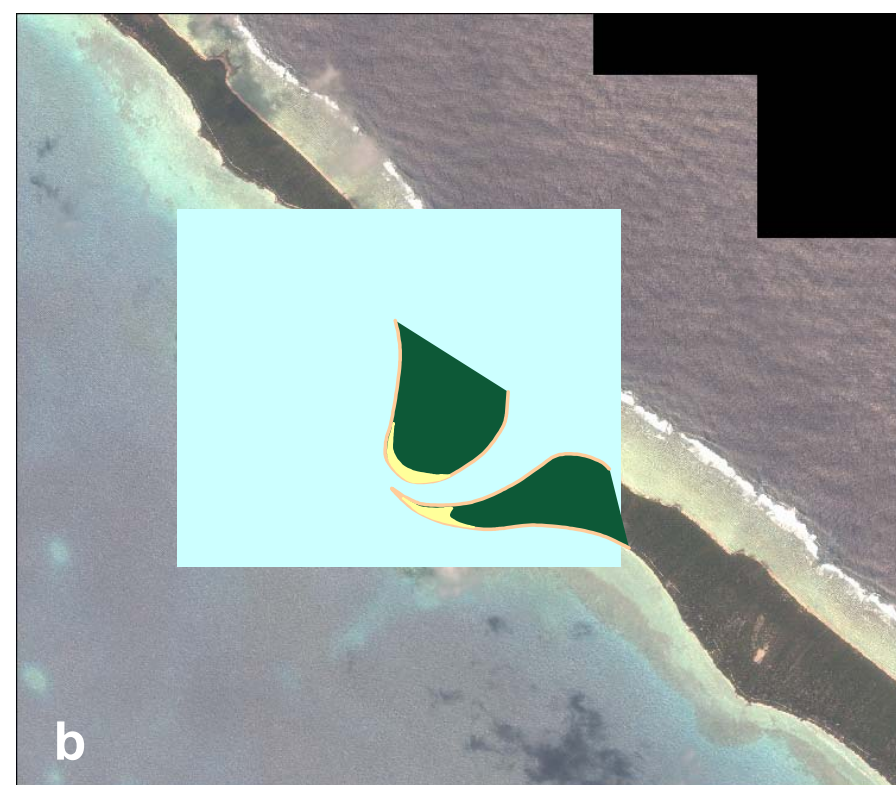
(b) Over time the channel fills with sand and eventually becomes narrower and shallower. The persistent northern sand transport pattern not only supplies this sand from the ocean reef through the passage but on the lagoon side it pushes a sand spit extending to the north.

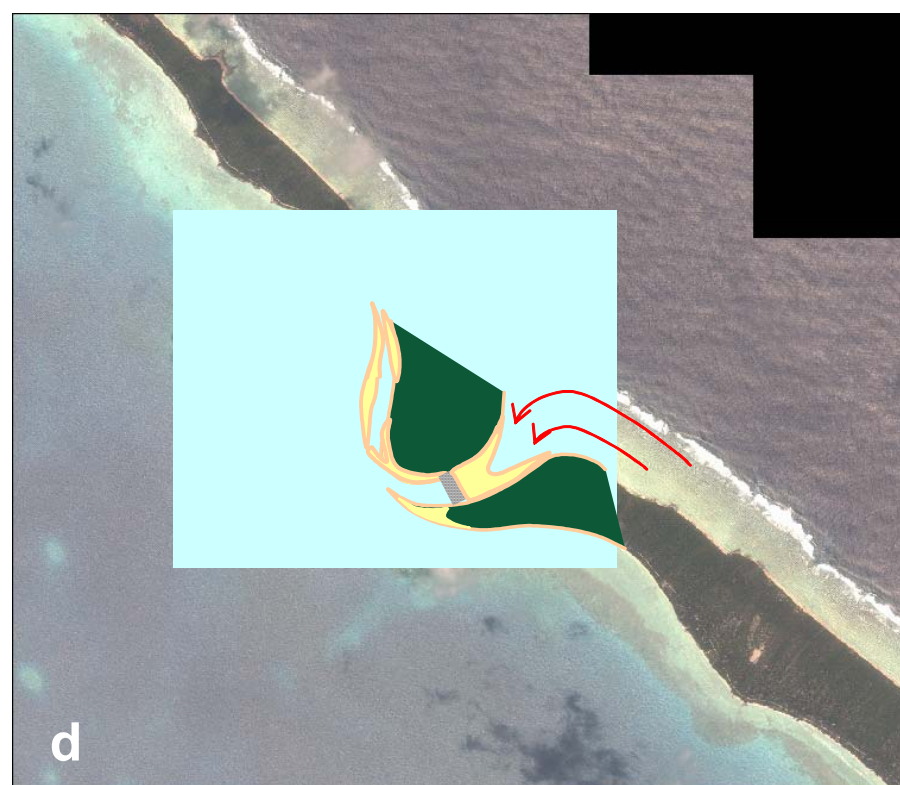
(d) At some time, about 70 to 100 years ago, villagers built a causeway across this channel (this area is still known as “*Terawabono*” – “the blocked channel”). This stopped the supply of sand moving to the lagoon side.

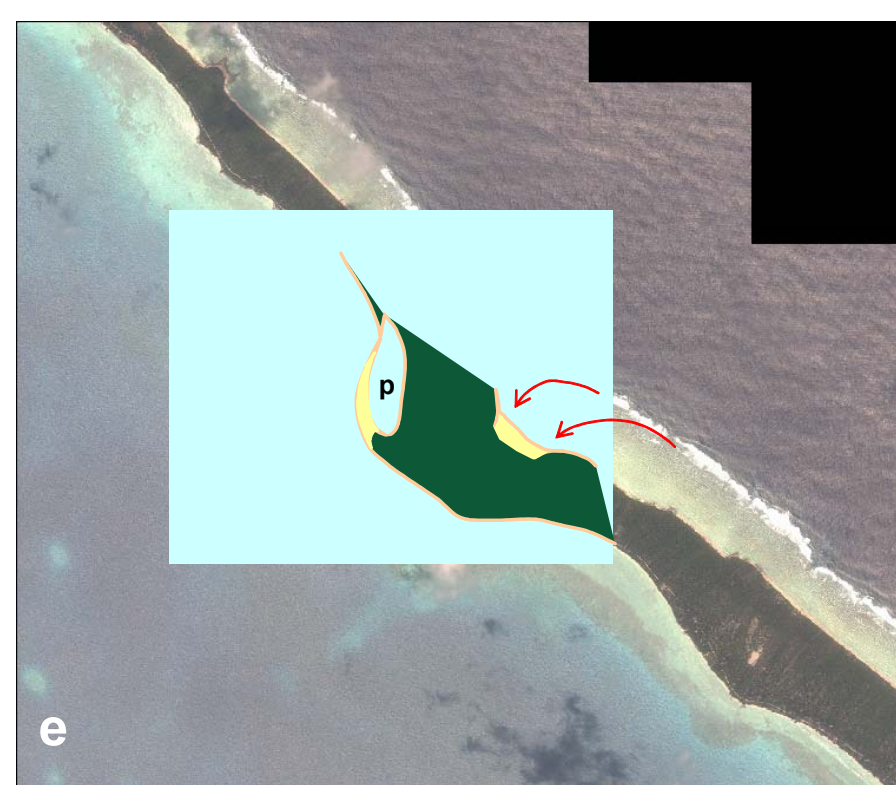
(e) With sand supply blocked the channel on the ocean side quickly in-filled (red arrows). On the lagoon side the unstable sandy spit moves and changes shape since the supply of sand from the ocean has stopped. Low areas which were once part of the lagoon / channel are isolated from the sea and over time become freshwater ponds (p).

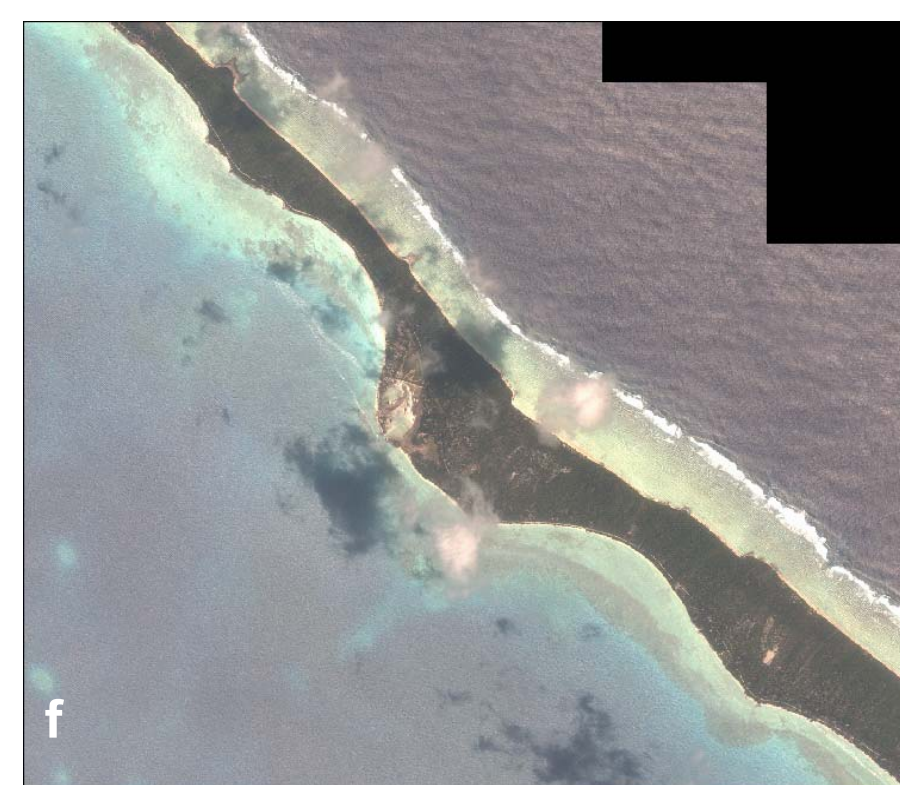
(f) Today, many people now live on this new land; however, the Tebunginako coastline is still moving and is unstable. The sand bank between the freshwater ponds and the lagoon has eroded to a thin strip and lagoon waves have now broken through, flooding settled areas with seawater.

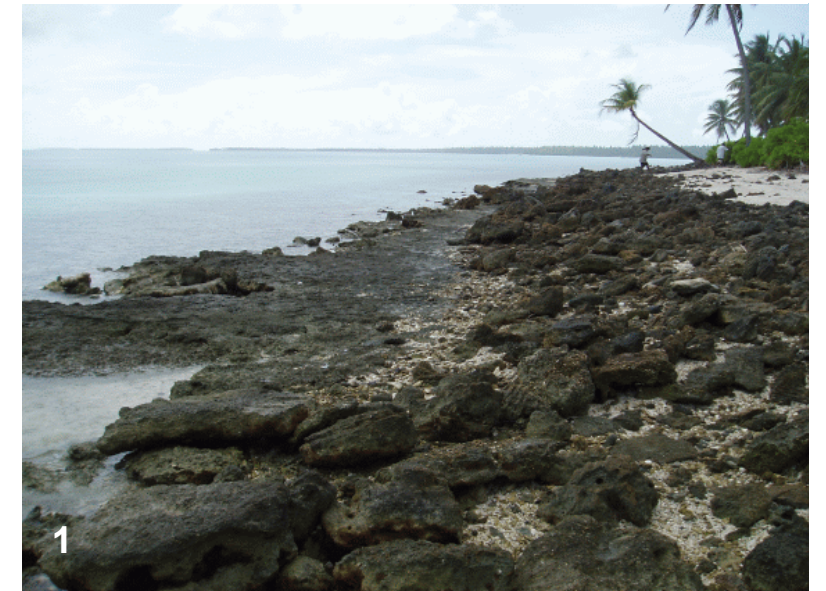
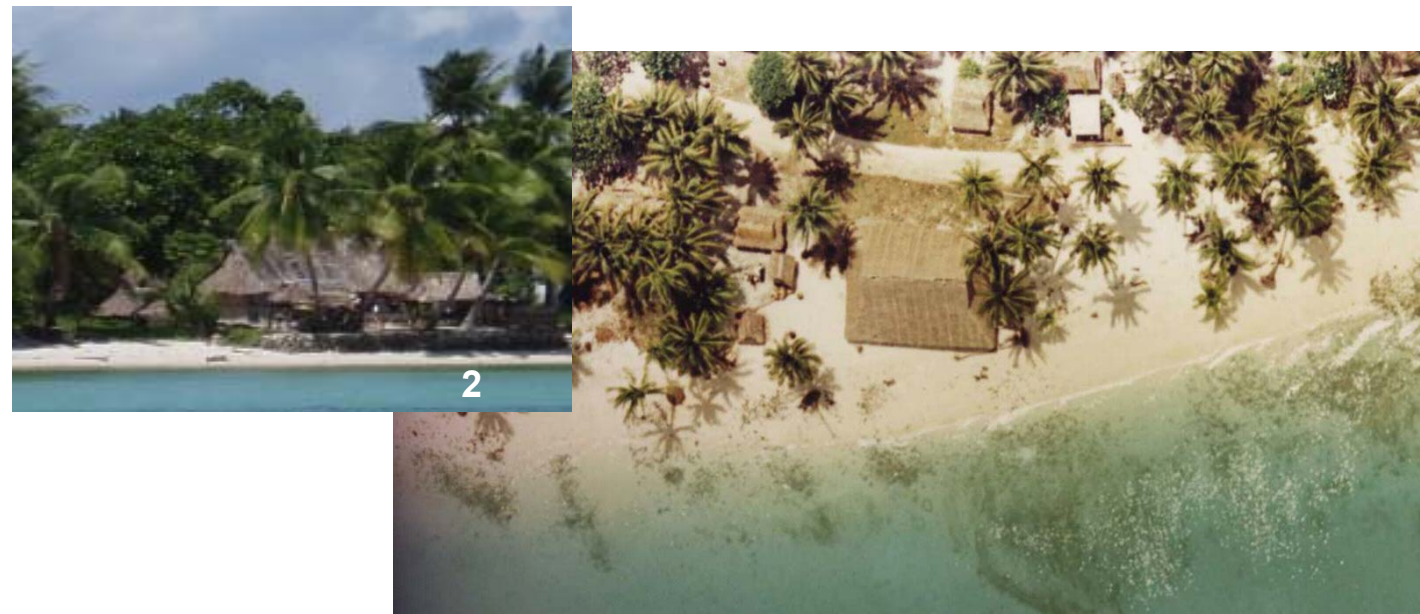
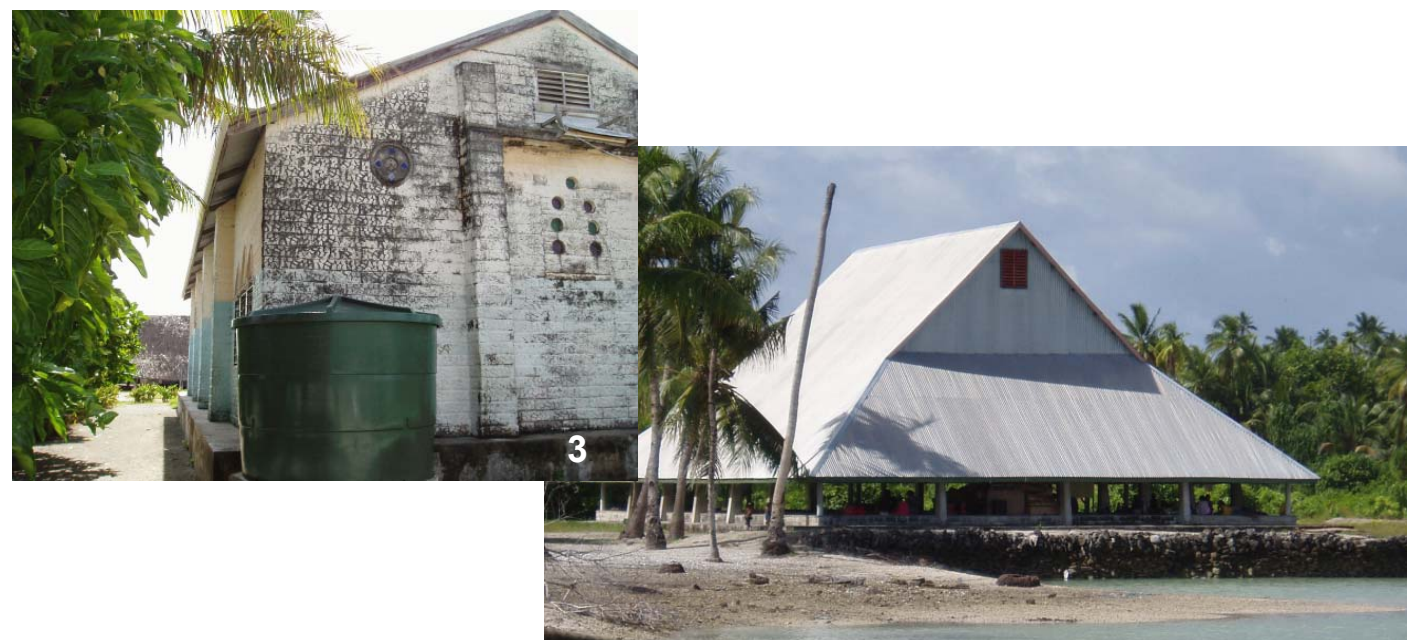
The people of Tebunginako have settled in areas which are unstable and the shoreline will continue to change over time for many years to come. Over the last 30 years the people of this village have spent a huge amount of time, energy and money trying to stop the natural movement of the lagoon shoreline. This has failed and much of the protective structures built have been destroyed by ongoing shoreline change and westerly gales (1).

In past times, people lived in harmony with shifting coastlines and their local buildings could be easily moved if the shoreline changed (2). Many of the houses in Tebunginako are still local but some large and important buildings (the village maneaba and church) are built of permanent materials and can not be easily moved (3).

During discussions with the people of Tebunginako Village it was agreed that the changes on their coast were caused by the blocking of the channel many years ago and that this coast would remain unstable for many years to come. It was also agreed that it would be better to use their time, effort and money to rebuild important buildings east of the road on high safe ground (4) and not to try and rebuild seawalls. It was understood that there was no need to move the whole village right way. In some areas accretion is occurring (the land is getting bigger) and so long as local houses are built in these areas, they could always be moved if need be. Certainly, permanent buildings should not be built anywhere west of the road and people in flooded areas should also be encouraged to move east of the roadway (4).
