EU EDF 9 – SOPAC Project Report 34b

Reducing Vulnerability of Pacific ACP States

NIUE – TECHNICAL NOTE
An assessment of Cyclone Heta's impact on Niue's coastline

23rd April – 4th May 2004

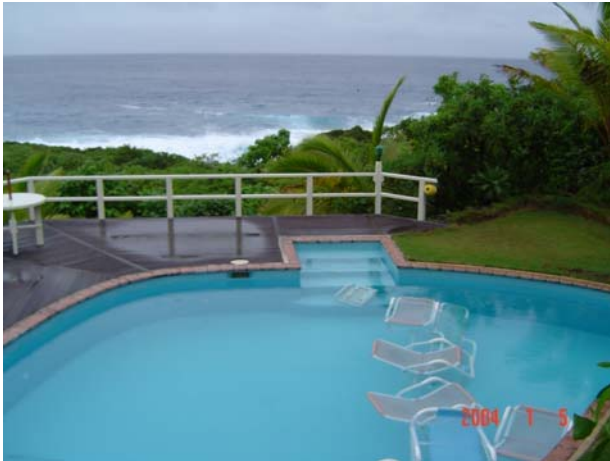
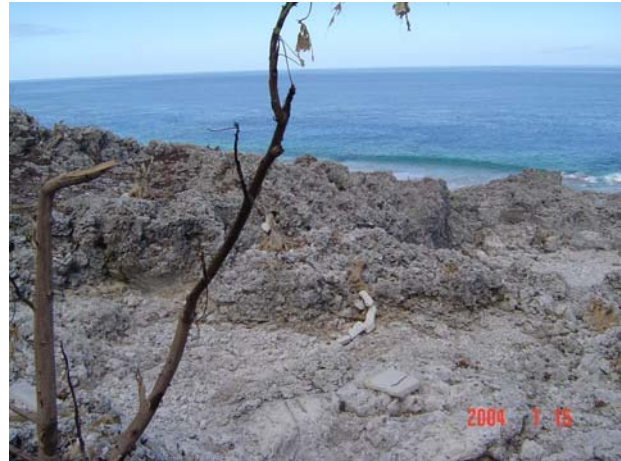
Pacific Island Paradise turned into barren rock – Namukulu Motel swimming pool (left) after Heta (right).¹

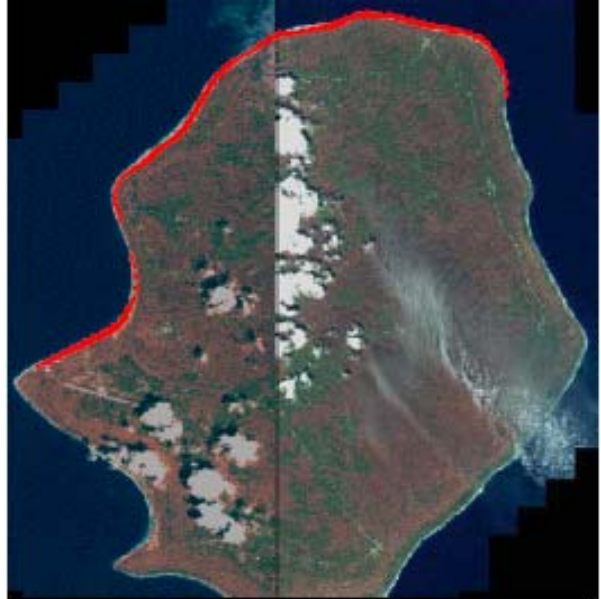
Figure 1: Post TC Heta IKONOS Scene 12/01/04 – Areas affected (red) by waves marked in red.

- Evidence for impacts of wave were found on sites up to +25 m above sea level and up to 200 m inland on the Alofi terrace. Areas affected by waves were delineated according to the post-Heta IKONOS scene (see Figure 1) and GPS mapping of coral rubble, several dm-m in size (see figures 2 & 3) and other debris thrown onshore by the waves. The accuracy of the latter is critical, since some areas have been cleaned up and location of debris might have been changed during the cleaning. The satellite image, taken 12 January 2004 one week after the cyclone struck, shows a clear indication of affected areas, where vegetation was wiped out, barren rock exposed and coral rubble deposited. All these areas show a high reflection and appear in white.

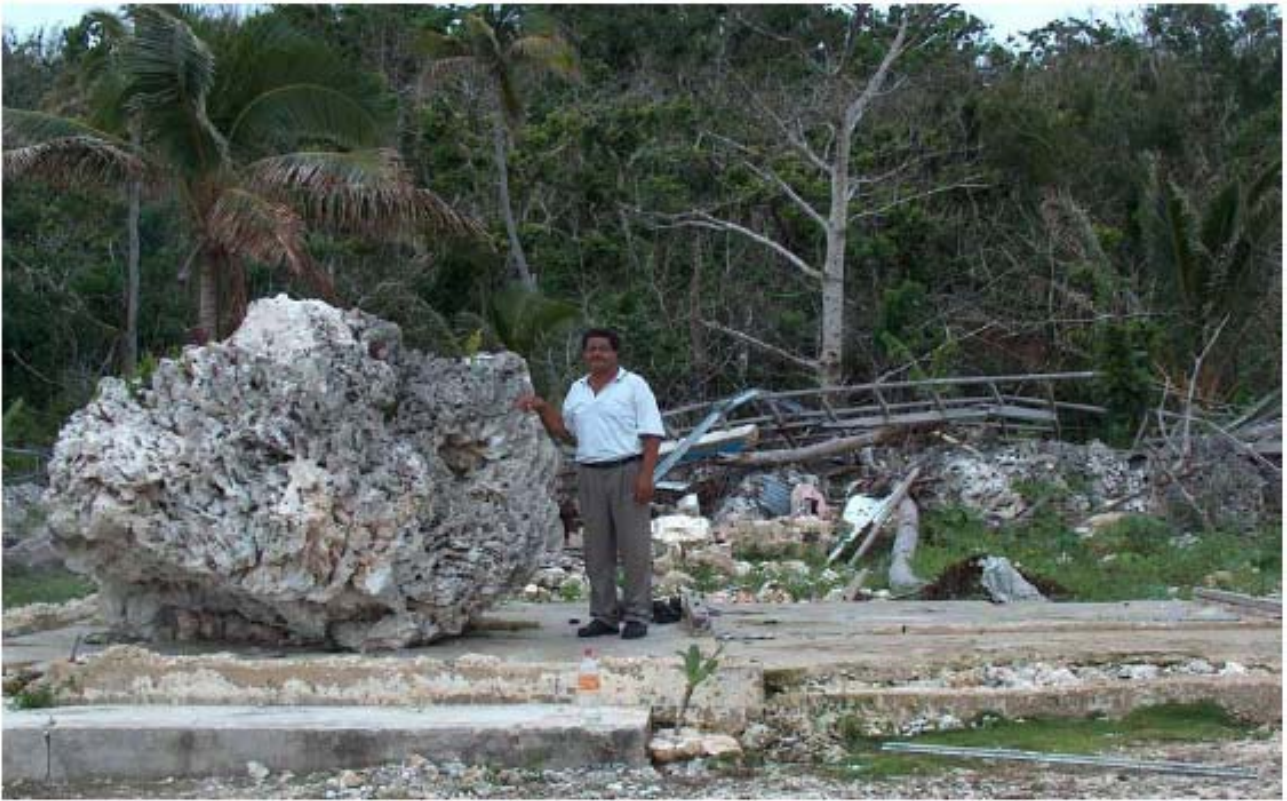
Figure 2: Deve Telagi, Director PWD, standing on the foundations of a destroyed building in Hikutavake and next to the biggest boulder picked up by the waves (~3-4 t). The boulder was thrown on the cliff edge during TC Ofa and during TC Heta transported some fifty metres further inland and smashed into this building.

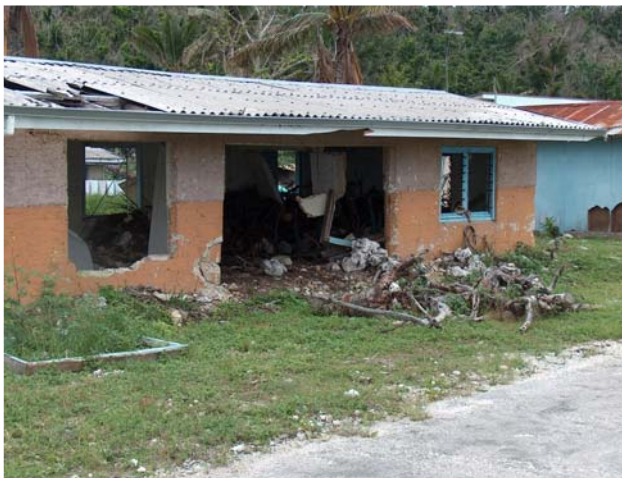
Figure 3: Building in Makefu smashed by coral rubble and tree debris.

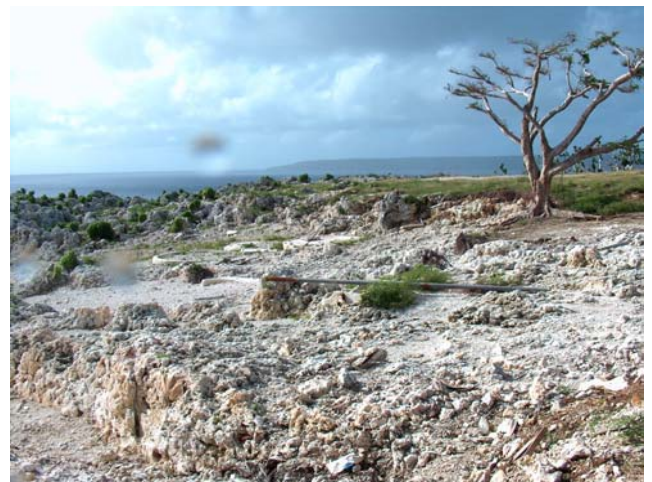
Figure 4: The former location of the Niue Hospital – barren rock is exposed where the waves washed over the cliff.

- The highest impacts by waves occurred along N to NW exposed coastlines, in particular in Alofi (especially Alofi South) and Makefu to Hikutavake. A corridor of about 20-50 m from the cliff edge was de-vegetated, the soil washed away and only the barren rock left (see Figure 4).
- Beside the sea track at Uluvehi, which was severely damaged, the waves approaching far inland at the N coast did not cause major damage, because all settlements and infrastructure are located at the upper terrace.

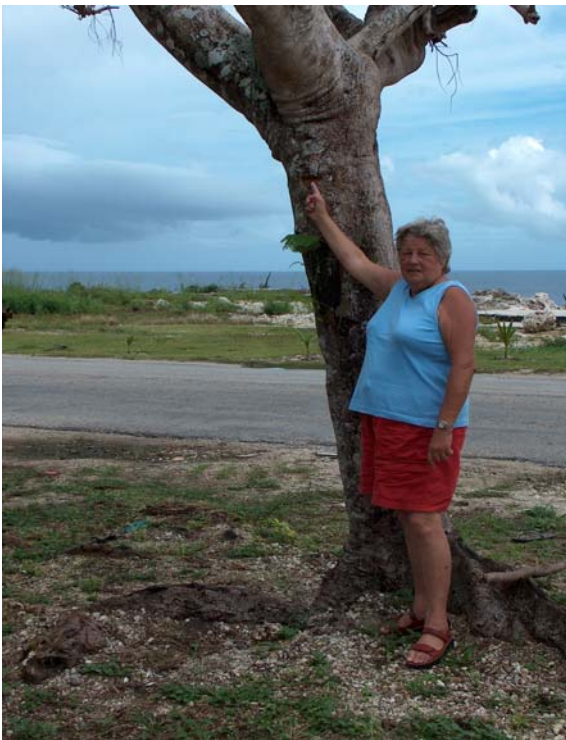
Figure 5: Mary from Alofi Rentals indicates the height of the waves.

- In Alofi South – the overall most severe affected area, both in terms of wave impacts (height/distance onshore) as well as property damage (hotel, hospital, houses and businesses) – the effects of channel/breaks in the cliff face are not obvious, since the whole terrace seemed similarly severely affected. But eye witnesses reported waves (swash) running parallel to the coastline and inundating the terrace around 1-2 m (see Figures 5 & 6).

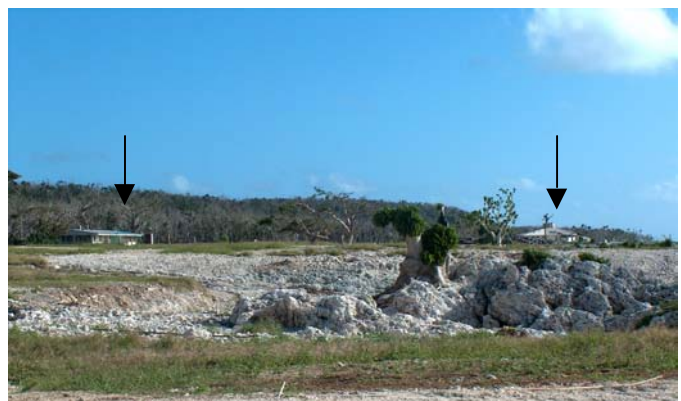
Figure 6: What's left? Only 3 buildings 'survived' the waves hitting Alofi South, the library, the restaurant of the Niue Hotel and one private home.

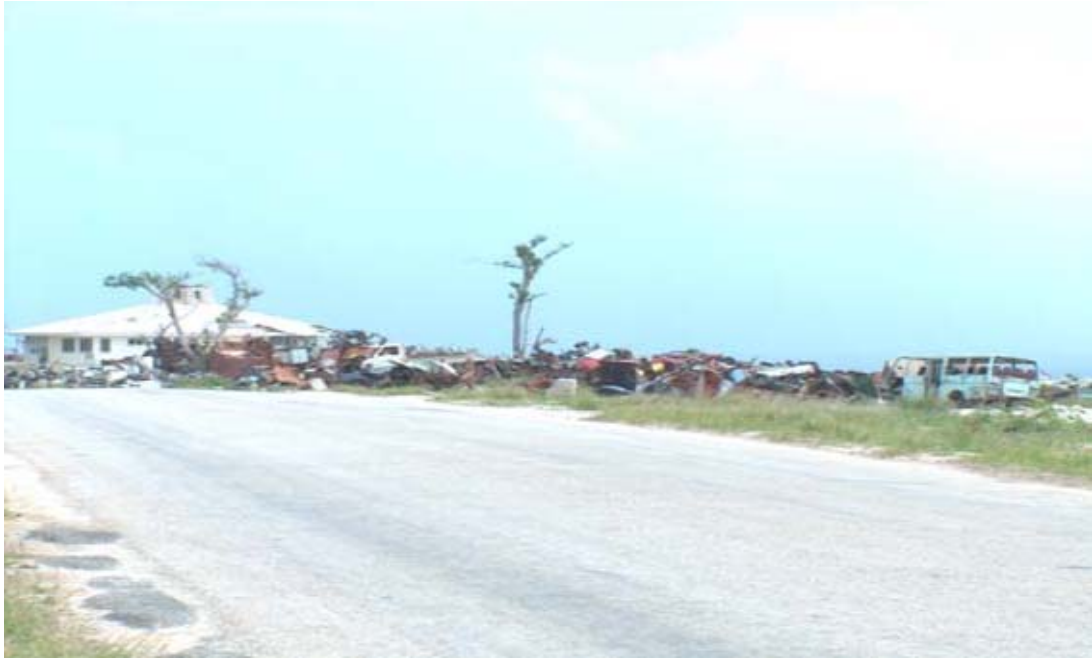
Figure 7: Crashed cars and iron debris collected after TC Heta, piled up in front of the remains of the Niue Hotel.

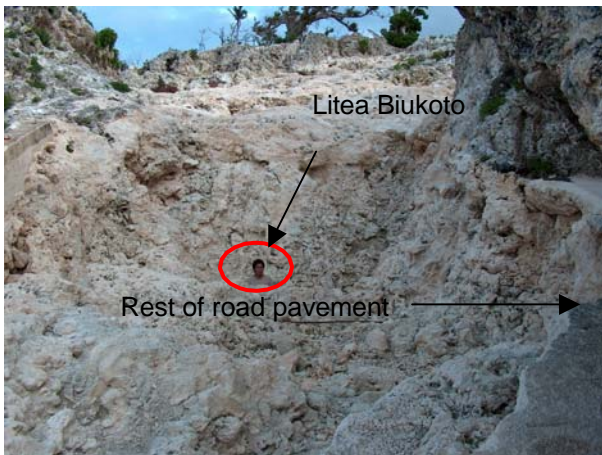
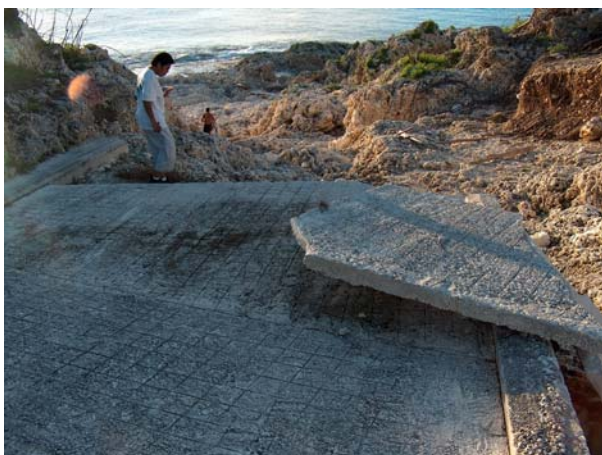
- Sea tracks: Wherever relatively loose sediments (e.g. breccia, conglomerate, beach sandstone) were exposed, e.g. after removal of concrete sealing, significant erosion took place. Erosional holes up to 2 m deep were observed at Numukulu and Uluvehi sea tracks (see Figure 8). Poorly cemented conglomerates and sandstones were noted at various locations forming a 1-2 m thick lithologic layer near the cliff base – some might be the remains of former pocket beaches and/or fillings of collapsed caves (see Figure 9). Whatever their origin, once removed these sediments (boulders/concrete blocks) act as “erosion weapons” and enforce further erosion and damage to infrastructure and buildings.

Figure 8: After the sealing was removed, waves dug huge holes in the weakly cemented fill: Uluvehi (above) and Namakulu (below) sea track.

6. Relocation of the fuel tanks to higher ground.
7. Sea tracks, coastal lookouts and picnic facilities which have been destroyed should be rebuilt either:–

- a. on a low-cost basis, considering replacement after each major cyclone, or
 - b. sufficiently robust to withstand forces acting during a major cyclone; ensuring that any surface sealing will not break off and allow erosion of the underlying sediments.

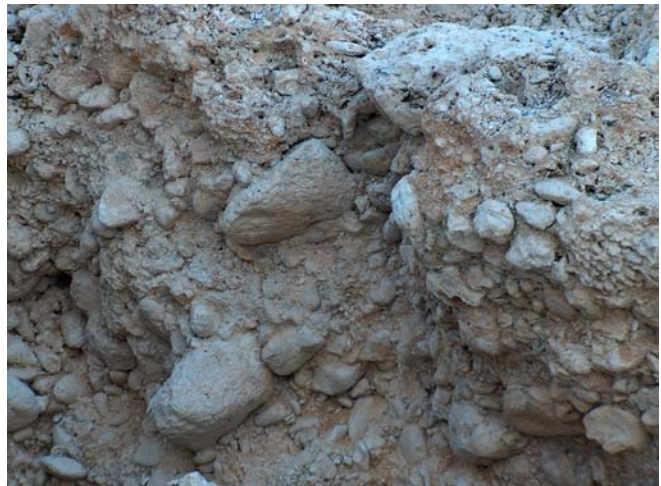
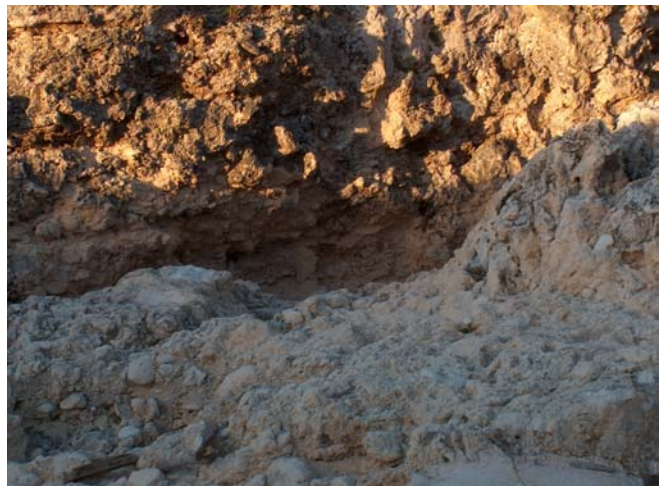
Figure 9: Poorly consolidated conglomerates in Uluvehi (above) and Namakulu (below) enable wave energy to erode significantly.

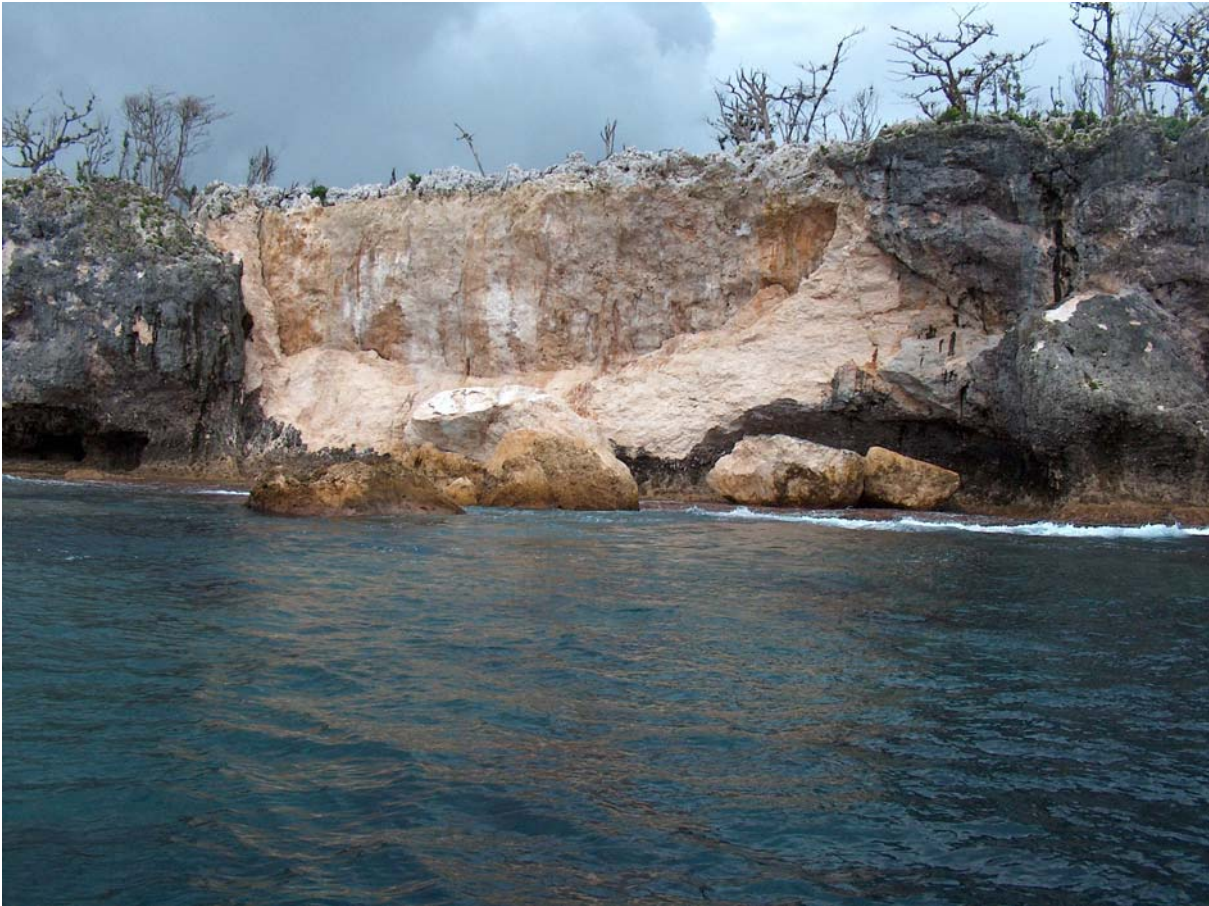
Figure 1: Cliff failure at Makefu South – one of the biggest failures that occurred during TC Heta.

Several cliff failures occurred along the N-NW coast of Niue during TC Heta. They have been surveyed from the sea and on-shore. Most of them are in a range from several 10 to few 100 m³, and two sites close to Makefu show a displacement of a few 1000 m³. They are currently not posing any major threat, since there is no interaction with human activity, like settlements on the cliff top or fishing or tourist activities at the cliff base. Most of the displaced blocks are too big to be picked up by waves or currents. The cliff failures are most probably a product of the gradual undercutting by the sea and subsequent development of notches, and the ground tremor produced by the giant waves crashing into the cliff during TC Heta.

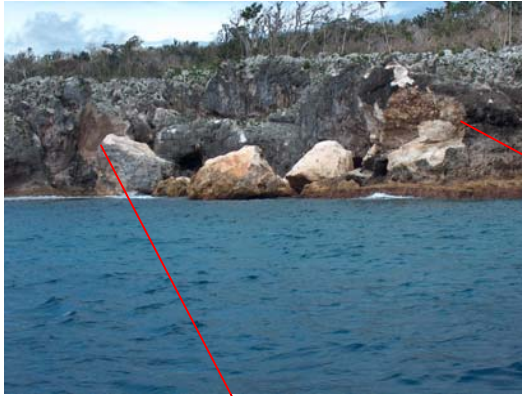
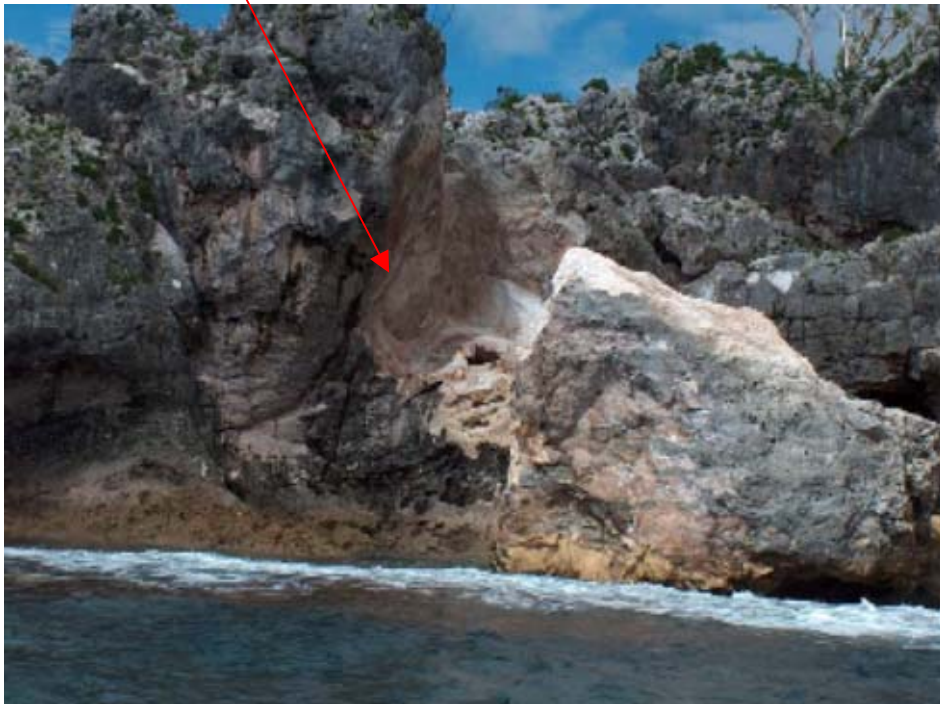
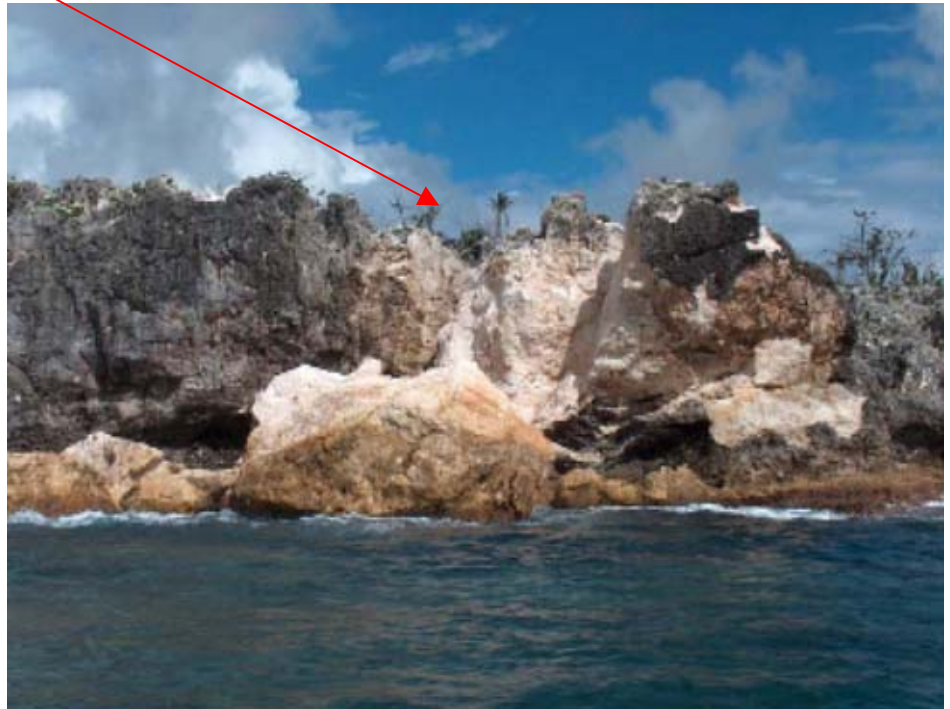
Figure 2: Cliff failures at Makefu.
