SEA SAFETY

INFORMATION BULLETIN

Number 6 - April 2011

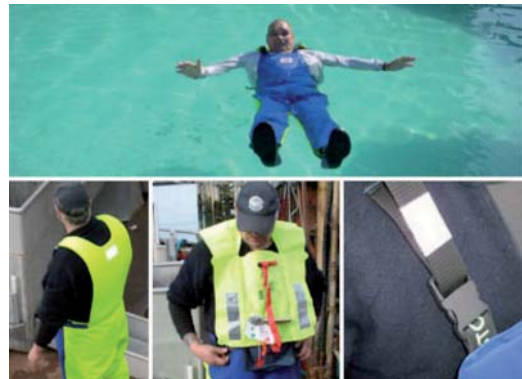
This new flotation bib (overalls) made by Stormline in New Zealand has special closed cell foam in the knees and the front and back to provide enough buoyancy to float a fisher while giving him or her adequate time to don an inflatable life jacket, which can be worn in a pouch on a belt at the back so as not to interfere with work. A fisher who falls overboard will have adequate flotation from the bib, though its buoyancy may not offer raised head support. This will give time for the fisher to bring the pouch to the front and put on and inflate the life jacket.

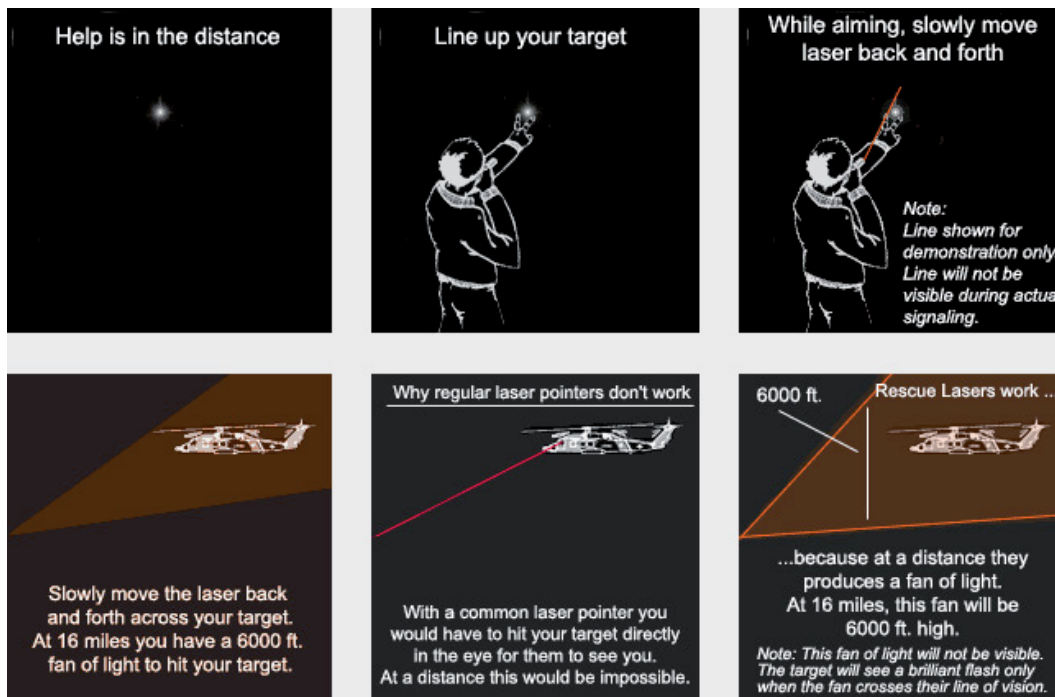
How to use the Rescue Laser Flare

The RLFAA023-01 Rescue Laser Flare Magnum is a hand-held day and nighttime laser signaling device that provides a convenient, effective way to signal a rescue party. Its waterproof, rugged design combines the safety of a laser signaling device with the convenience of a flashlight. It is the most popular model with mariners.

Visibility: 20 miles (32 km) nighttime, optimum conditions;
1–3 miles (1.6–4.8 km) daytime
Waterproof: to 80 feet (24 m)
Laser diode: 10,000 hours mean life
Operational life: 72 hours continuous use before changing battery
Battery: two (2) AA batteries

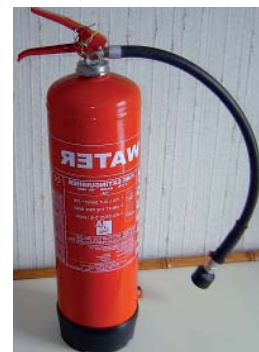
On decked boats with inboard engines and
electrical systems. Carry a minimum of two (2)
fire extinguishers of type 2-A; 20-BC mounted
in proper brackets.

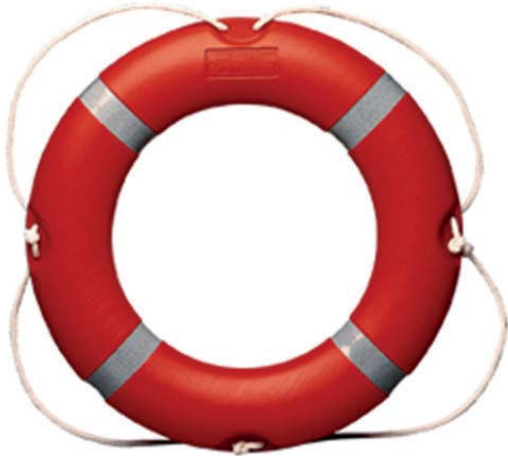
On small decked boats carrying passengers, have minimum 2 lifebuoys on board with minimum 15-m line each.

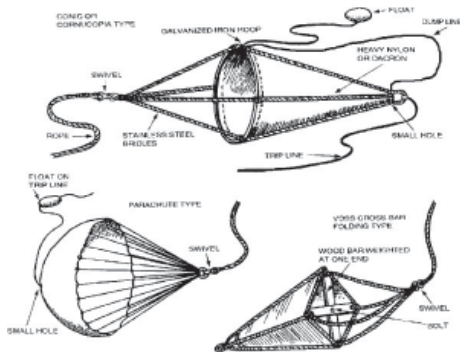
On all small boats it is advisable to carry a Sea Anchor, three (3) common types are shown here with a canvas commercially made sea anchor below.

Anything that will create good DRAG in the water can also be used to slow down rate of drifting.

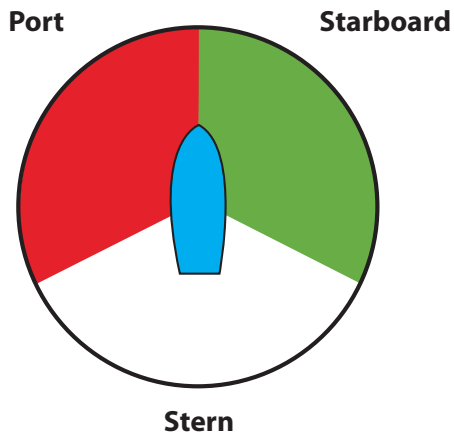
Any vessel overtaking another must keep clear of overtaken vessel.

Port: If a motorised boat approaches within this sector, maintain with caution your course and speed.
Starboard: If any vessel approaches within this sector, keep out of its way.
Stern: If any vessel approaches this sector, maintain with caution, your course and speed.

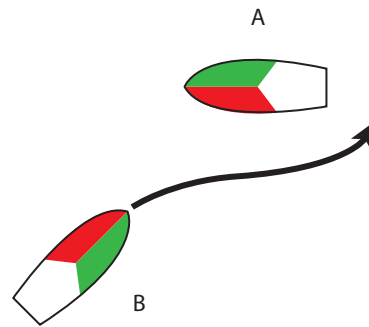
Vessel B to keep clear of vessel A and must avoid crossing ahead of vessel A.

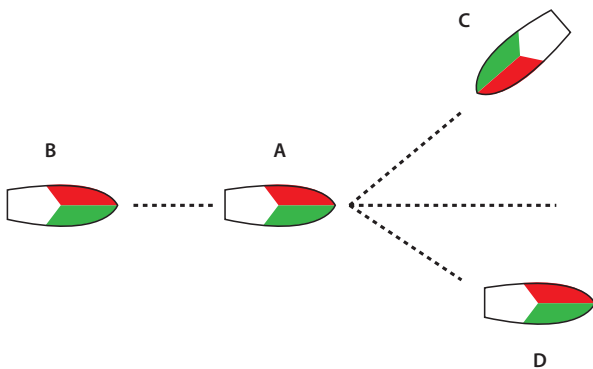
A keeps clear of D.
 B keeps clear of A and D.
 C keeps clear of A and B.
 D doesn't alter course while being overtaken by A and B.

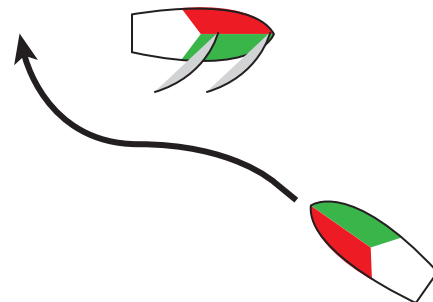
A powerboat keeps clear of any type of sailing vessel.

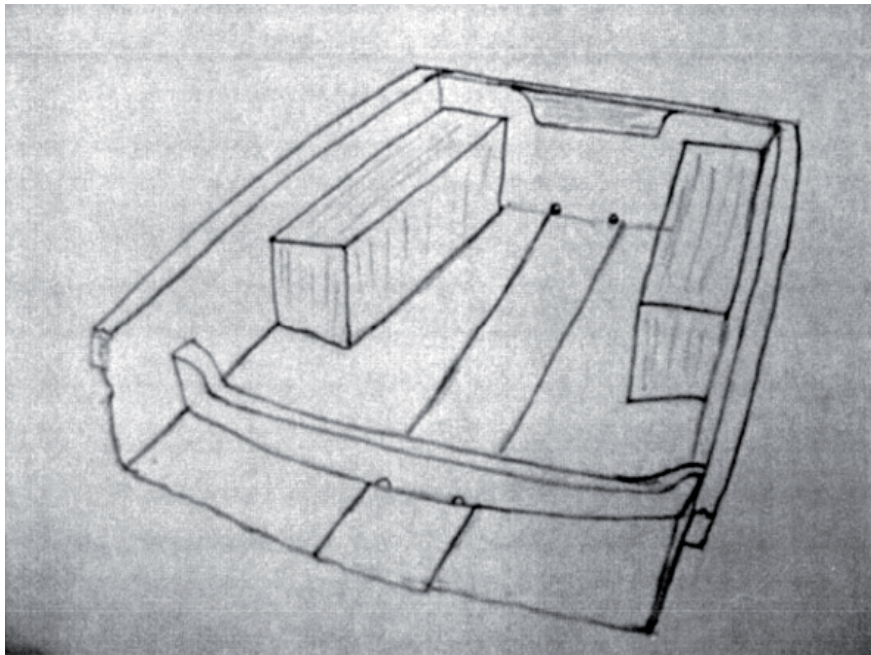
**Retro-fitted buoyancy chambers used as seats
in stern of boat**

- Be large enough and seaworthy enough for the job. Overloading has caused many fatal accidents; **DO NOT OVERLOAD THE BOAT.**
- Have proper built-in buoyancy that will keep the boat afloat and level if it fills with water, even with the engine in place. (see illustration below).
- Be kept in good condition.
- Carry appropriate basic safety equipment as shown in section 1.

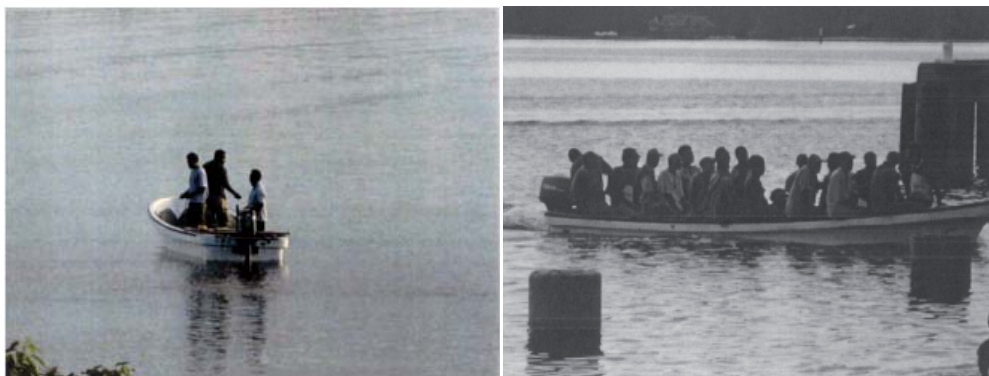
Boat with light load prepares for departure (left) and boat more than 100% overloaded (right)

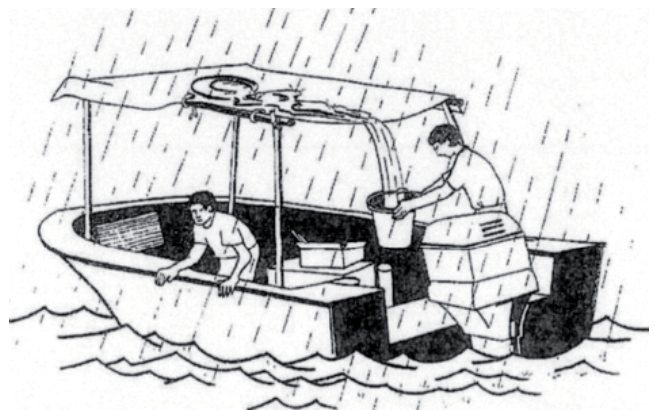
The benefits of having a tarpaulin or canopy is that rainwater can be collected as well as giving shade from sun. If a couple of wooden poles are on board the tarpaulin can also be used as a sail.
