# **A REVIEW OF FLOODING IN APIA, SAMOA, APRIL 2001**

Stephen Yeo\*  
Department of Physical Geography  
Macquarie University

*July 2001*

*SOPAC Technical Report 338*

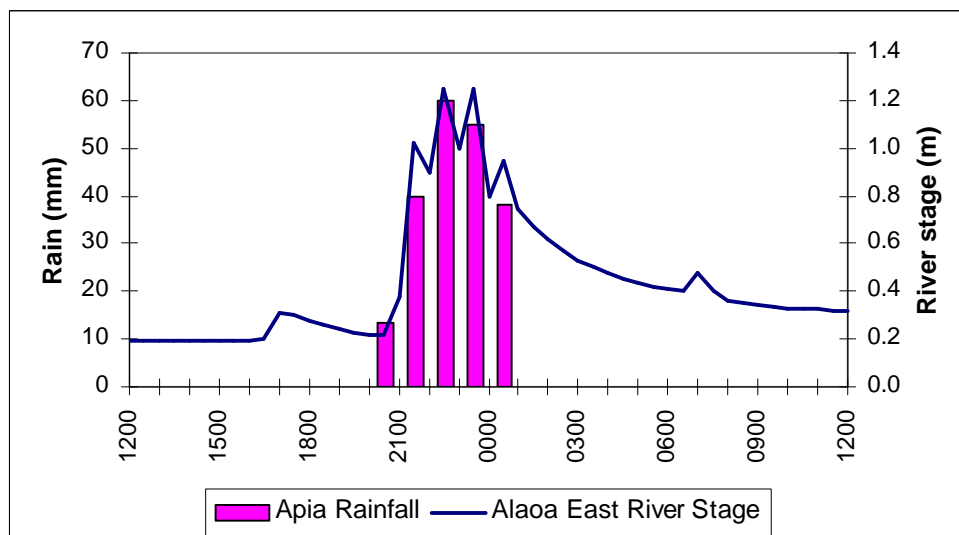
Figure 2.2: Hourly rainfall at Apia Observatory and flood hydrograph at Alaoa East (Vaisigano River East), 15-16 April 2001

The rapid rise of the rivers is demonstrated by the flood hydrograph for the Vaisigano River (East Branch) at Alaoa East station (Figure 2.2). The lag between rainfall (at Apia) and river response was negligible. The flood rose at about 9.30 pm and was reported to have receded from most affected properties by 3 am.

Note: Catchment area 16.5 km<sup>2</sup> at Alaoa East. Source: Data from Apia Observatory

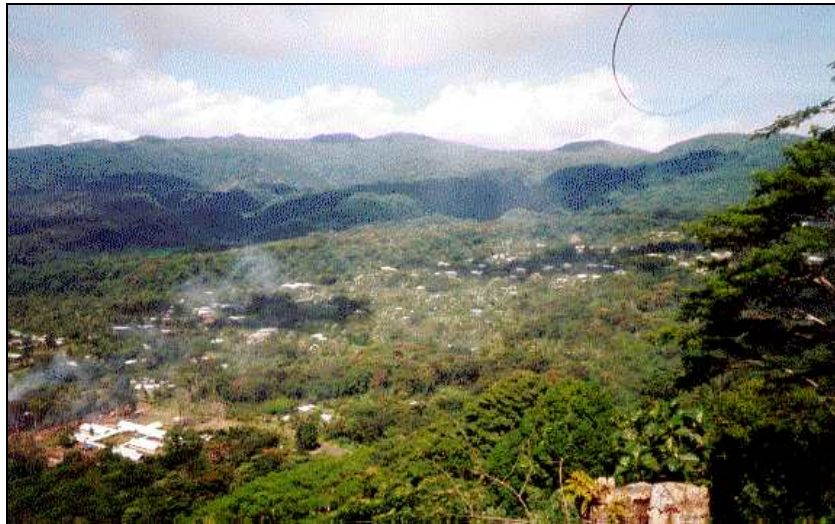
*Figure 2.5: Views of the Vaisigano River Valley from Robert Louis Stevenson tomb site, Mt Vaea*

The short and steep nature of the catchments of northern central Upolu render them conducive to rapid-rising floods following heavy rain. The character of these river valleys is exemplified by the Vaisigano watershed, which has an area of 33 km<sup>2</sup> (Baisyet, 1990), rising at an elevation of 1158 m on top of Upolu's lava dome and falling to sea level over a distance of only about 12 km, which yields an average slope of about 1 in 10. The topography is illustrated in Figure 2.5, and the high proportion of steep slopes is indicated in Table 2.1. The drainage pattern for the Vaisigano River is distinctively pear-shaped, as three tributaries meet at Alaoa (Figure 2.1), resulting in a propensity for particularly flashy hydrographs.

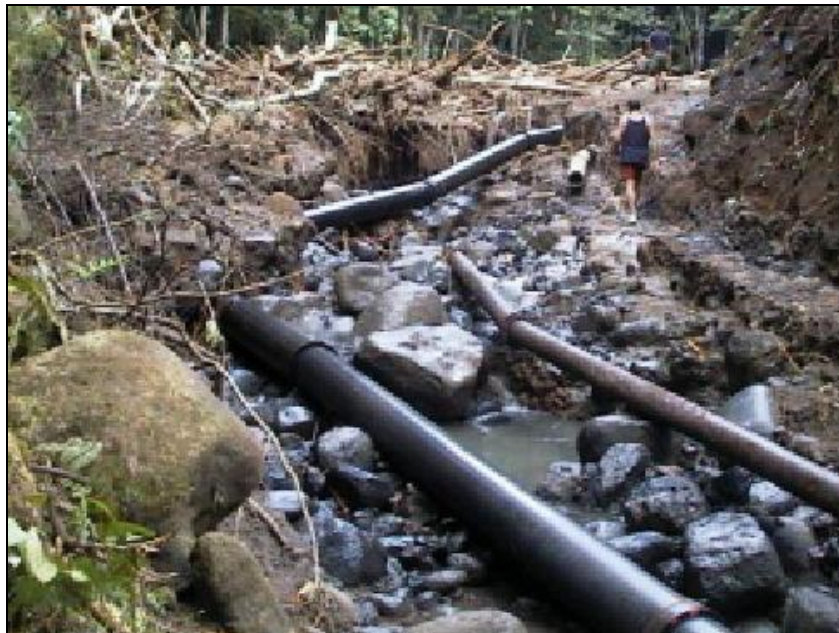
Damages to roads, bridges and water-supply pipelines, and the subsequent interruptions, have been recorded after most floods in Table 2.2. Damages to infrastructure after the 2001 flood were estimated to cost \$3.3 million.<sup>2</sup> This includes an estimated loss of \$1.1 million to Public Works Department (PWD), principally to roads (not bridges); a loss of \$2.0 million to Samoa Water Authority (SWA),<sup>3</sup> with almost half the damage sustained at Alaoa Treatment Plant and with much damage to transmission pipes (e.g. Figure 3.1); and a loss of \$0.2 million to Electric Power Corporation (EPC), which manages hydro stations (*Sunday Samoan*, Sun 27 May 2001, p.3). The PWD's losses do not include insured damages to construction work at the Lelata Bridge site (which crosses the Vaisigano River – see Figure 2.3) and at the Tuaefu Bridge site (which crosses the Fuluasou River). Holes drilled at Lelata Bridge for a new foundation were filled by rocks and debris, and the completion dates for the bridges were put back by months, at an estimated cost of 'hundreds of thousands of tala' (*Samoa Observer*, Sat 21 Apr 2001, p.5). The Hydrology Section at Apia Observatory sustained a loss of about \$31 500 when three recorders and their sheds were washed away (Iosefatu Eti, Hydrology Section, pers. comm., 11 Jul 2001).

*Figure 3.1: Damaged pipeline near Fuluasou River*

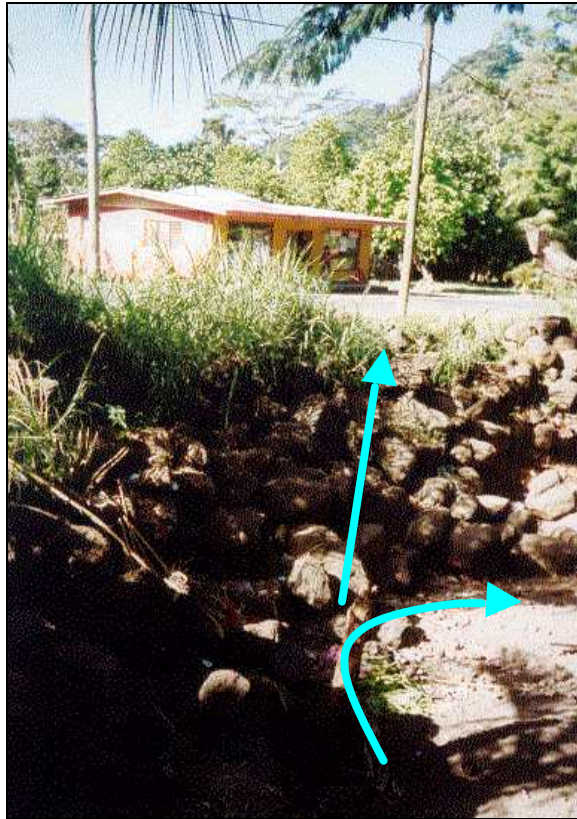
Some small-scale river straightening may be warranted, however. It is interesting to observe that in more than one area the floodwater first escaped from channels on very tight river bends, and that flood depths opposite those bends tended to be greater than in adjacent areas. The Gasegase Stream at Sinamoga is one such place (Figure 4.1). Rocks from the revetment wall were removed by the flood and deposited in the road, and depths near the shop behind were about 1.1 m (see Site 15 on Figure 2.3). River straightening can have unforeseen geomorphic consequences, however, for when a channel is straightened the slope is steepened, and stream power increased, ultimately leading to unwanted channel instability elsewhere.

Figure 4.1: Gasegase (Vaimoso) Stream, Sinamoga, showing directions of flow

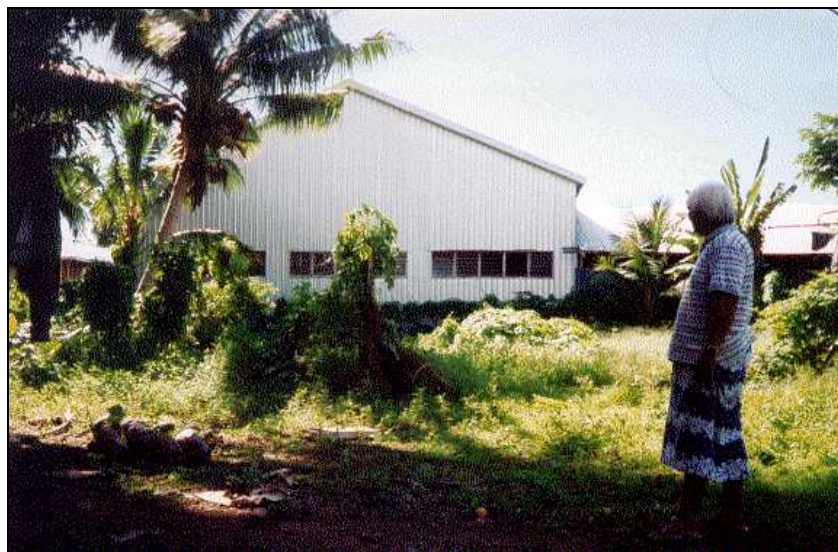
Much of Apia is situated only one metre above sea level (Isikuki Punivalu, pers. comm.). Flooding is not unexpected in such areas – a comment after the 1939 flood is telling: ‘We noticed many houses which had all the appearance of being built in the middle of a lake’ (*Western Samoa Mail*, Sat 21 Jan 1939, p.4). Reclamation and subsequent development of low-lying land has exacerbated the problem. Place names of now developed areas provide some indication of their history – Taufusi, for example, means ‘swamp’ (*Samoa Times*, 31 Jan – Feb 7 1975, p.2). Sites 5 and 11 on Figure 2.3 were originally swamps. It is natural that after heavy rain these areas revert to drainage sinks. Site 16 contains a factory that was apparently constructed on land reclaimed from an old river channel (Figure 4.2). Re-activation of this channel following heavy rain should not surprise.

Figure 4.2: Factory situated on reclaimed land, blocking flood channel, Fa'atoia

Settlement of flood-labile land, and reclamation from swamps and old channels, has been fuelled by a shortage of land as people migrate to Apia for work and education. Apia recorded a net gain of 1218 people in the five years to 1991 (Department of Statistics, 1991, p.22), and is now estimated to have a population as high as 42 000 (Nia Belcher, Department of Lands, Surveys and Environment [DLSE], pers. comm., 12 Jul 2001). These immigrants may have little choice over where to live, such as a family from Savai'i that rents freehold land (Site 9).

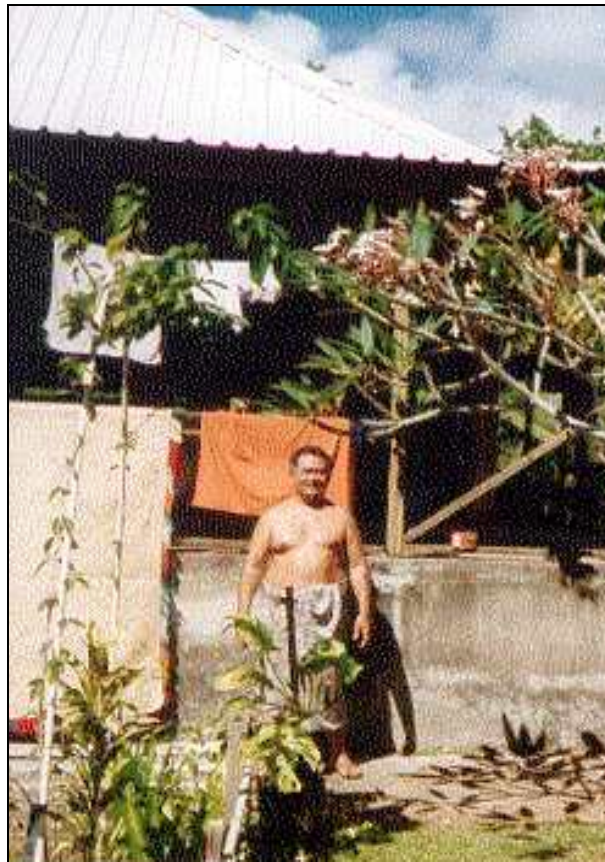
techniques take on special importance. Dr Bourke (*Samoa Observer*, Wed 26 Jan 2000, p.3) advocated the use of barriers to stop trees and other debris clogging water inlets. Where possible, transmission pipes (such as those in Figure 3.1) should be relocated beyond the active river channel, which is a naturally dynamic entity. The most obvious flood-proofing technique for buildings is to raise floor levels, which may require external financial assistance (*Samoa Observer*, 11 Feb 1982, p.2). The advantages of floor-raising (such as the fale in Figure 4.3) are reduced frequency, depth and duration of flooding. Even if there is no scope to raise floors, valuable equipment or goods can be stored at a higher level. The recent relocation of the electrical switchboard to the first floor, and construction of an off-site storage shed on high ground, are examples of this at Aggie Grey's Hotel. The flood-prone schools should relocate administration offices (with their valuable equipment) to first floors where available. The substitution of water-resistant materials for susceptible materials (e.g. chipboard furniture) is another form of flood-proofing. Insurers can promote these measures by specifying conditions in contracts with flood-liaible businesses, for example by insuring nothing within 0.30 m of the floor (at one time a common approach in Ba, Fiji). In response to the April flood, an insurer has required one business to construct platforms above the factory floor for the storage of equipment.

*Figure 4.3: Raised fale, Fa'atoia*
