EU EDF 8 – SOPAC Project Report 139  
Reducing Vulnerability of Pacific ACP States

**FIJI TECHNICAL REPORT**  
**River Aggregate Assessment in Nakavu Navua and Naduri Sigatoka**  
**and the Sigatoka Sand Dunes, Southern Viti Levu, Fiji**

April 2009

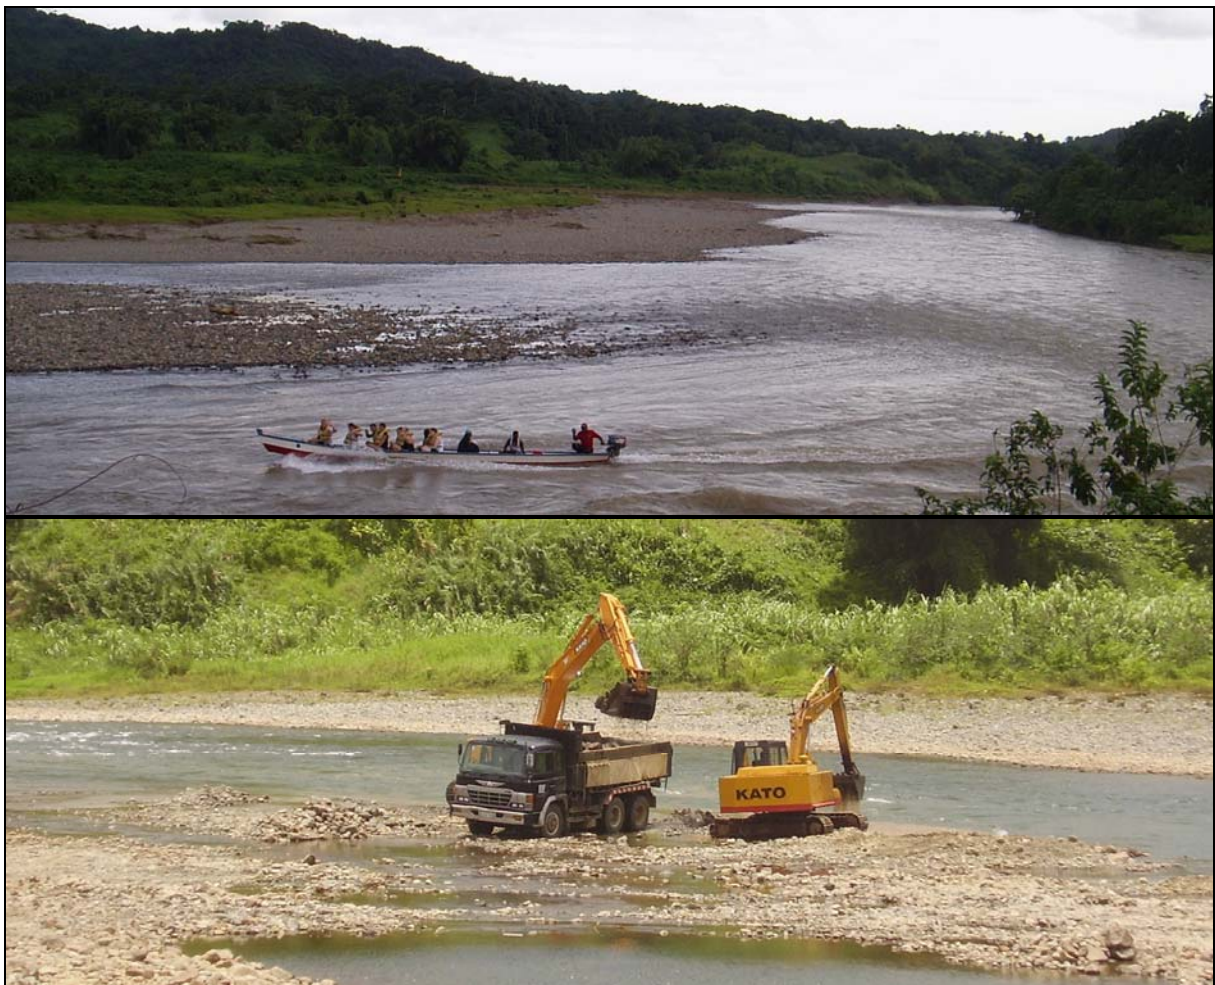
*Nakavu River aggregate deposit (top) and extraction (bottom).*

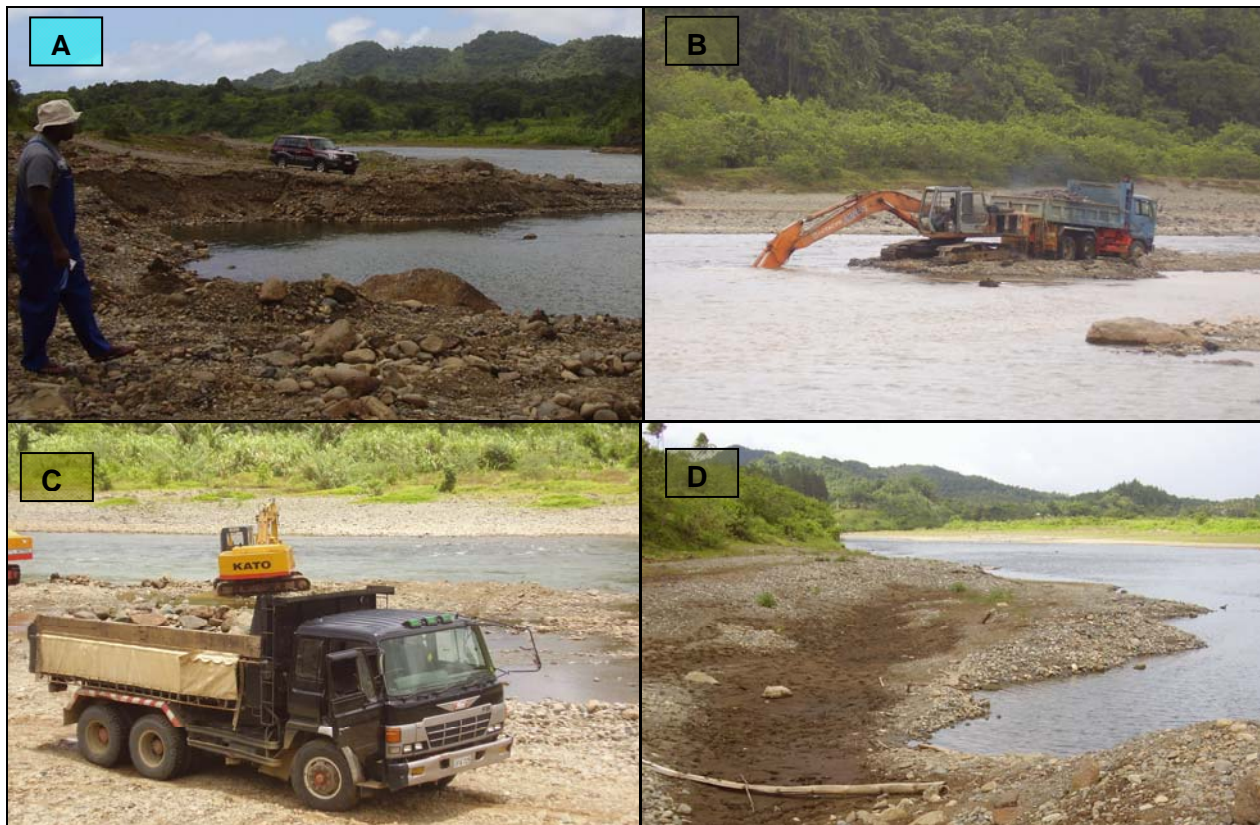
**Figure 11.** Aggregate extraction and its impacts at Nakavu. A) An extraction pit at the Nakavu extraction site; B) Aggregate extraction from the main river channel in progress. C) Bigger rock boulders extracted from the river channel are taken to the crusher in a dump truck. D) Accumulation of mud in sand bars are becoming more prevalent.

Recent intensive aggregate extraction activities in the Nakavu area have caused the creation of numerous extraction pits in the channel and along banks of the river (Figure 11A). These extraction pits have acted as sediment sinks in which significant sediment is retained either temporarily or permanently. It was evident during a number of site visits in the last four years that sedimentary materials, particularly gravel and boulders, are being transported further downstream at a much reduced level in contrast to what used to happen in the past.

- Numerous extraction pits in the river channel and bank.
- Accumulation of mud on sand bars and the river bed (Figure 11D).
- Significant reduction of aggregate resources particularly coarse aggregate (Figure 12).
- Reduction in the amount of coarse gravel being deposited in the adjacent lower part of the river due to increasing intensity of extraction at Nakavu.
- River water remains murky for longer periods of time.
- Algal blooms in the shallow stagnant part of the river.
- Erosion of the river bank and the adjacent aggregate deposit (Figure 12).
- The river has become shallow in some places due to uncontrolled extraction practices in the river channel.

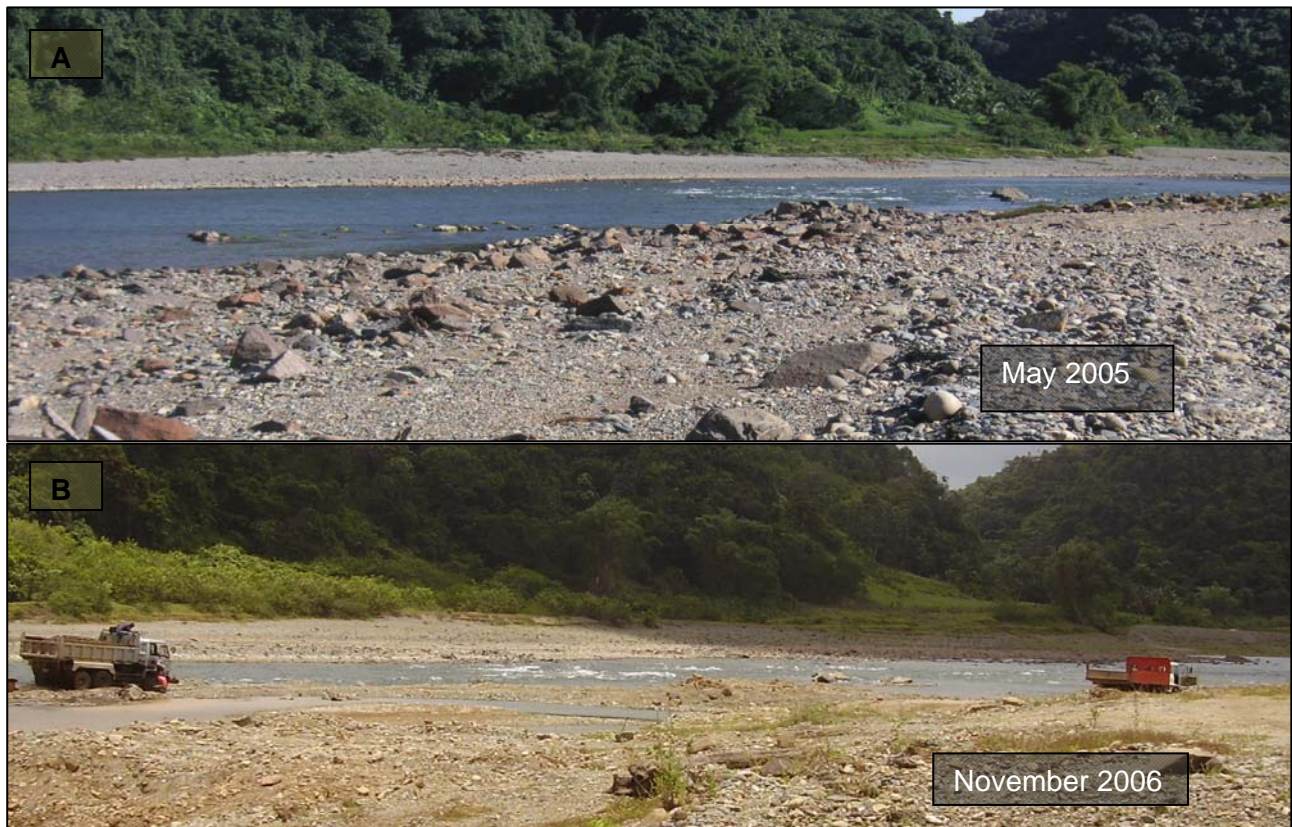
**Figure 12.** Photos capturing the level of aggregate extraction at the Nakavu Aggregate Deposit 1 looking across to Aggregate Deposit 2 on the opposite side of the river. A) This photo was taken in May 2005 exhibiting abundant sand and gravel resources on either side of the river during small to medium-scale extraction operation. B) As aggregate extraction intensified, resources have been significantly reduced as manifested by the depression in the river channel and bank as shown in the November 2006 photo. The aggregate deposit on the other side of the river continues to erode into the river channel in response to lowered river bed due to excessive extraction.

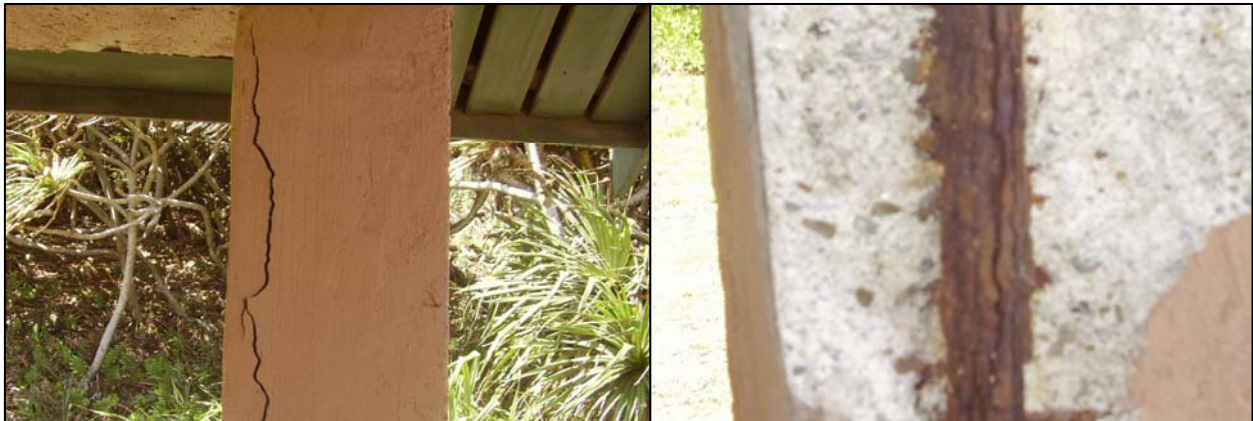
**Figure 15.** Photos of the concrete post of the SSD rest house. A) Cracking is visible on the post of the rest house. B) Vertical cracks in the corroded metals indicate the expansion of the metals during corrosion that resulted in the cracking of the concrete.

On another note, it was discovered that the use of sand on the seaward side of the dunes for the construction of a rest house has yielded an undesirable outcome. The sands are believed to contain a significant amount of salt, as seawater is usually blown over and deposited on this side of the sand dunes. This salty sand tends to corrode embedded metals in the concrete resulting in the cracking of the concrete posts of the rest house (Figure 15A)., The metal tends to expand during the corrosion process (Figure 15B) putting pressure on the enveloping concrete causing the eventual cracking of the concrete walls.

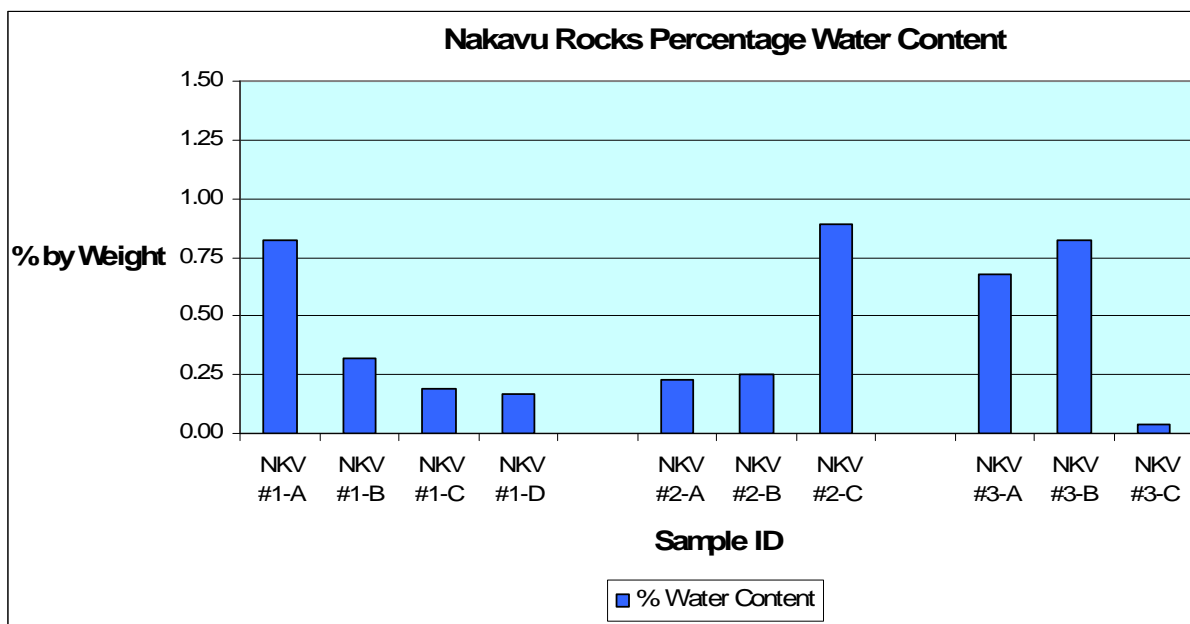
4.2.2.1 *Nakavu*. All rock specimens have water absorption below one percent by weight with samples NKV #1C, NKV #1D, NKV #2A and NKV #3C recording below 0.25 %.

Figure 16. The histogram of the water content of various Nakavu rock hand specimens.

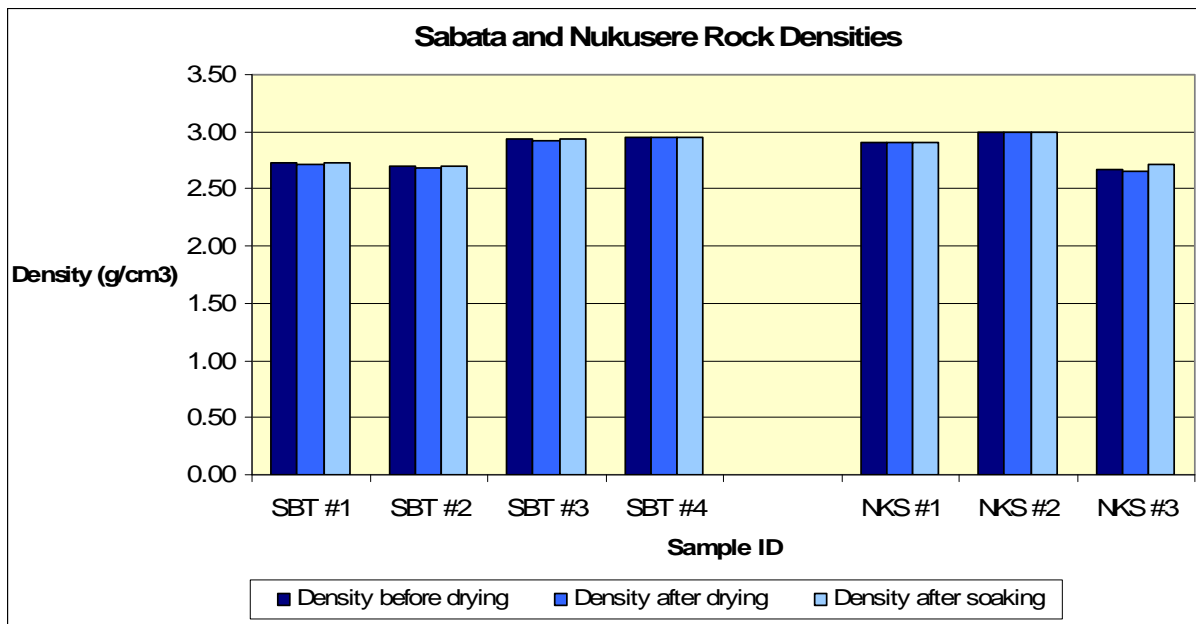
4.2.3.2 Sabata and Nukusere. Similarly, the Sabata and Nukusere rock samples have rock densities between 2.5 and 3.0 g/cm<sup>3</sup>. Minimal variations in density were recorded for all samples before drying, after drying and after soaking as shown in Figure 19 below.

**Figure 19.** The rock density histogram of the Sabata and Nukusere rock specimens.

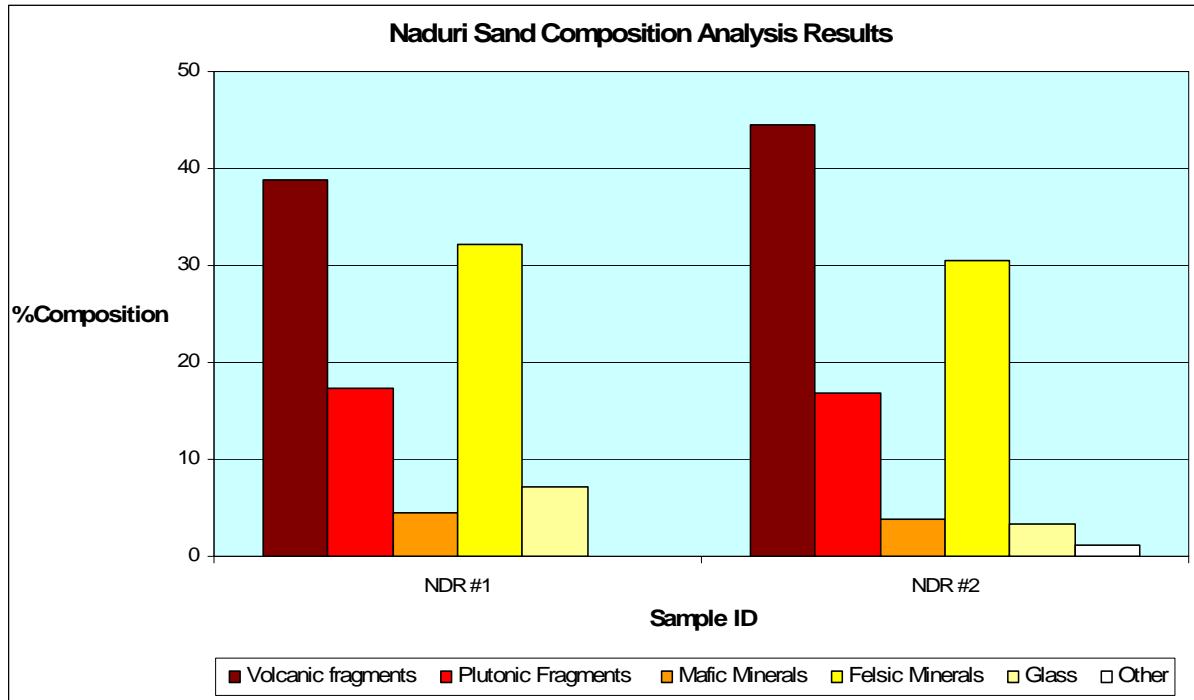
Figure 24. The histogram of the percentage composition of the Naduri sand.

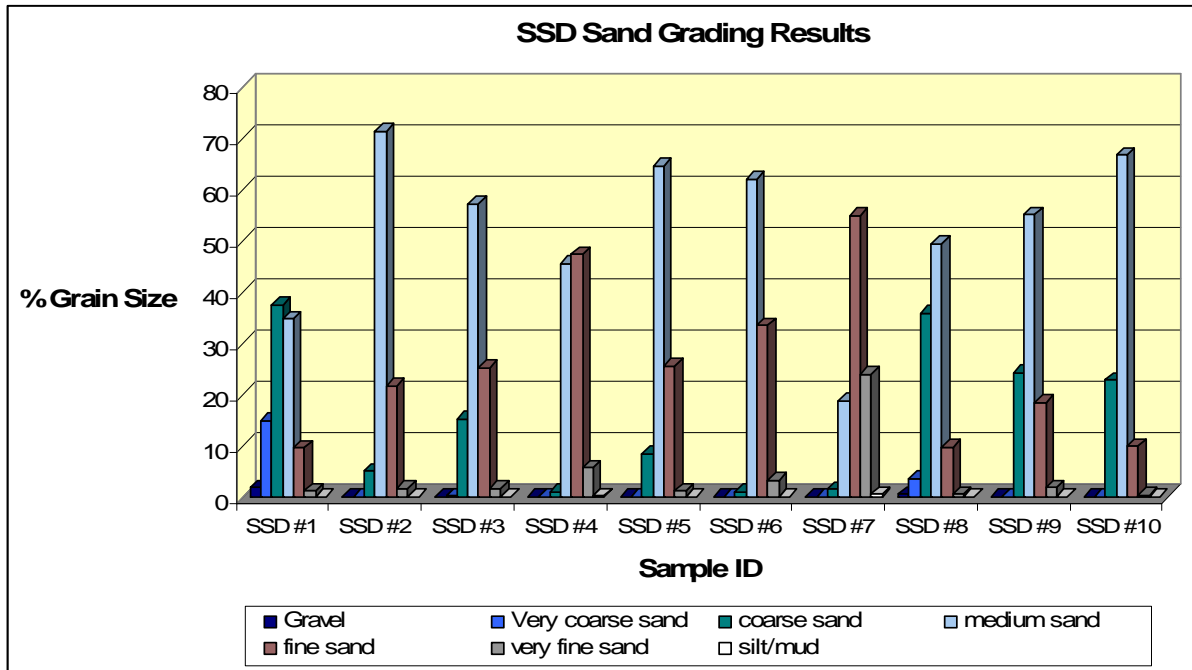
Figure 25. The histogram of the SSD sand grading results.

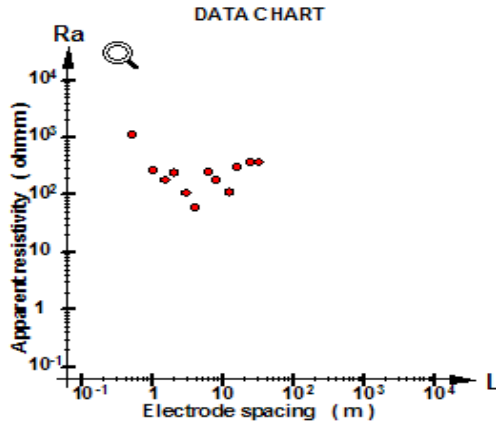
Volcanic rock outcrops occur to the north-western end of the deposit and on the other side of the river (eastern side). This may affect the actual depth of the aggregates deposit as the depth to the bedrock gets shallower toward the outcrops.

Figure 1. Sounding curve for sounding <Nakavu Field Data 1.dat> - Wenner array at "Nakavu 1".

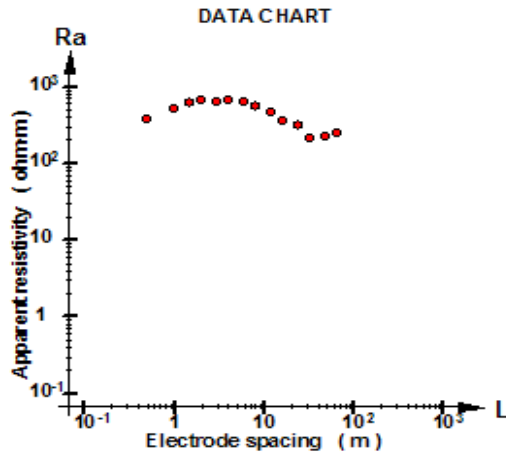
The top layer at this site is composed predominantly of sand. Coarse aggregates are exposed at the next layer below sand towards the river channel edge. A massive basaltic outcrop occurs to the south of this deposit (on the other side of the river).

Figure 1. Sounding curve for sounding <Nakavu Field Data 2B.dat> - Wenner array at "Nakavu Profile 2B".

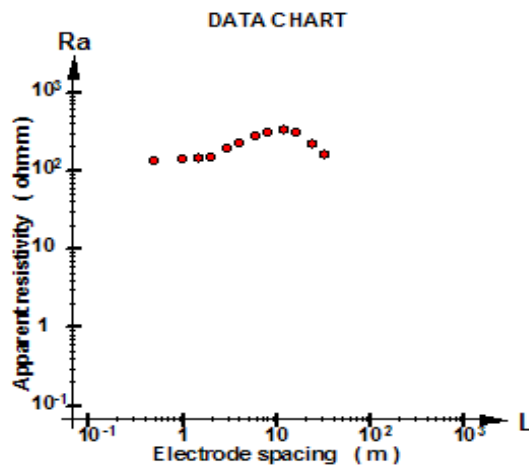
This site is a relatively flat and broad flood plain. The upper layer is composed of gravelly sand and the lower layer is made up of sandy gravel.

Figure 1. Sounding curve for sounding <Nakavu Field Data 3.dat> - Schlumberger array at "Nakavu Profile 3".
