# KIRIWATSAN Water Resources Assessment Makin Island, Kiribati

## Water Resources Assessment

### MAKIN ISLAND, KIRIBATI

May 2015

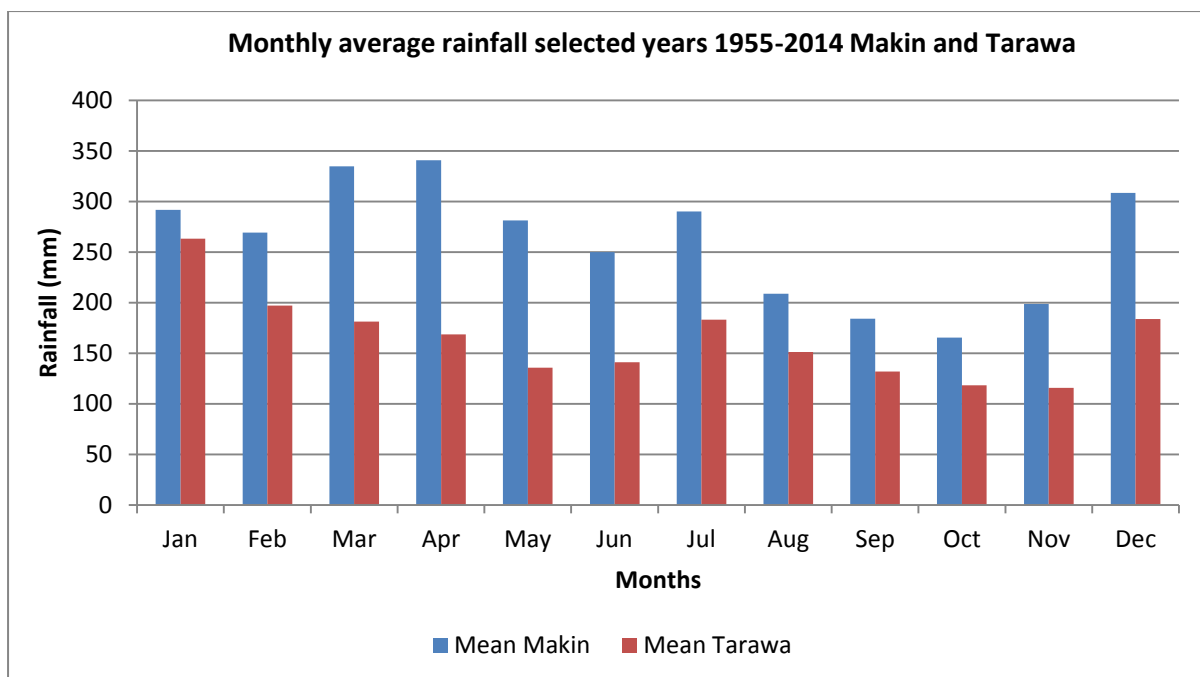
**Figure 6. Average monthly rainfall for common years between Makin and Tarawa for the period 1955-2014.**

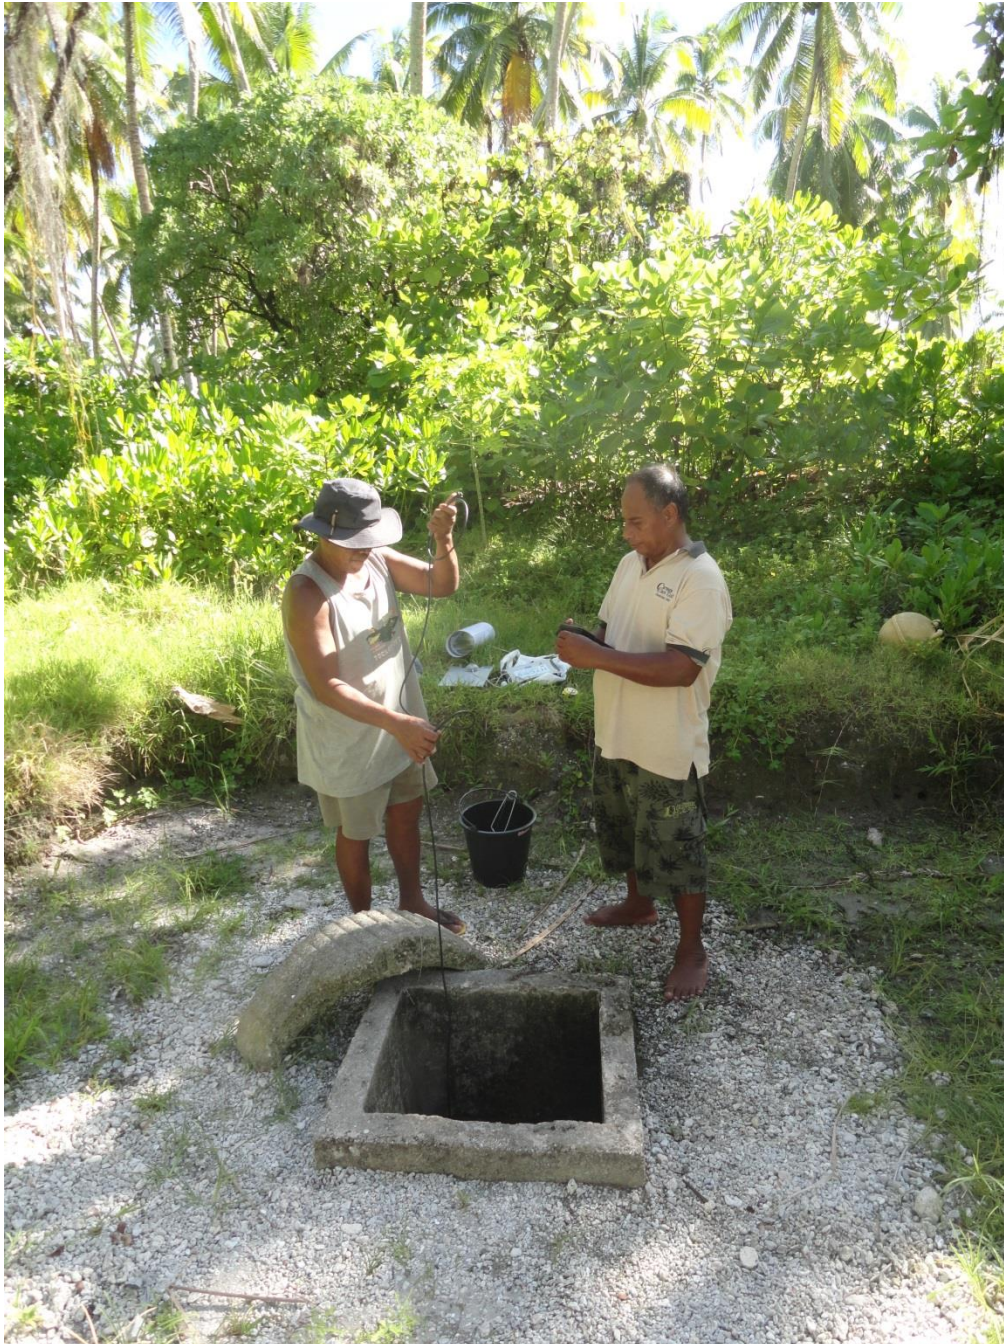
In Kiebu, groundwater is accessed by shallow wells and unprotected or poorly protected wells<sup>1</sup> with an estimated 50% of households abstracting the groundwater with the use of bailers (Figure 9). Most wells are poorly sited and constructed. Many wells have inadequate casing or are unlined, and constructed with minor consideration to reducing the potential for contamination or with regard to optimal water quality.

**Figure 9. Community well in Kiebu Village assessed by survey team – groundwater from this well is abstracted by bailers (i.e. tins and containers).**

- 1 of wells using a solar pump – installed but is not working; and
- at the other well using bailers, namely buckets, tins and containers – most bailers were found unprotected, lying on the ground, thereby increasing potential for contamination (Figure 9).

- Concrete aprons surrounding the wells to prevent the infiltration of surface water from the sides.
- Fencing to restrict access by animals and others trespassing into the well area.

- The installation of hand pumps such as the *Tamana* pump, which
  - is relatively easy to operate and maintain at the community level;
  - uses locally available materials for repairs;

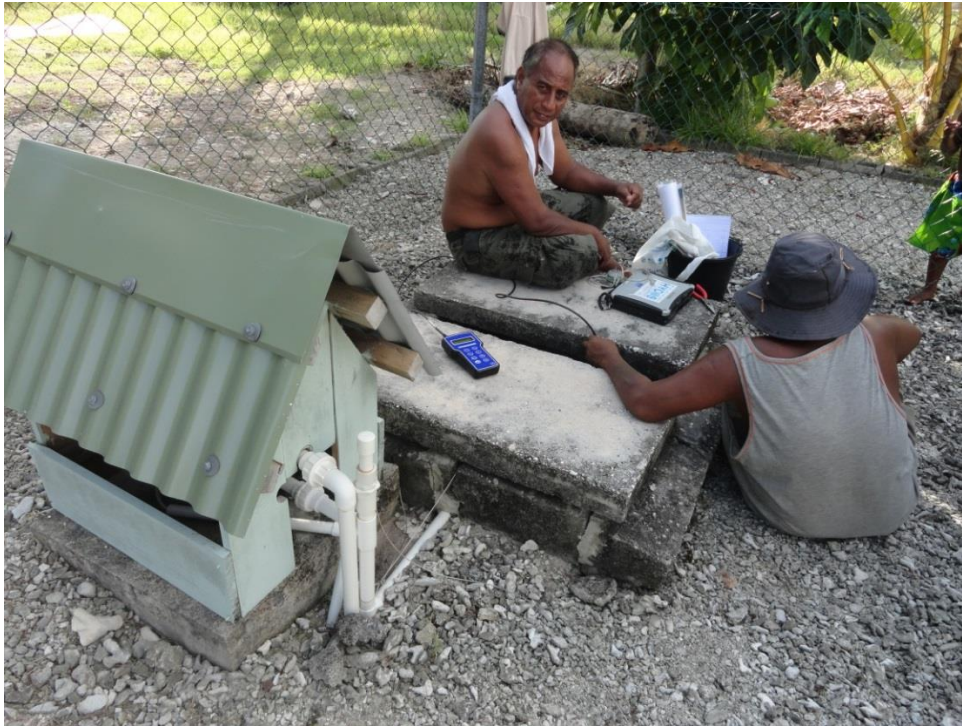
**Figure 10.** Health Clinic well, which showed brackish water quality, is attached to a solar pump system that was not working during the survey.

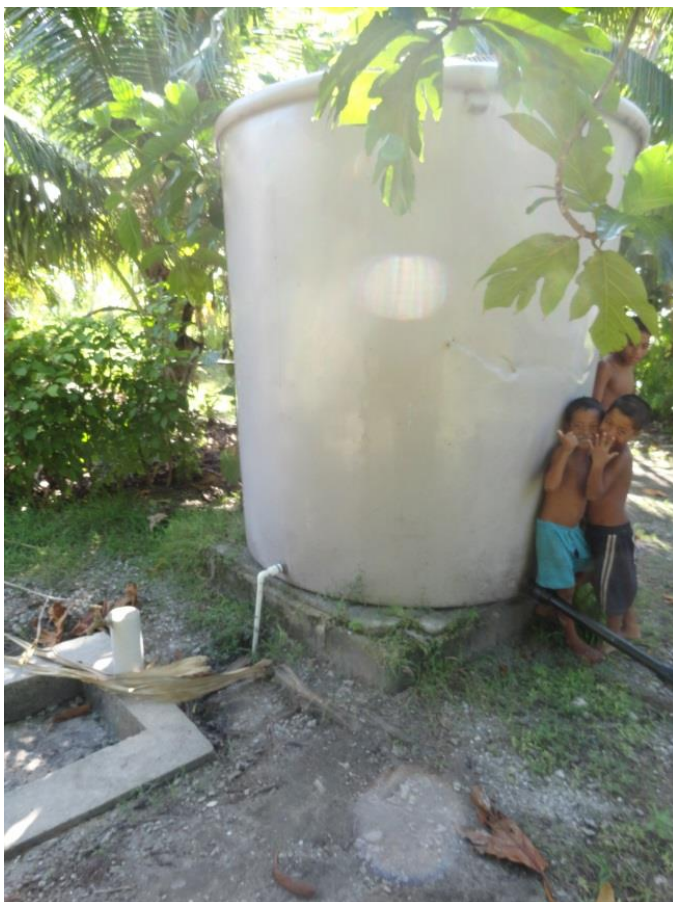
**Figure 11.** Rainwater tank connected to a tap stand in Kiebu Village.

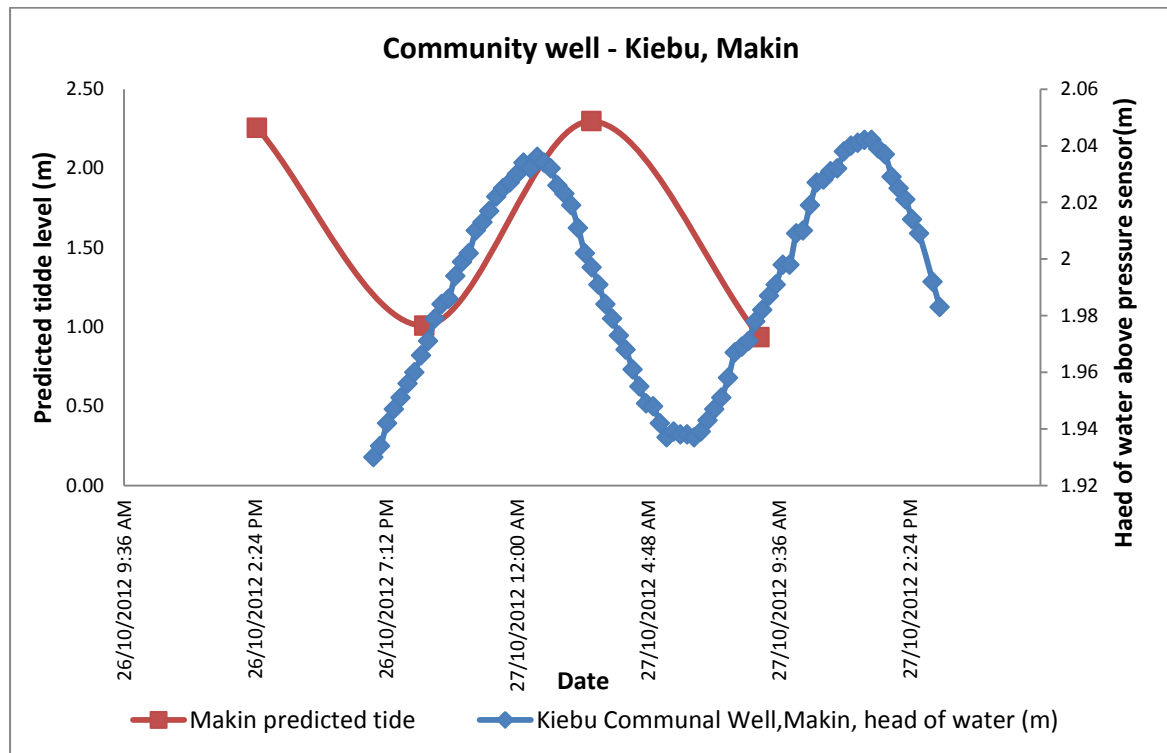
Figures 12 and 13 present the analysis of groundwater level and the predicted tidal levels at two monitoring wells, namely the communal well and health clinic well, at Kiebu Village (~0.5 km apart).

Figure 12. Predicted tidal height and measured groundwater level at the community well at Kiebu Village with groundwater monitoring commencing at 6.45 pm (26<sup>th</sup> October 2012) and terminated after 20.7 hours.

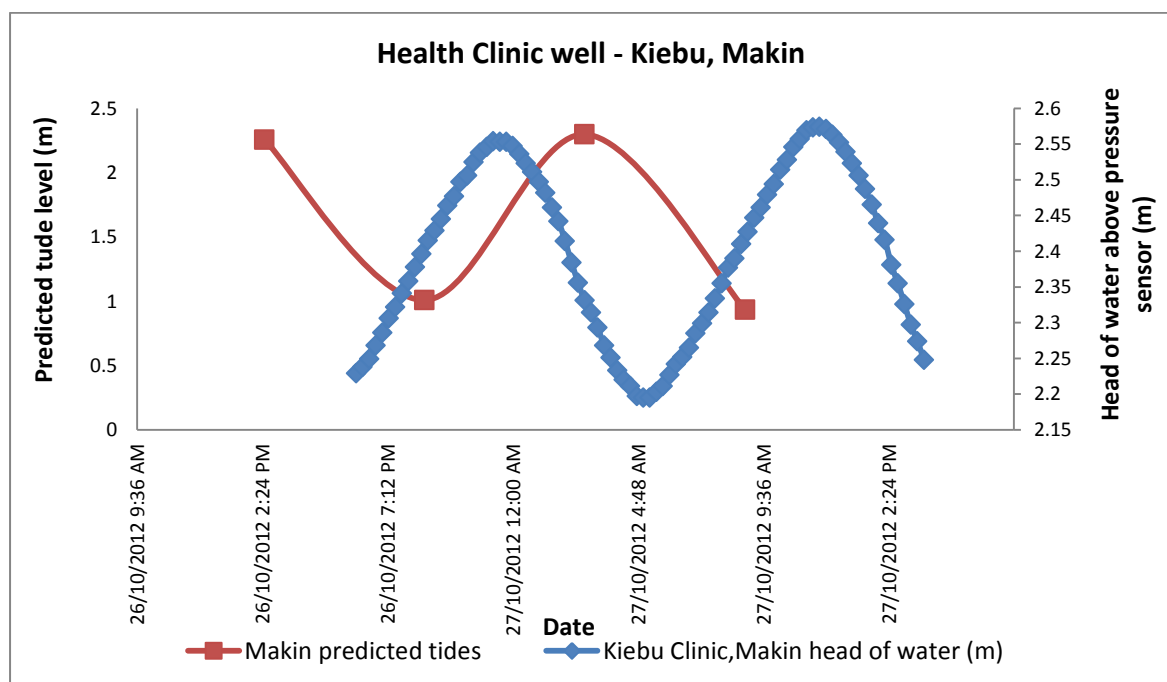
Figure 13. Predicted tidal height and measured groundwater level at the Health Clinic well at Kiebu Village with groundwater monitoring commencing at 6 pm (26<sup>th</sup> October 2012) and terminated after 28 hours.

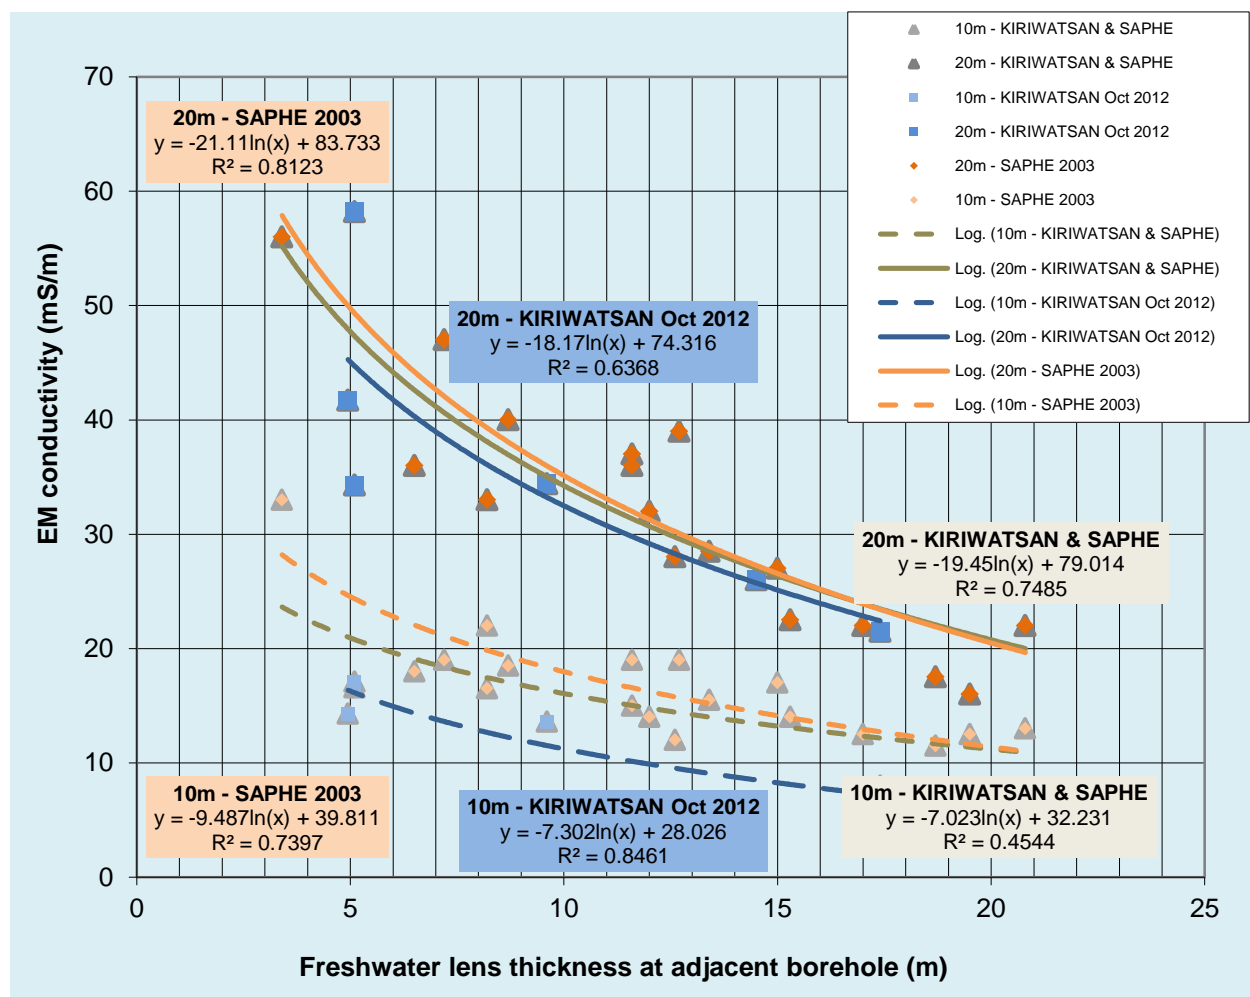
The three calibration datasets are presented as logarithmic curves and equations which are used to calculate freshwater thickness Figure A8-1 (below).

Figure A8-1. Calibration data from (1) SAPHE; (2) KIRIWATSAN; and combined (3) KIRIWATSAN & SAPHE. Note that (3) was used to estimate the freshwater lens thickness for 10-m and 20-m separations.

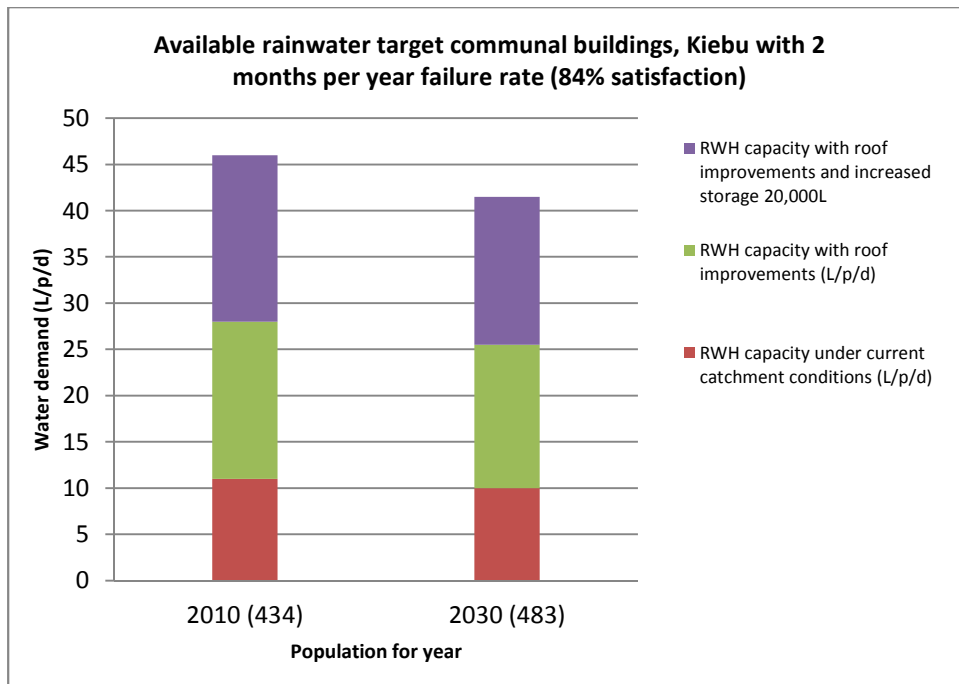
**Figure A10-1. Analysis of all target communal buildings in Kiebu Village.**

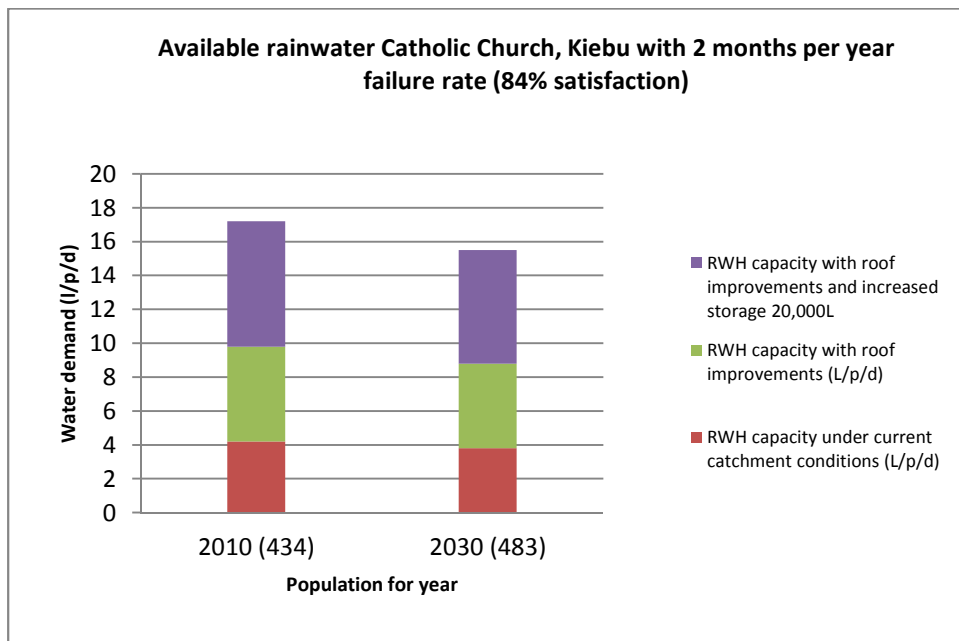
**Figure A10-2. Analysis of Catholic Church in Kiebu Village.**

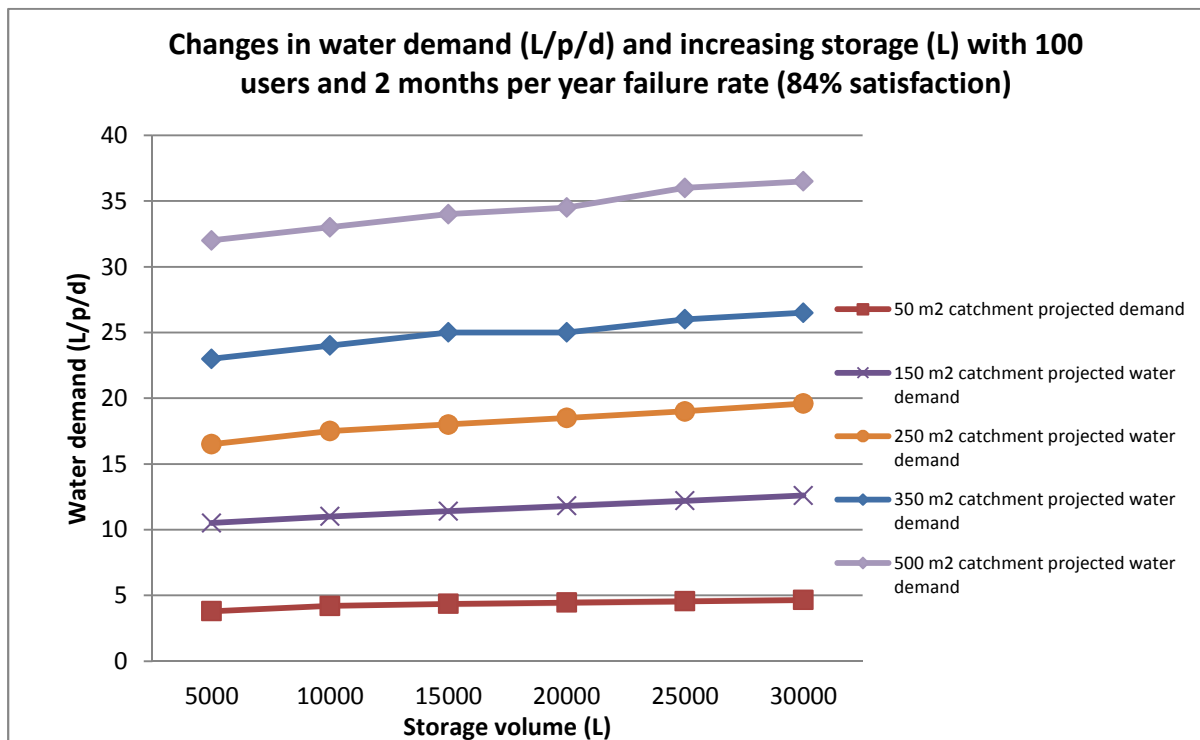
**Figure A10-6. Analysis of changing water demand on varying roof catchment area based on a fixed number of users and 84% satisfaction.**

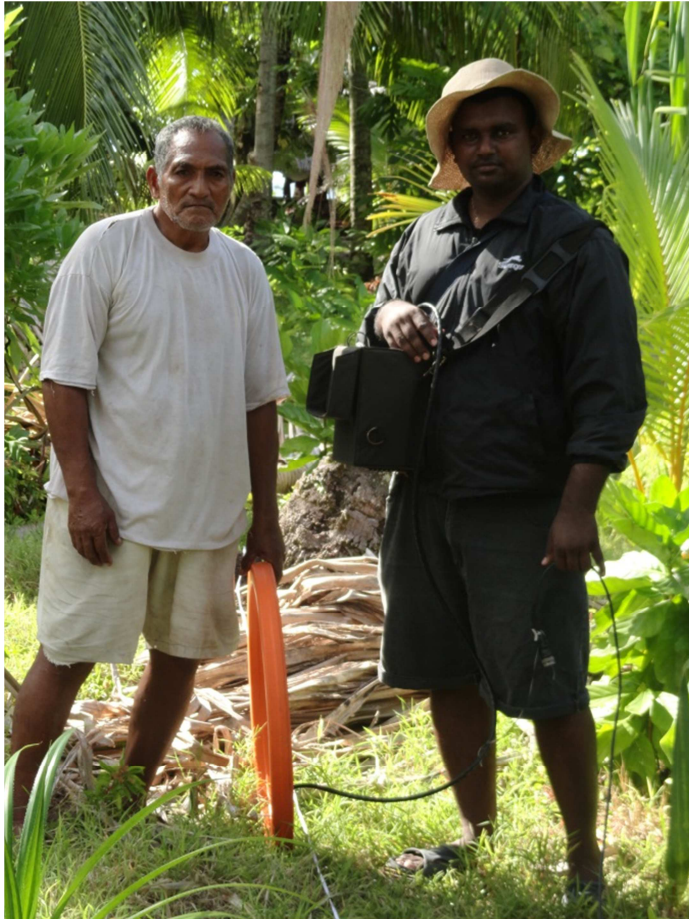
**Figure A12-4.** EM34 survey across Kiebu islet.

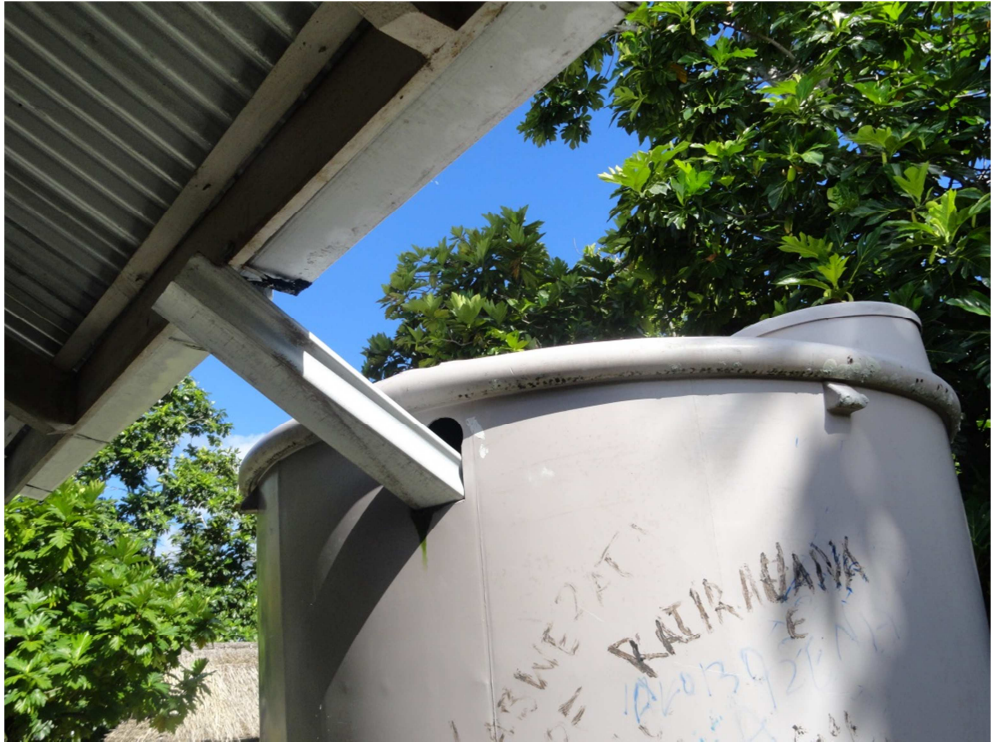
**Figure A12-6. Inadequate RWH facility showing the use of an additional gutter as downpipe.**

- Repair or replacement of roofing materials with preferably corrugated zinc-aluminium coated steel.
- Repair or replacement of fascia board and guttering to cover the entire roofing edge.

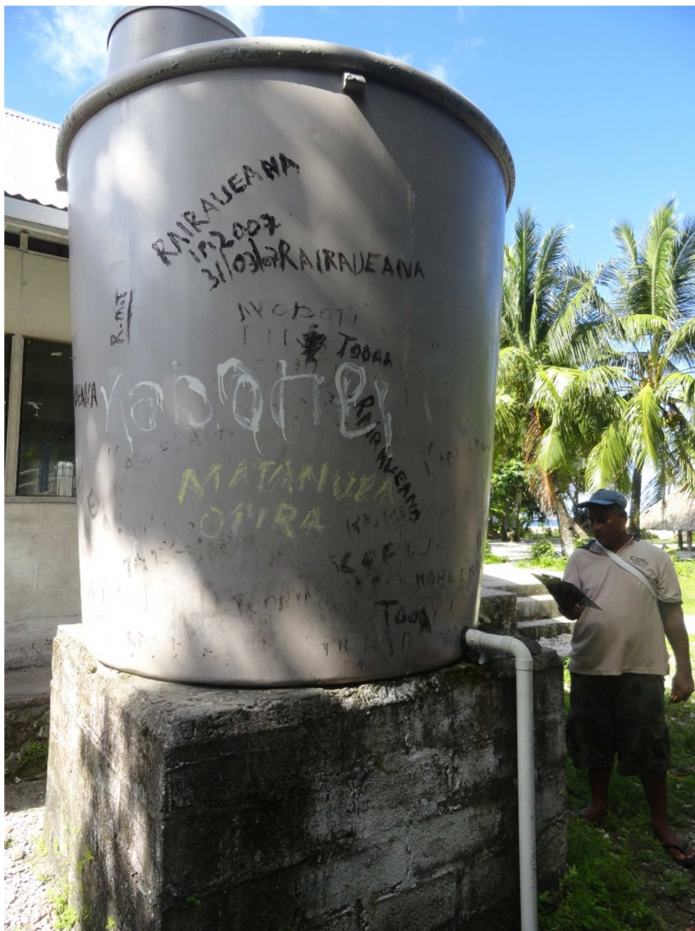
**Figure A12-7. Rainwater tank mounted on a raised tank stand.**

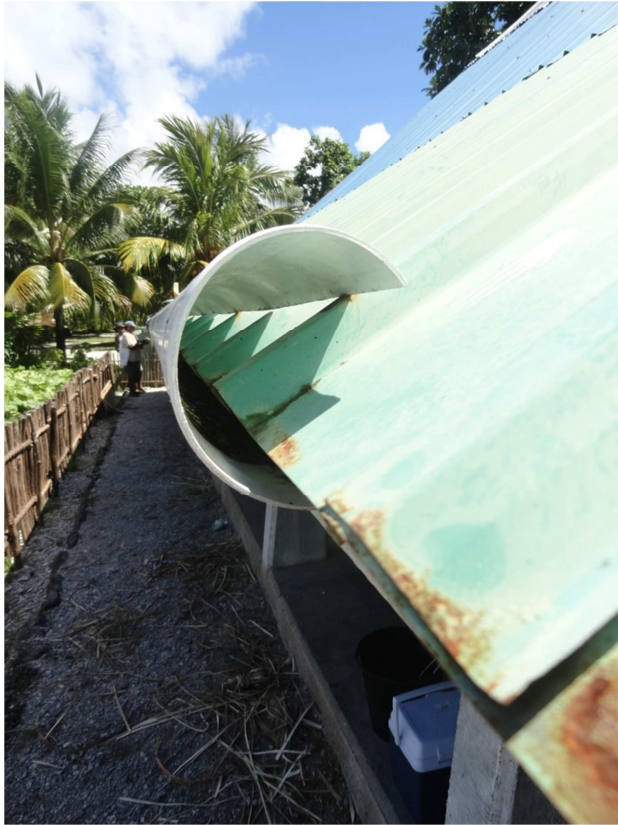
**Figure A12-8.** Split PVC pipes used as guttering on a maneaba roof catchment – the pipes allow splash losses from the rainwater collection system.

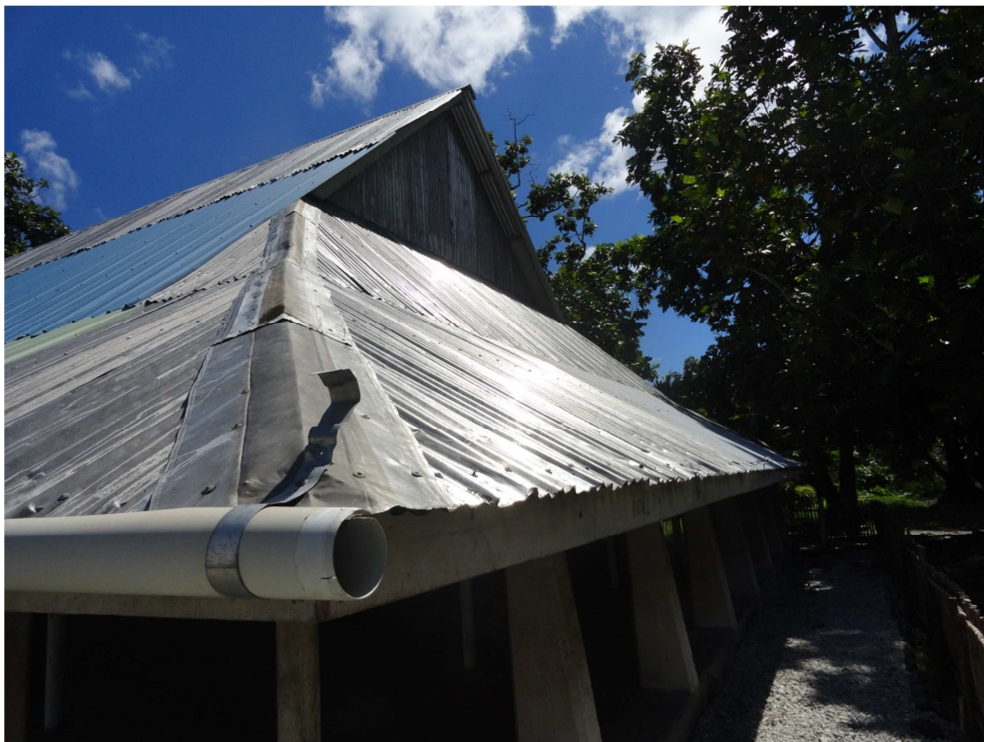
**Figure A12-9.** Split PVC pipe used as guttering and covering some parts of the roof edge.

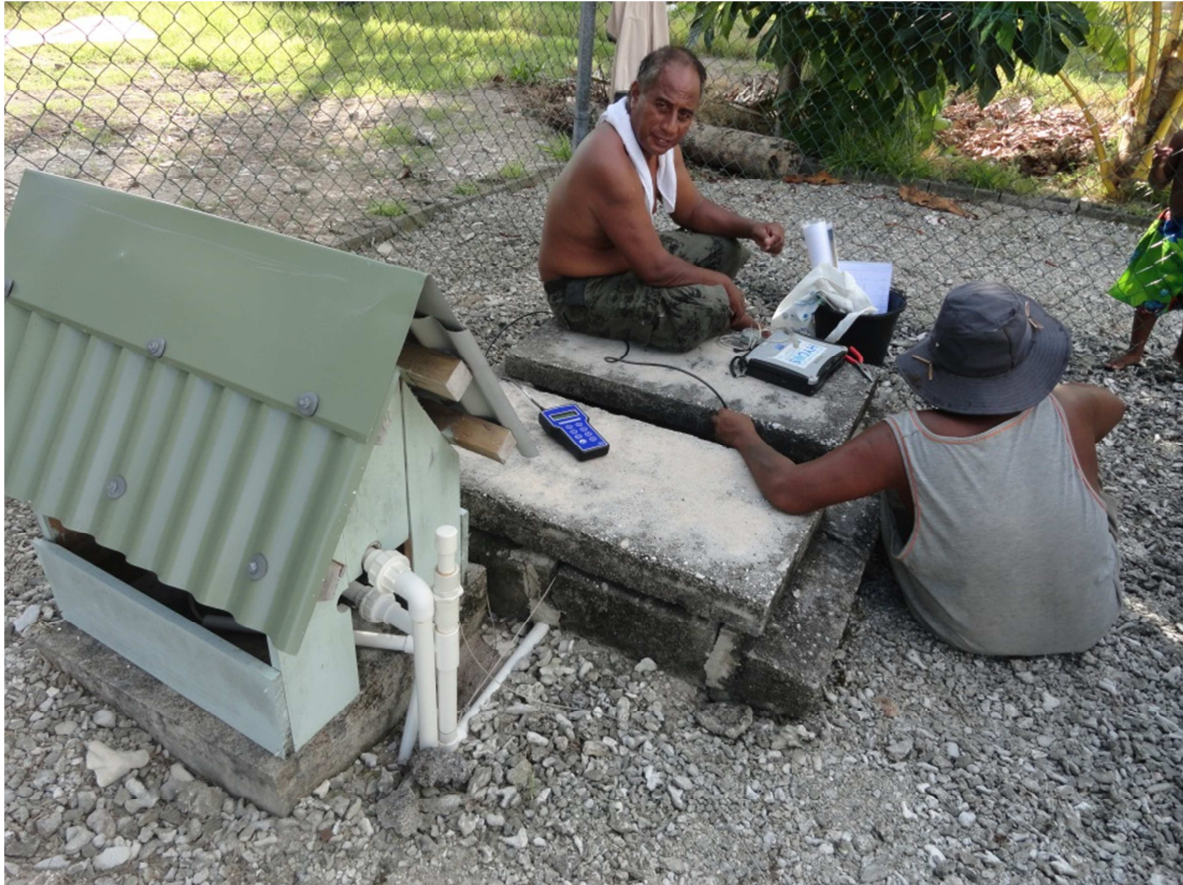
*Figure A12-12. Team taking salinity measurements at the village Health Clinic well.*
