# **COASTAL PROCESSES AND THE ROTUMA WHARF FIJI**

Brendan J. Holden  
SOPAC Technical Secretariat

*July 1992*

*SOPAC Technical Report 146*

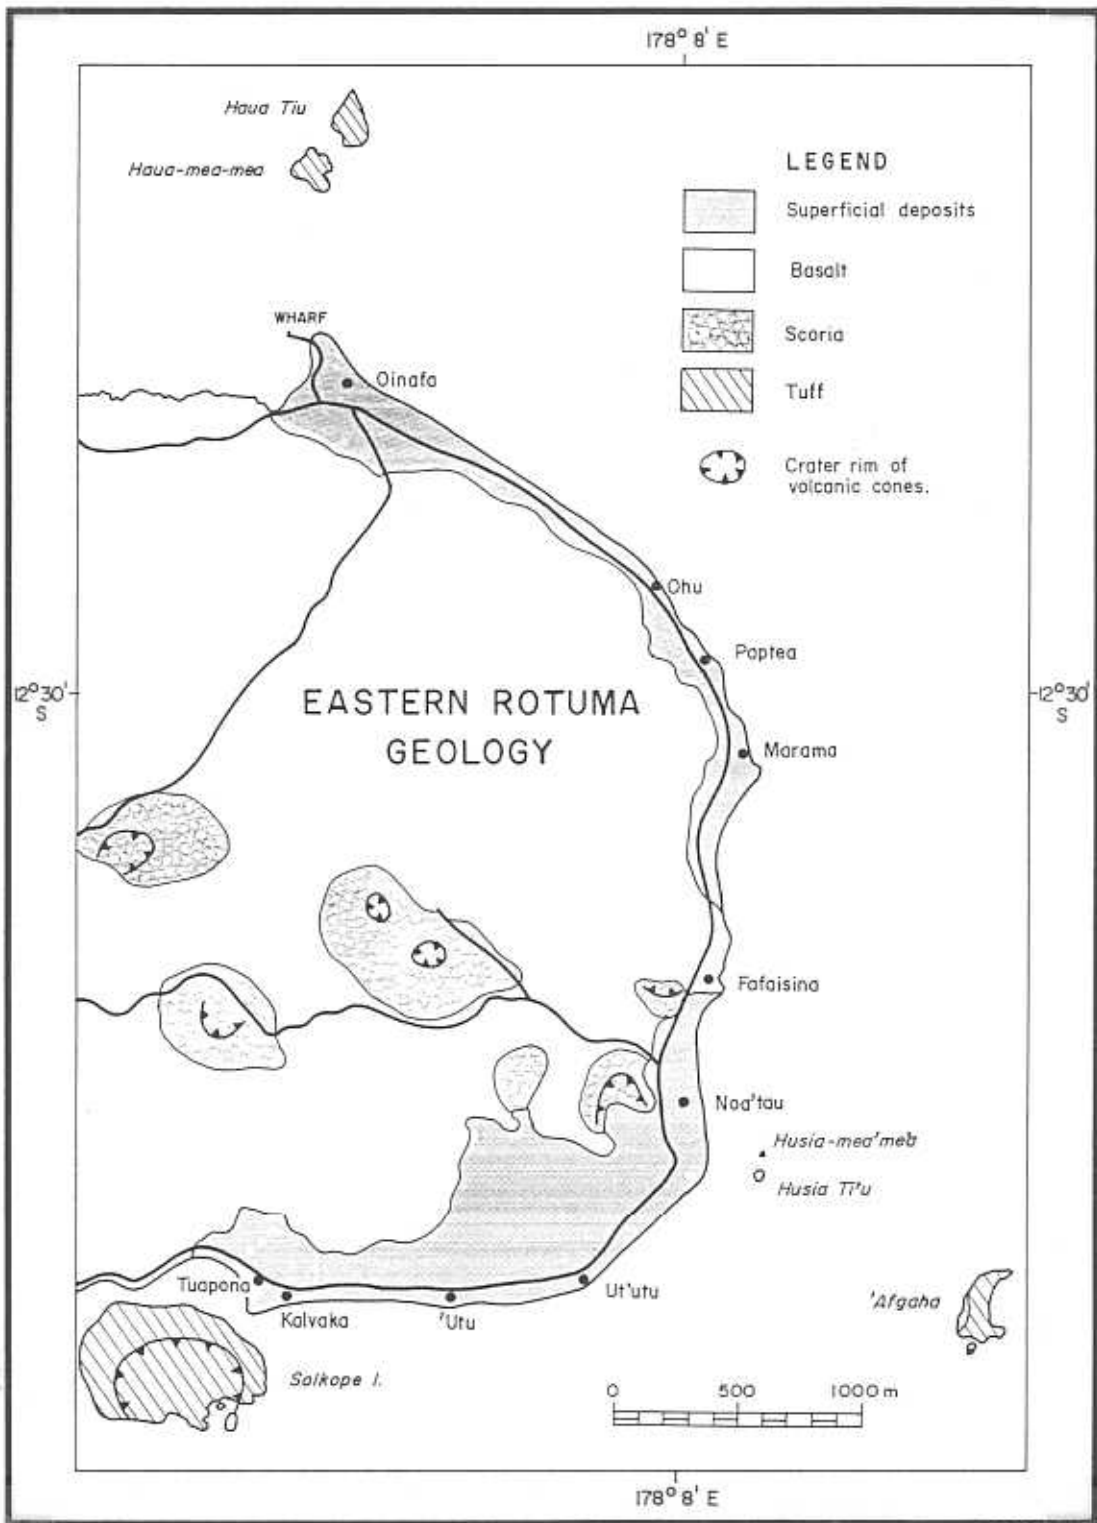
Figure 3. Geological map of eastern Rotuma.

The geological map of Rotuma (Figure 3) indicates that the island is mostly basalt lava and scoria, except for some depositional areas near the coast (Woodall 1987). The shore around the east end of the island, from Oinafa to Kalvaka (Figure 3), is a coastal plain with only a small section of lava near the shore at Fafaisina. There are also substantial coastal plains in Pepjei and Juju districts on the south coast and at the Motusa isthmus (Figure 1). These coastal plain areas and the smaller beaches are composed of carbonate sand and gravel derived from the reef (Woodhall 1987, page 21).

The shoreline around the east end of Rotuma, from Oinafa to Kalvaka, is characterised by fine carbonate sand, black rock outcrops and beachrock slabs. Littoral drift is northwestward from Marama, to Oinafa and southward and westward from south of Marama to Kalvaka (Figure 3). Along this shore there are several locations where black rock outcrops, perpendicular to the shore or slightly offshore, act as groynes and pocket the fine sand. Fronting Paptea village the groyne
