**COASTAL EROSION PROBLEMS IN THE  
GILBERT ISLANDS GROUP, REPUBLIC OF KIRIBATI  
Phase II**

April 1994

SOPAC Technical Report 191

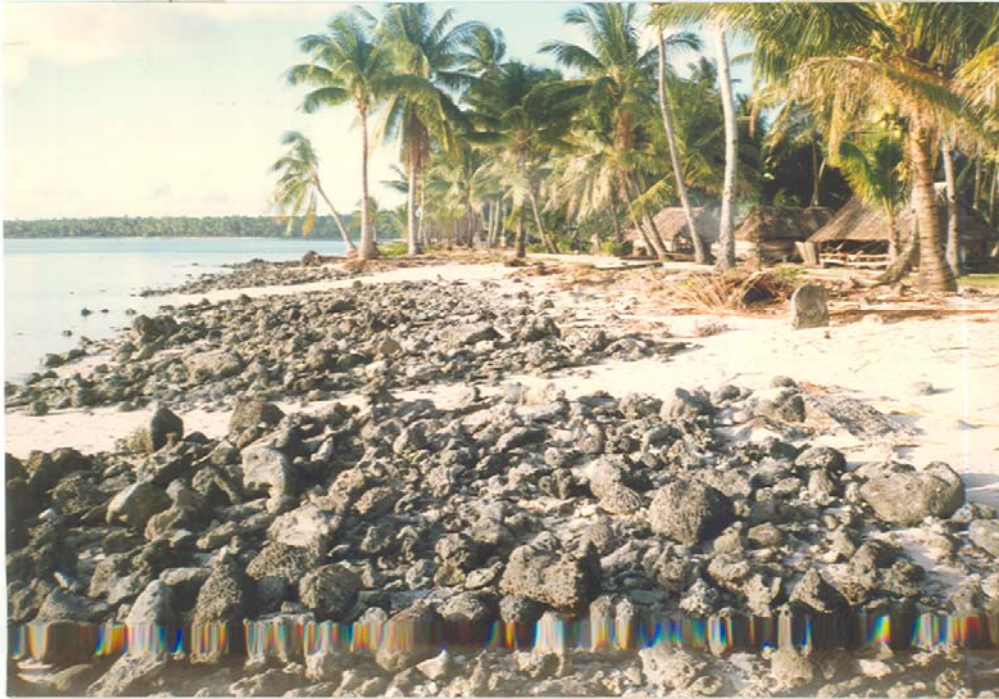
8  
6238

This site is located along the lagoon shore on an old recurved spit complex (Figure 7). The length of shoreline being eroded extends over 500 m of which the southern-most 200 m is the most affected (Figure 8). Shoreline erosion has affected a large number of traditional house structures and two maneabas. The southern-most maneaba is now floored with sand washed in by waves. The foundations (coral rock pillars in the sand) are all that remain of a number of other traditional design buildings (Figure 9).

Figure 8. Tebunginako, Abaiang. View northwest along lagoon shoreline towards village, showing extensive remains of previous attempts at seawall construction. Pathways have been cleared through the seawall rubble to create boat launching sites.

Public Works Division (PWD) records indicate that two previous attempts at coastal protection have been made at Tebunginako (Appendix 3). In 1978 a gabion seawall (wire baskets filled with coral boulders) was constructed along 500 m of shoreline and in 1980 a "dyke" of 60 m length was constructed. Both of these structures have failed to control the erosion and now litter the beach (Figure 8).

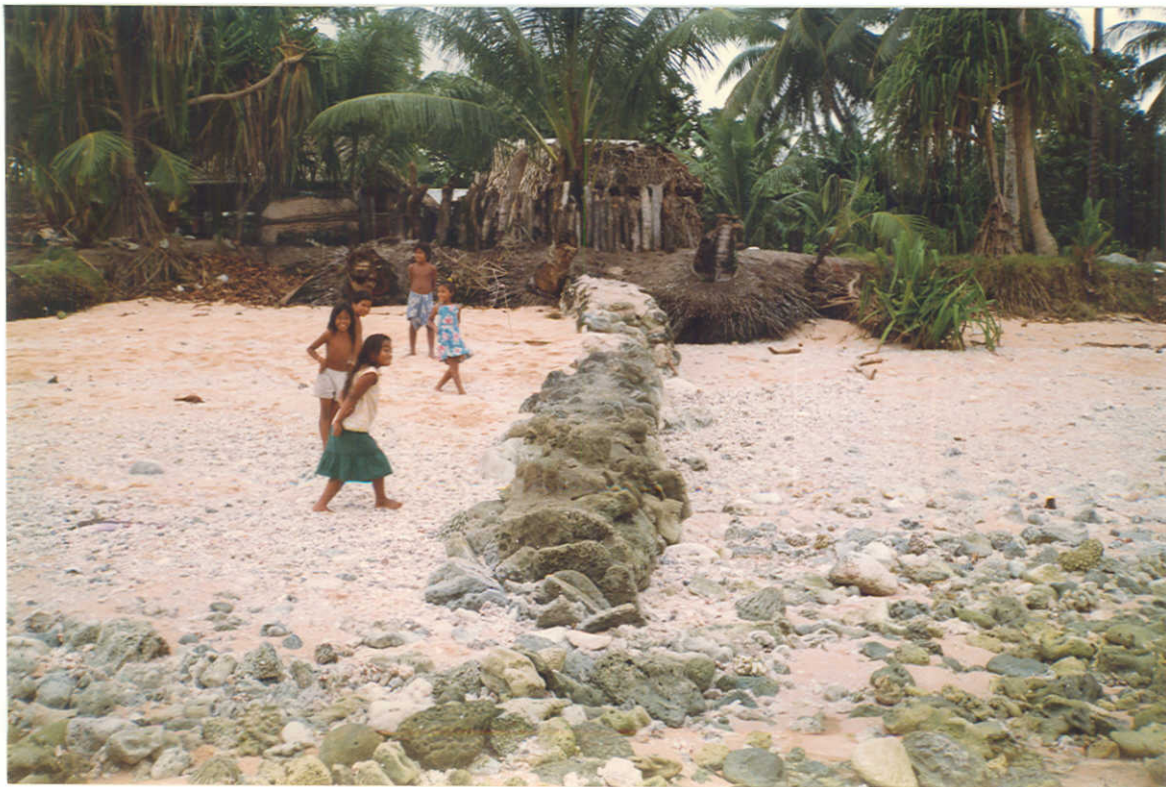
36  
6238

Figure 18. Naka Primary School, Makin. View of locally constructed small groyne located approximately 200 m south of school site. The greater volume of sand on the left (north side) of the groyne indicates that the most recent predominant direction of longshore transport has been from the left (north).

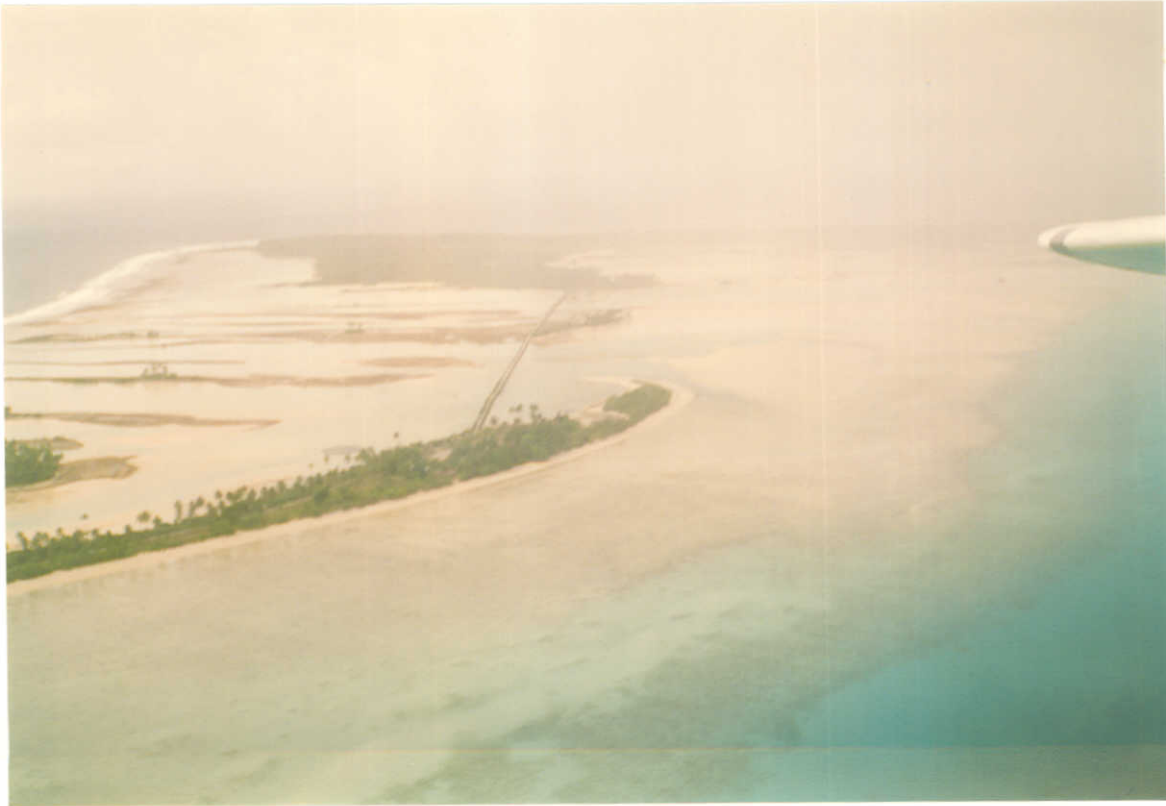
27  
6286

Figure 27. Keuea/Tanimainiku School, Butaritari. Aerial view southwest showing sandspit and causeway. The study site is located in the middle of the spit along the lagoon shoreline.

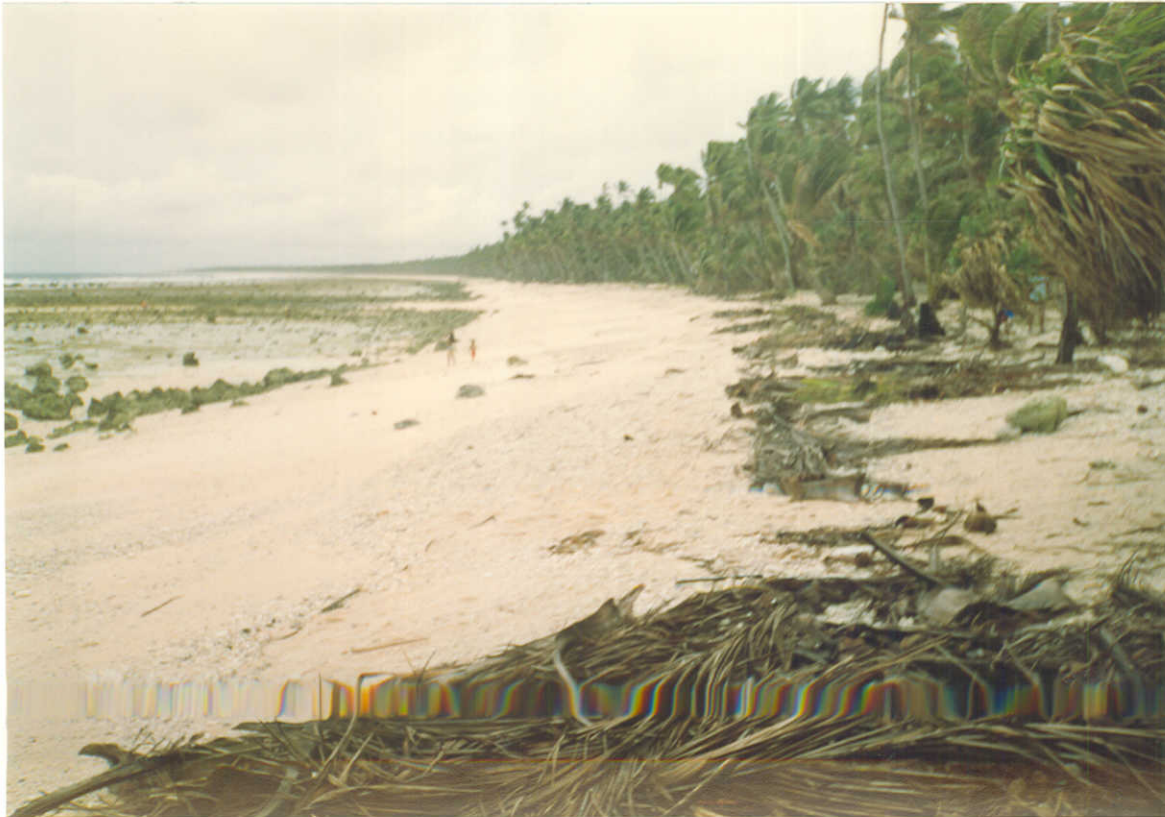
10  
6285

The length of shoreline examined at Taribo was approximately 50 m south of the school and 100 m south of the man-made boat channel (Figure 32). A beach profile was surveyed from a point inland across the backshore and onto the reef flat (Appendix 5). According to local sources, between the two and six am on Monday 4 January 1993 at least three large "tidal waves" (properly called a storm surge) washed over the beach ridge and onto the island behind of the shoreline. Waves breaking on the edge of the reef were estimated to have heights of 4-6 metres. As a result of the storm surge waves, sand and cobble debris were carried up to 50 m inland of the normal high tide beach ridge (Figure 33). Local sources also

Figure 32. Taribo, Arorae. View northwest along exposed shoreline approximately 100 m south of man-made boat channel.

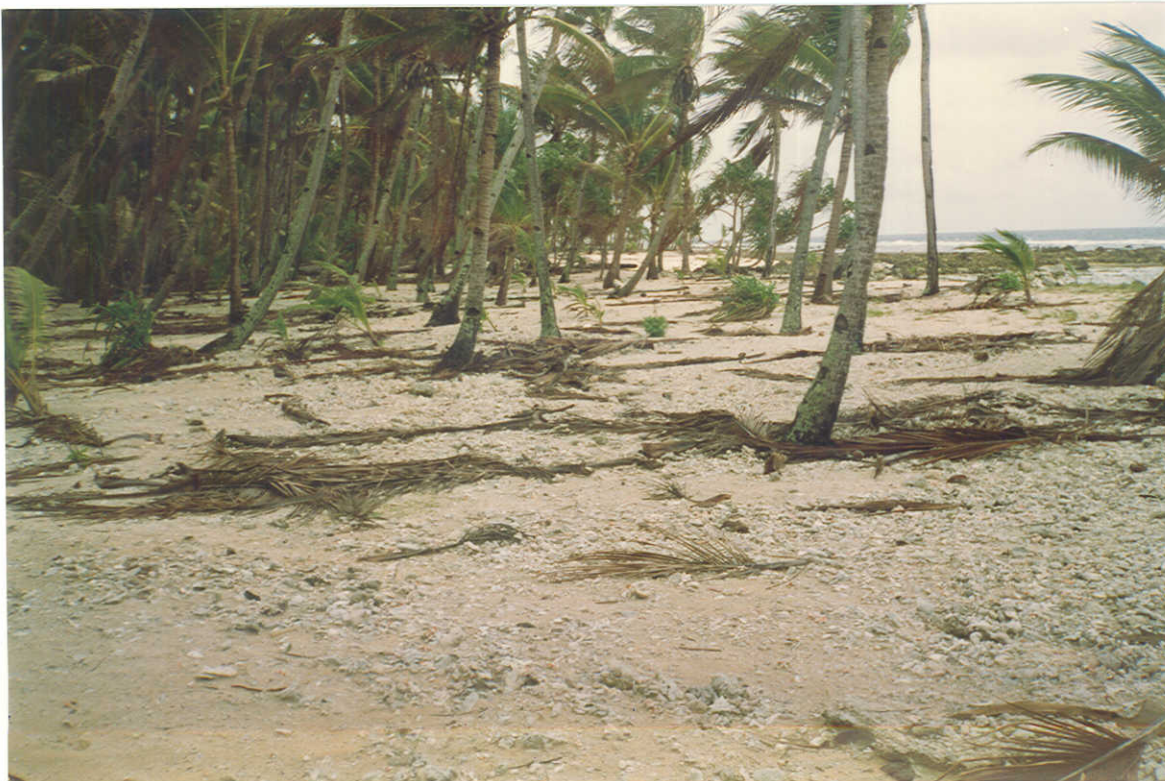
11  
6285

Figure 33. Taribo, Arorae. View south through backshore showing storm surge overwash deposits (approximately 0.5 m deep) extending 40-50 m landward of beach ridge shown in Figure 32.

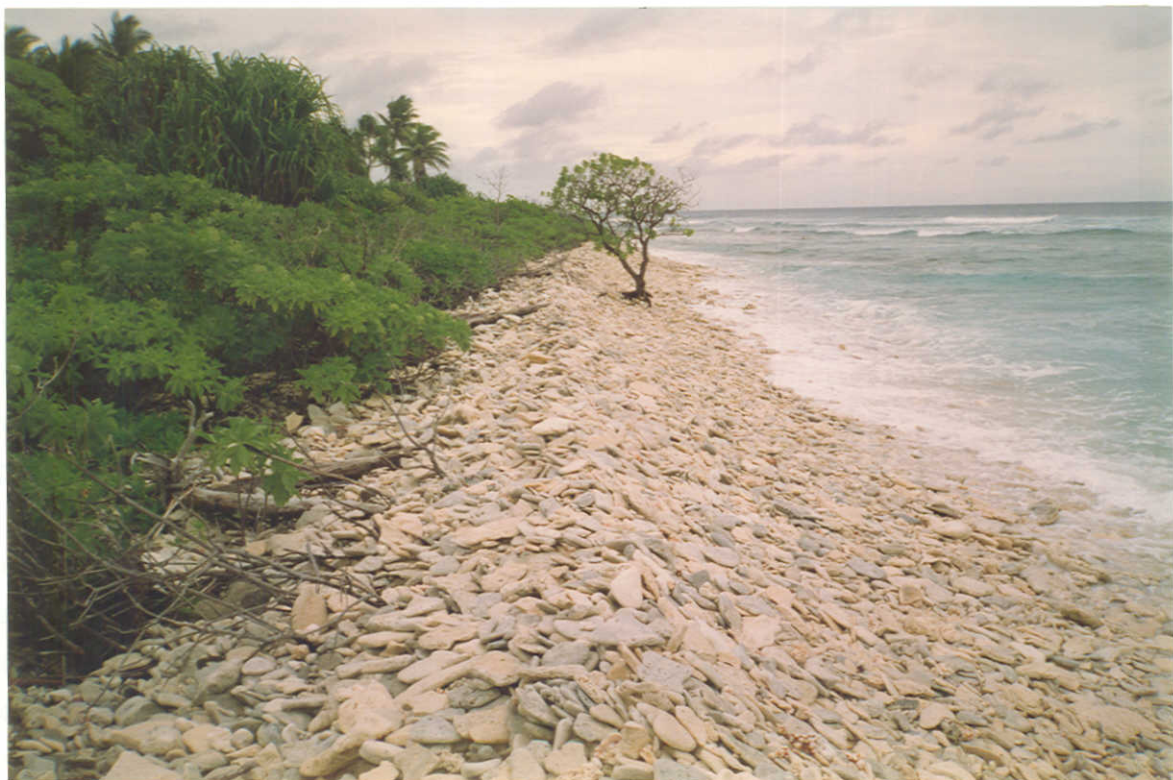
15  
6285

Figure 35. Batitotai, Arorae. View southeast along narrow beach ridge composed of coral rubble. The beach ridge has recently migrated landward as indicated by small tree on beach and burial of backshore vegetation.

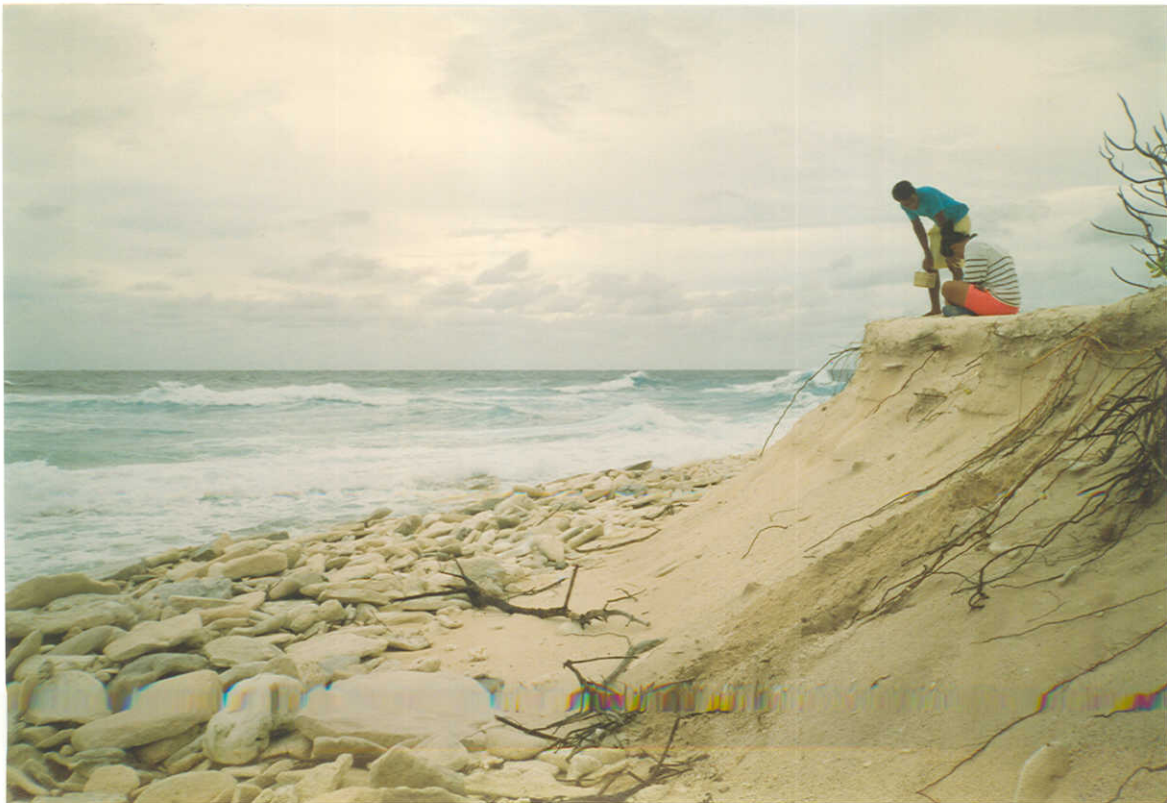
16  
6285

Figure 36. Barbaroroa, Arorae. View north showing erosion scarp associated with early January storm surge and subsequent strong westerly winds and waves.

Presently, apart from some survey markers and the land itself, there are no assets at risk. The land is not being utilized for subsistence food supply and supports a salt tolerant scrub bush. The site of the Arorae Navigation Stones is about 200 m inland of the study site and is not deemed to be at risk. Therefore, it is recommended that no action be taken at the site.

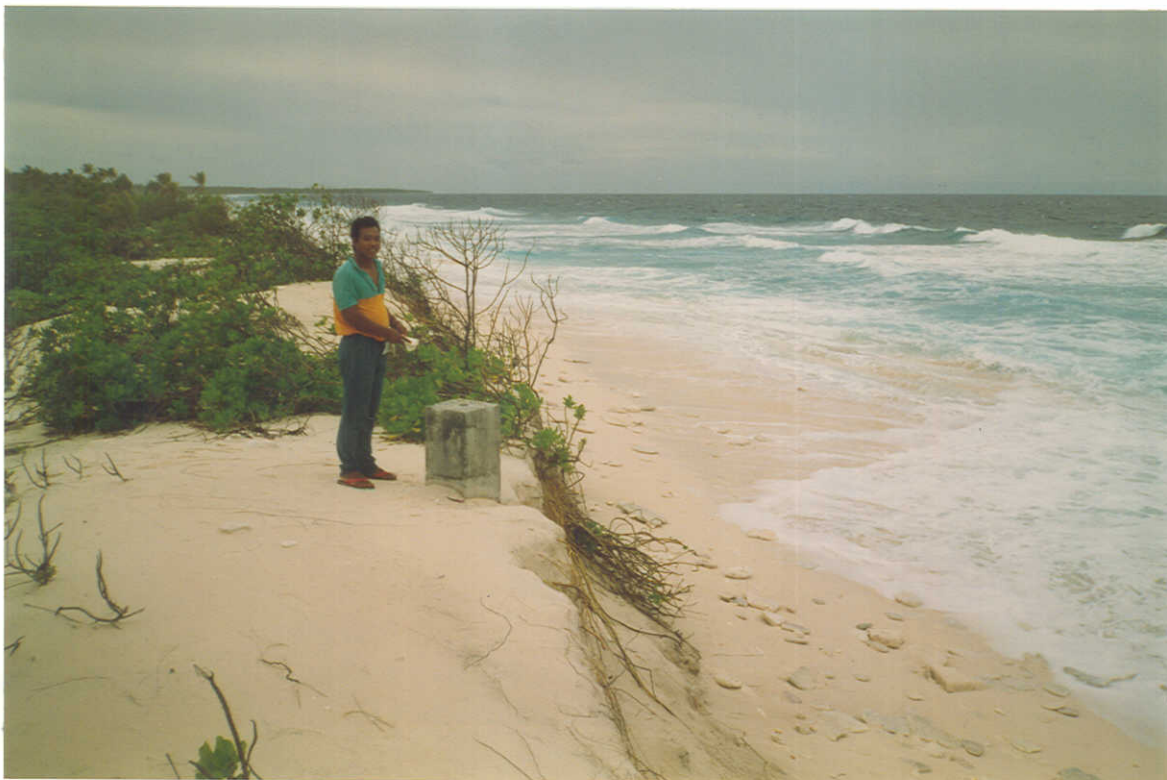
17  
6285

Figure 37. Barbaroroa, Arorae. View southeast along crest of erosion scarp. Information on concrete monument indicates installation by USAF survey in 1965.

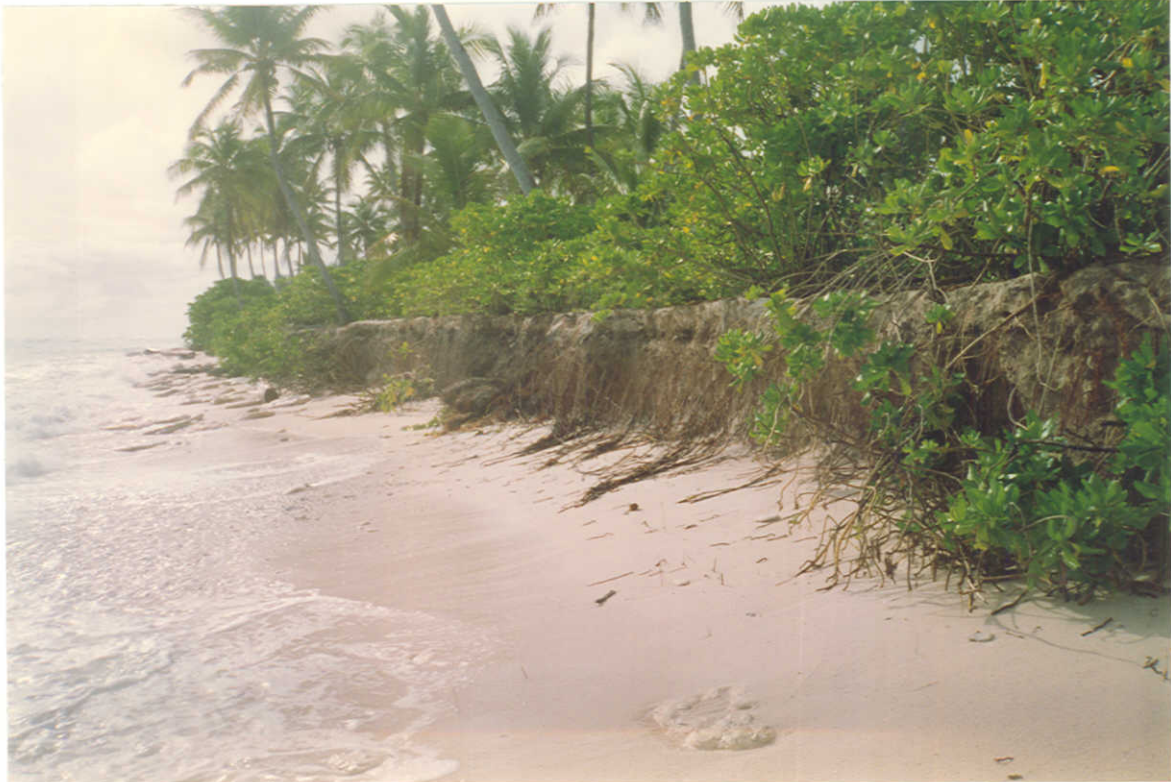
24  
6285

Figure 39. Taboiaki, Beru. View northwest showing erosion scarp along shoreline at beach profile site south of village.

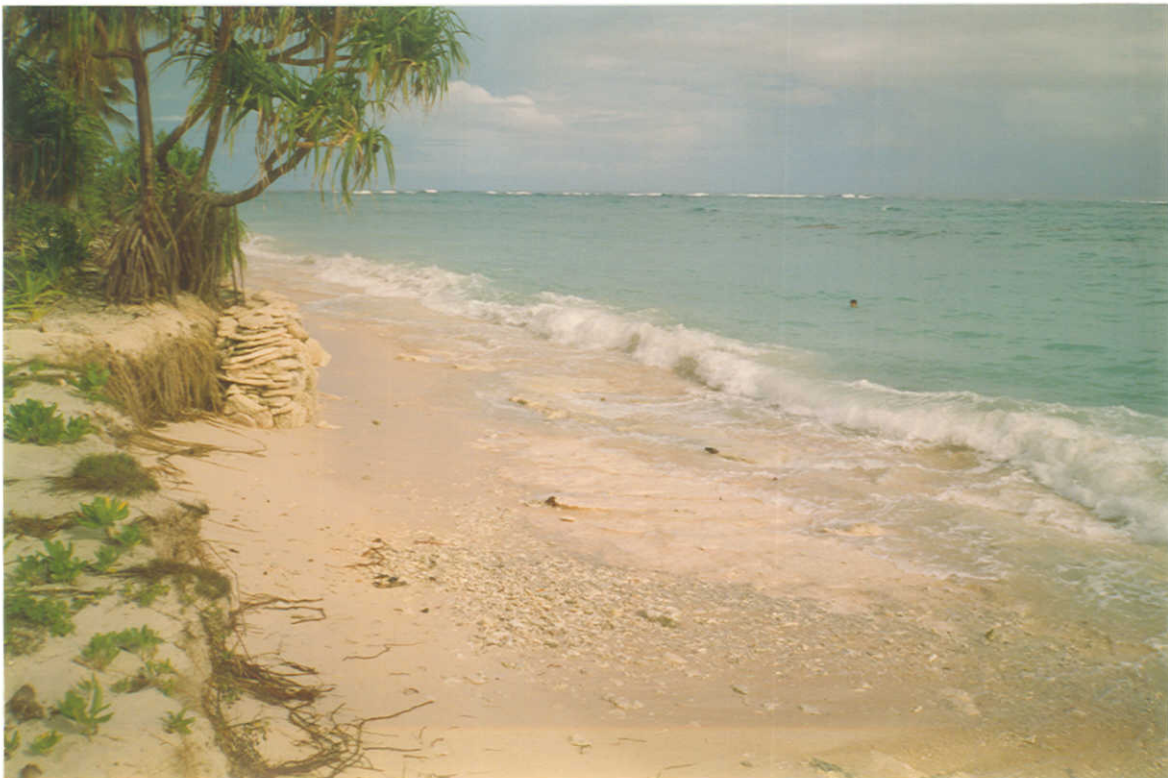
23  
6285

Figure 40. Taboiaki, Beru. View southeast at beach profile site showing erosion scarp, beachrock on lower foreshore and end portion of privately constructed seawall.

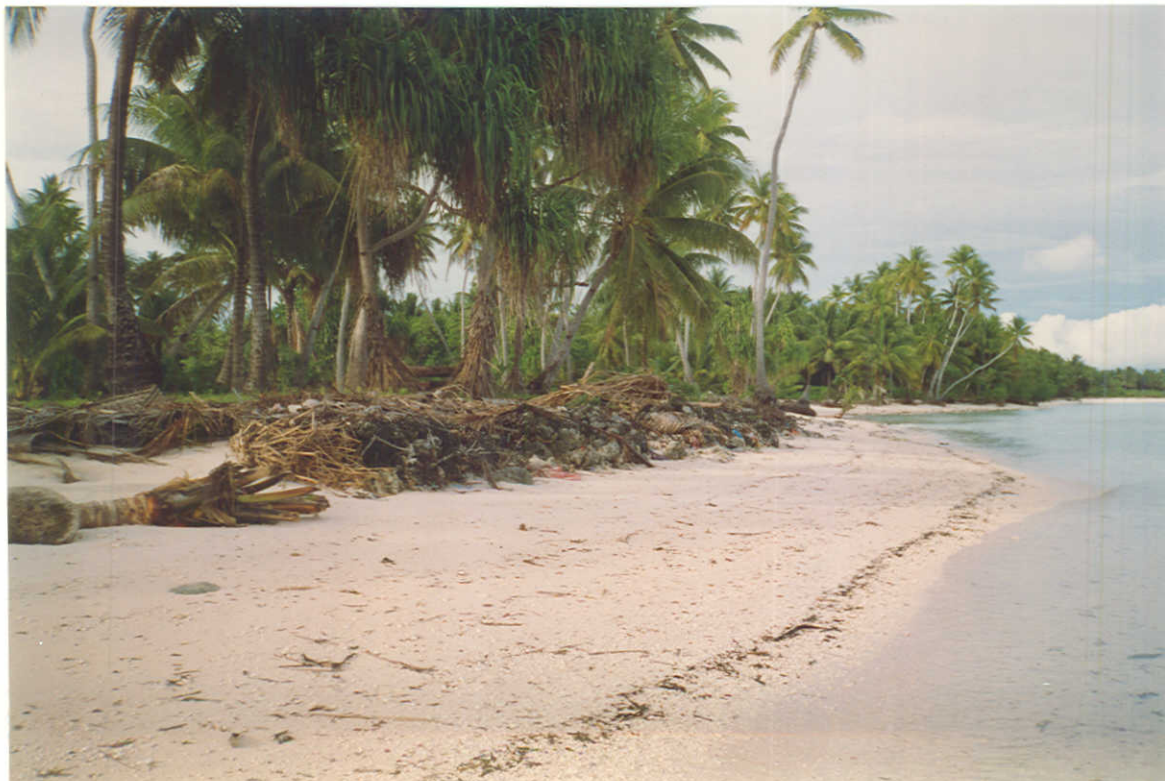
3  
6287

At the study site, a previous rock filled gabion wire basket seawall has mostly failed and only small sections of the original seawall exist. In fact only about 5 m of the original 100 m exists (Figure 45, 46). Apparently the seawall was constructed about 1985 and had started to fail within two to three years. Requests to have the seawall repaired were initially made to Home Affairs about 1988. The representative from the village that acted as a local source of information was pleased to see us but chided us for our tardiness. Local sources also provided information on the longer term changes on the southeast corner of the island. Apparently some 60-70 years ago shoreline erosion became a problem at Tekariaria and the village was moved to the new site at Kirimotoia (Figure 44).

Figure 46. Takaeang, Aranuka. View northeast of gabion basket seawall remains to east of school site.

A possible solution was discussed with the villagers whereby the teachers quarters could be relocated back 5-10 m from the shoreline. It is not recommended that a seawall along the shoreline be re-built.

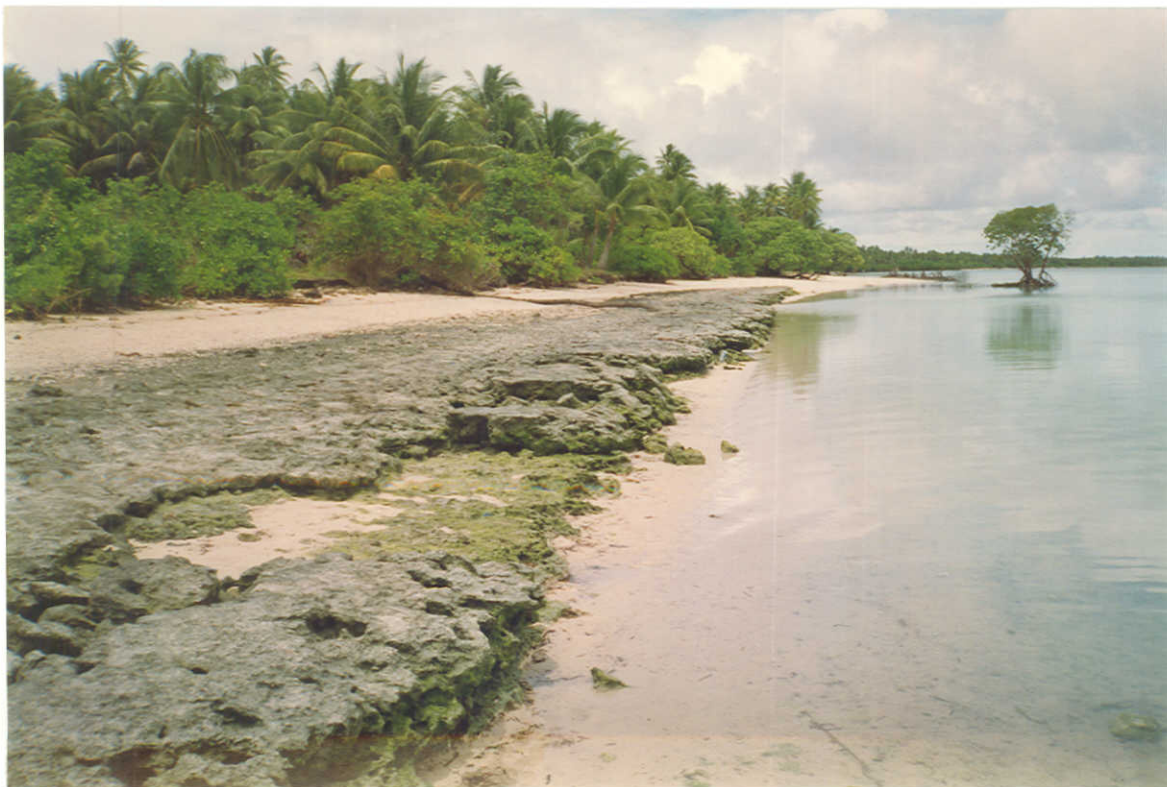
13  
6287

The lagoon shoreline at Buariki South is fronted by exposed beachrock extending over about 500 m along the shoreline (Figures 48, 49). According to local sources the amount of erosion has amounted to about 10 metres over the last 50 years. This would appear to be consistent with a similar width of exposed beachrock. Both the map and airphoto shows an exposure of beachrock which indicates it has been so for some time. The study site and beach profile were also just north of the foundations remaining of a trader store (Langley) which was now very close to the shoreline. The store had been operated at the site for some time in the past. However, the original position of the shoreline relative to the store could not be determined.

Figure 49. Buariki South, Aranuka. View south of beach profile site showing extensive area of exposed beach rock and natural shoreline with narrow beach.
