**INITIAL RECONNAISSANCE OF THE
EFFECTS OF CYCLONE KINA IN
CENTRAL AND EASTERN VITI LEVU**

April 1993

SOPAC Miscellaneous Report 149

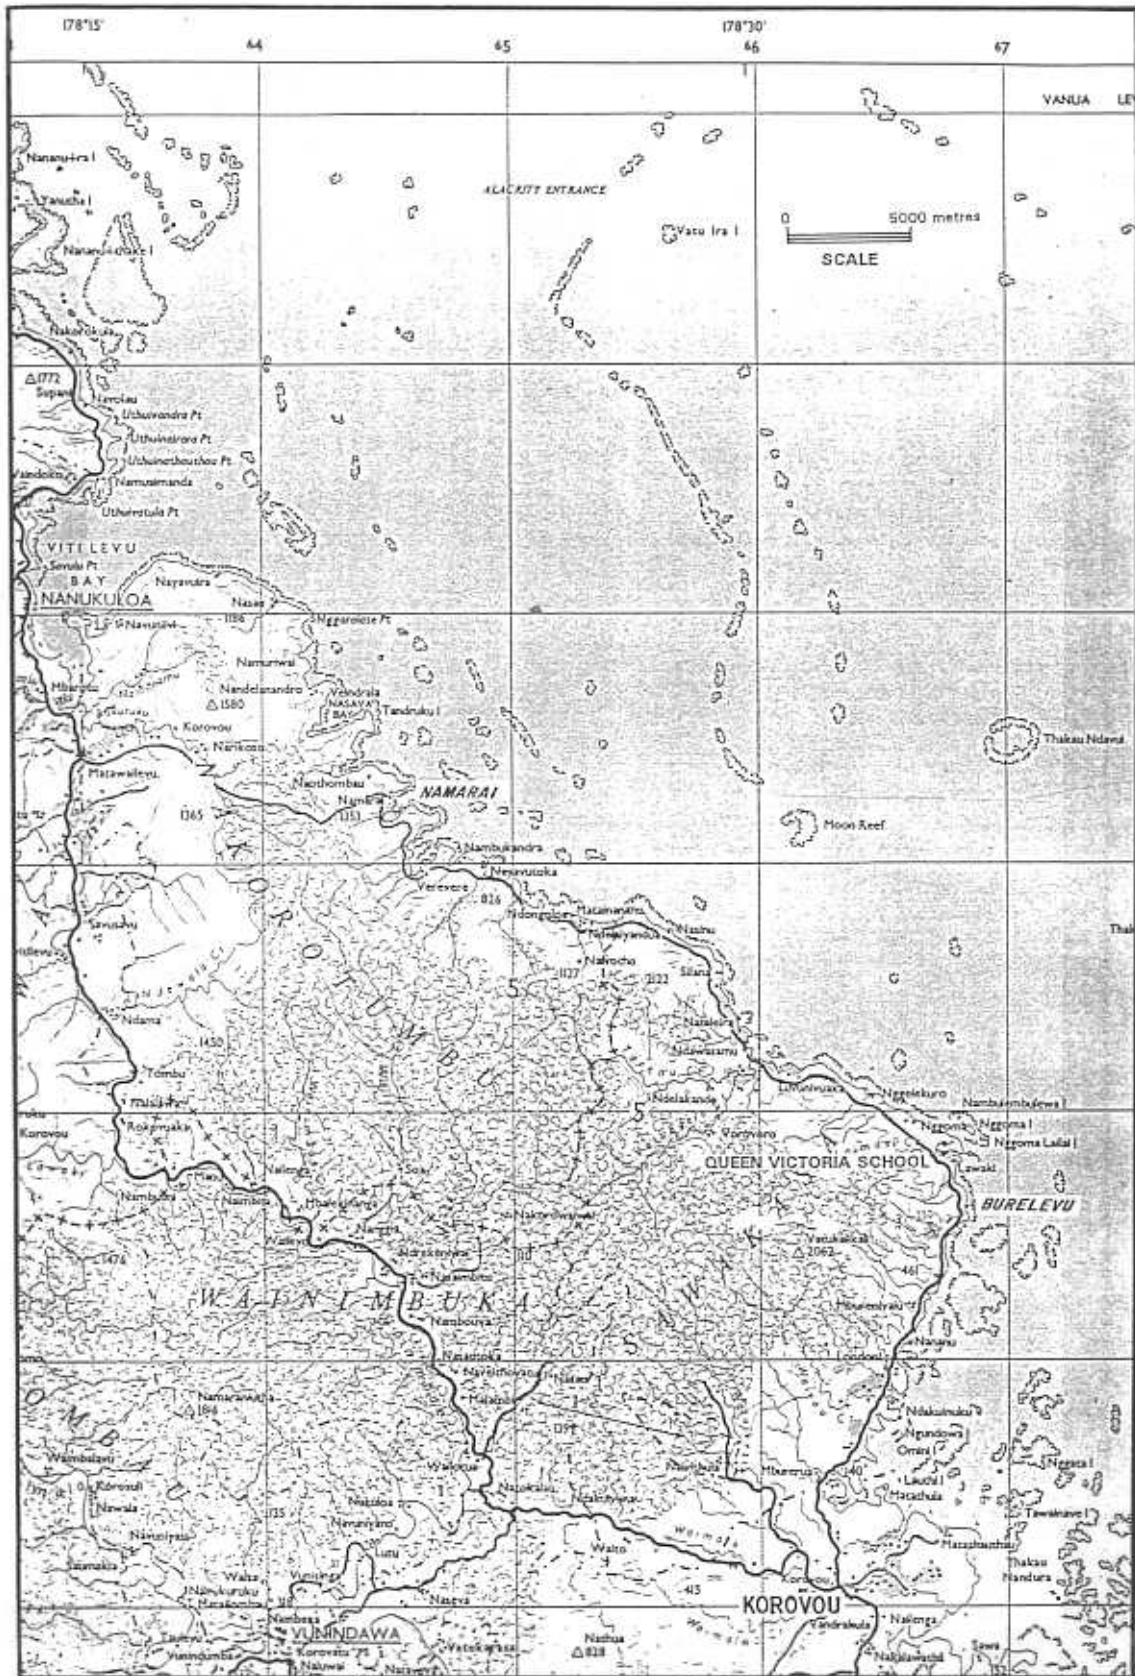
the fringing reef is interrupted only by (i) river mouths of coastal catchments which may have deltas developed, the largest of which is Tavena Creek at Dawasamu; and (ii) three bays to the north (Figure 11).

Figure 11. Map of northeast Viti Levu, note the proximity of the fringing reef to the coast, major bays and small area coastal catchments.
