# KIRIWATSAN Water Resources Assessment Nikunau Island, Kiribati

## Water Resources Assessment

### NIKUNAU ISLAND, KIRIBATI

April 2015

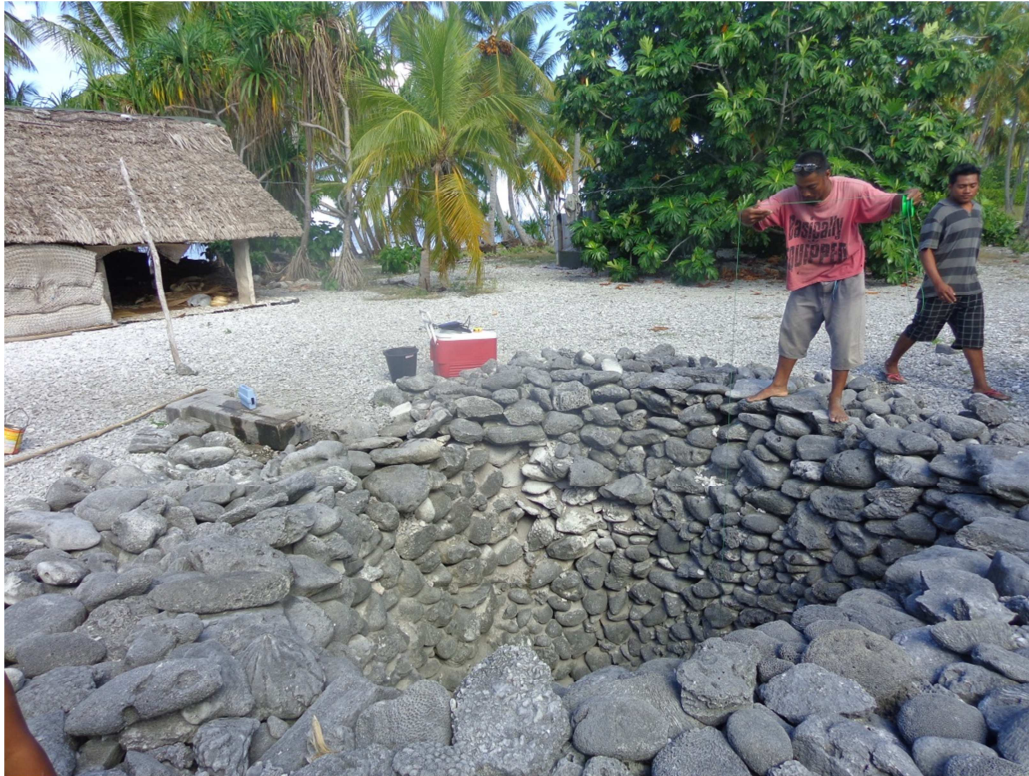
**Figure A11-2. Water- table and well- dimension measurement done by village workers.**

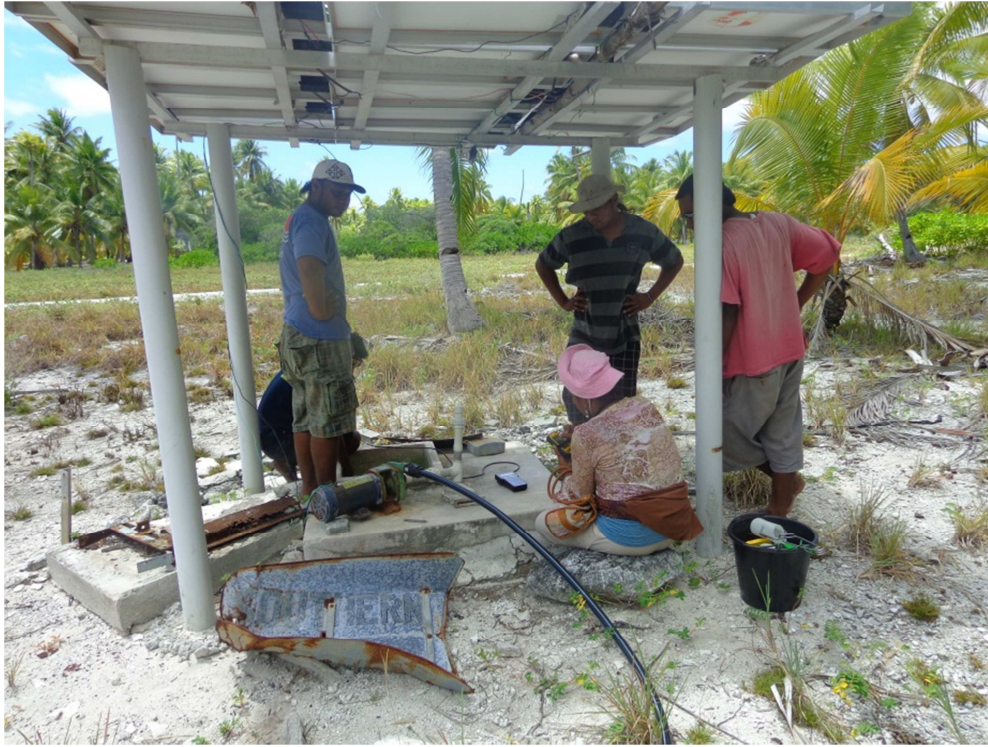
**Figure A11-4.** Survey team assessing the Muribenua Village well; water is abstracted by solar pump.

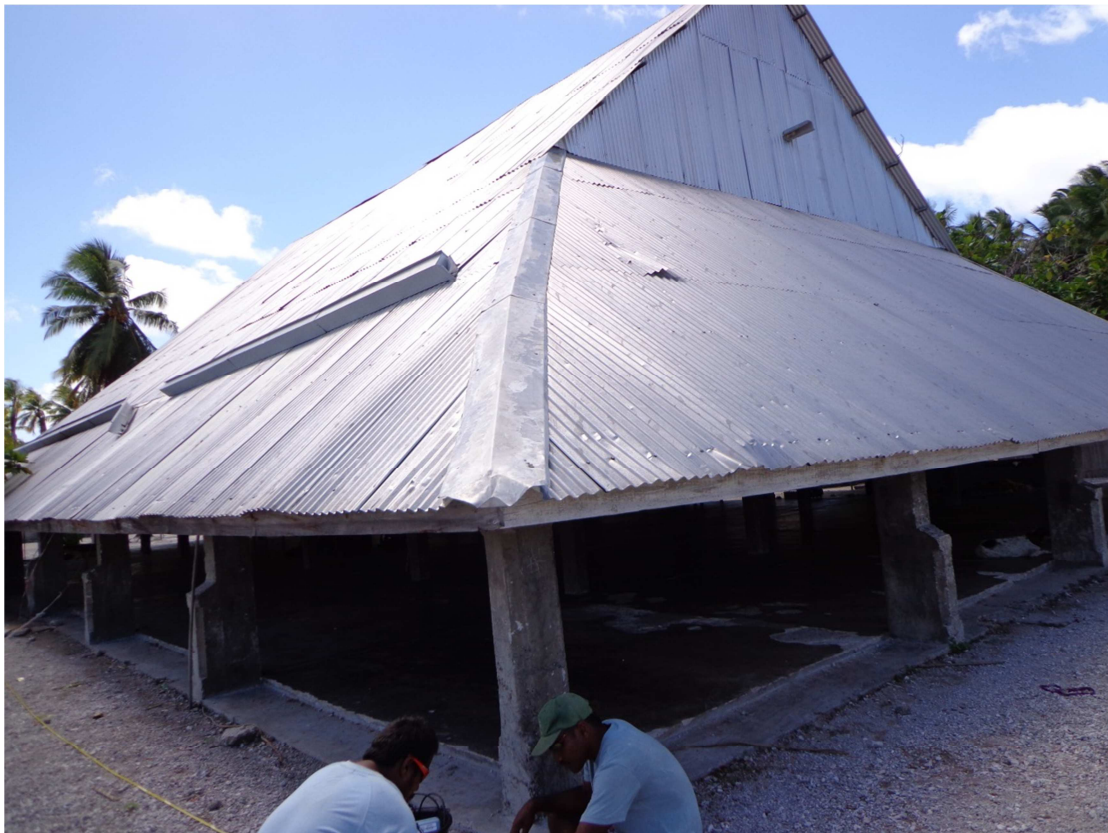
**Figure A11-5.** Rainwater harvesting assessment conducted at the Island Council Maneaba in Rungata Village.

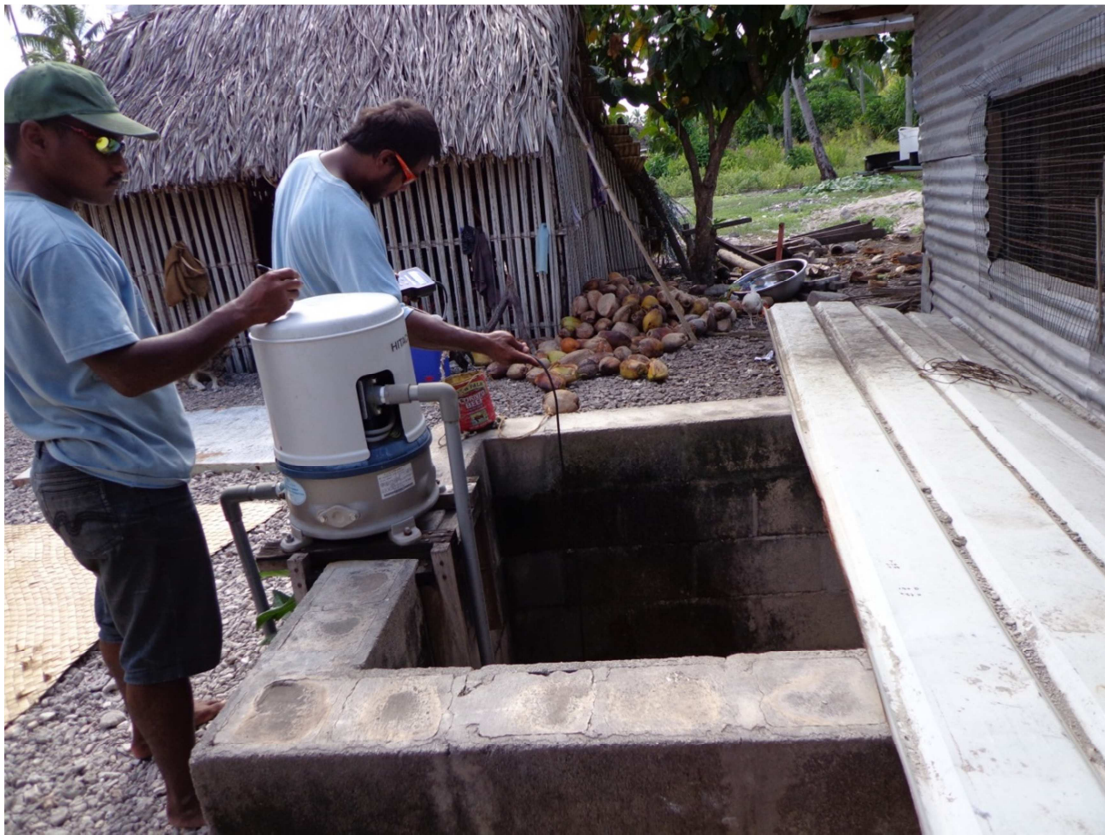
*Figure A11-7. Village workers assessing water salinity level using an EC meter.*

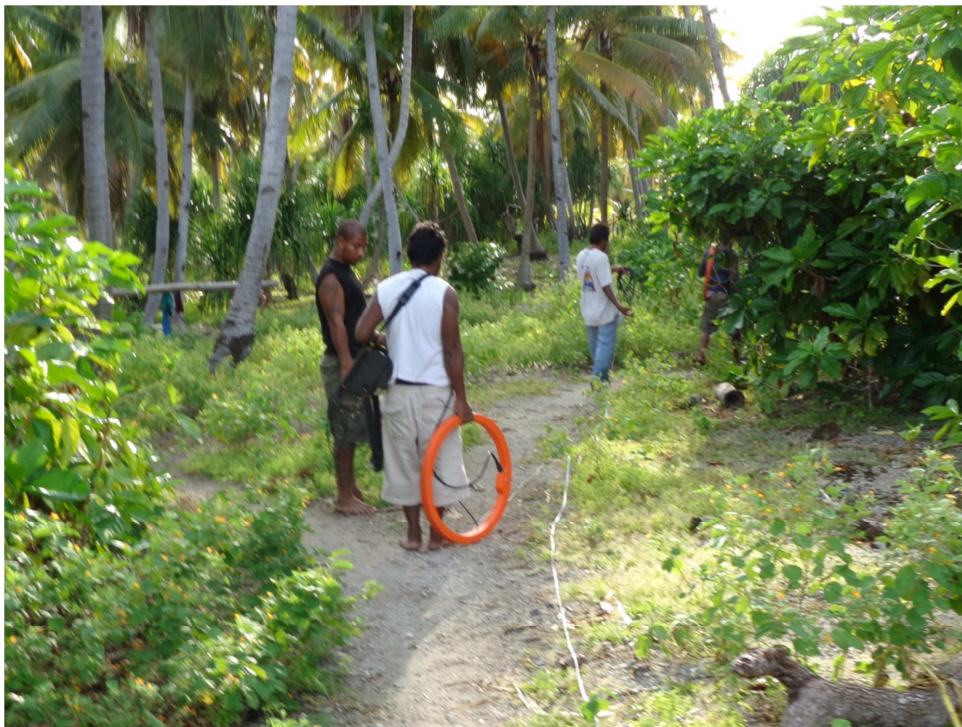
**Figure A11-9.** EM34 survey team working around Nikumanu Village.

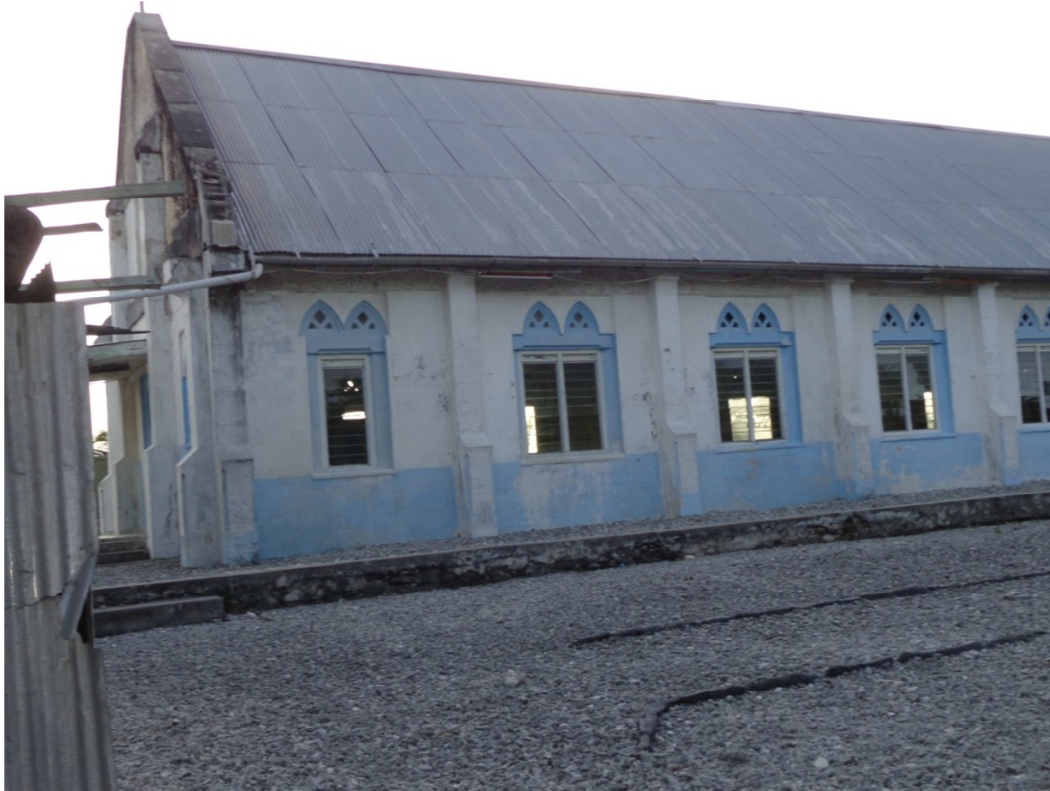
*Figure A11-10. KPC Church in Nikumanu, a potential rainwater harvesting site for the village.*

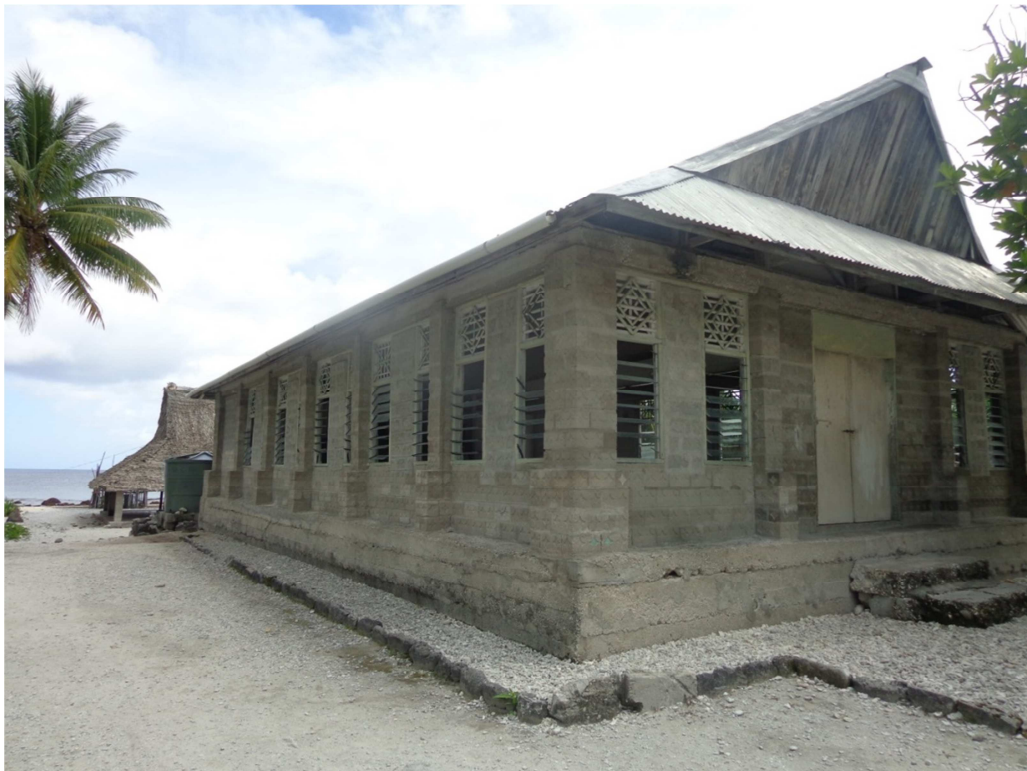
*Figure A11-11. Catholic Church in Nikumanu, a potential rainwater harvesting site for the village.*

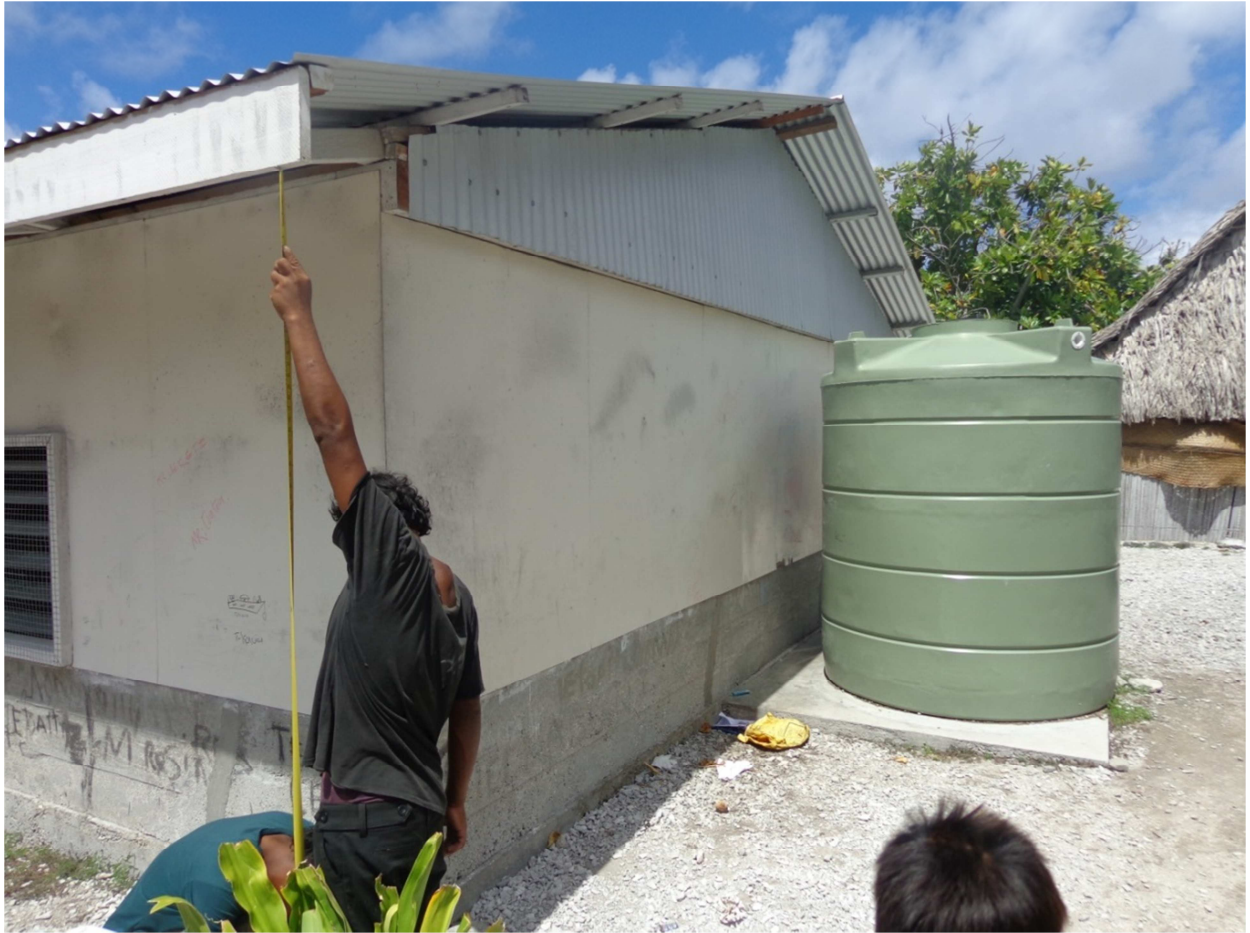
*Figure A11-12. Survey team measuring the roof height of a private building in Rungata Village.*
