# EVALUATION OF THE IMPACTS OF HARBOUR ENGINEERING

## ANIBARE BAY REPUBLIC OF NAURU (RON)

May 2001

SOPAC Technical Report 316

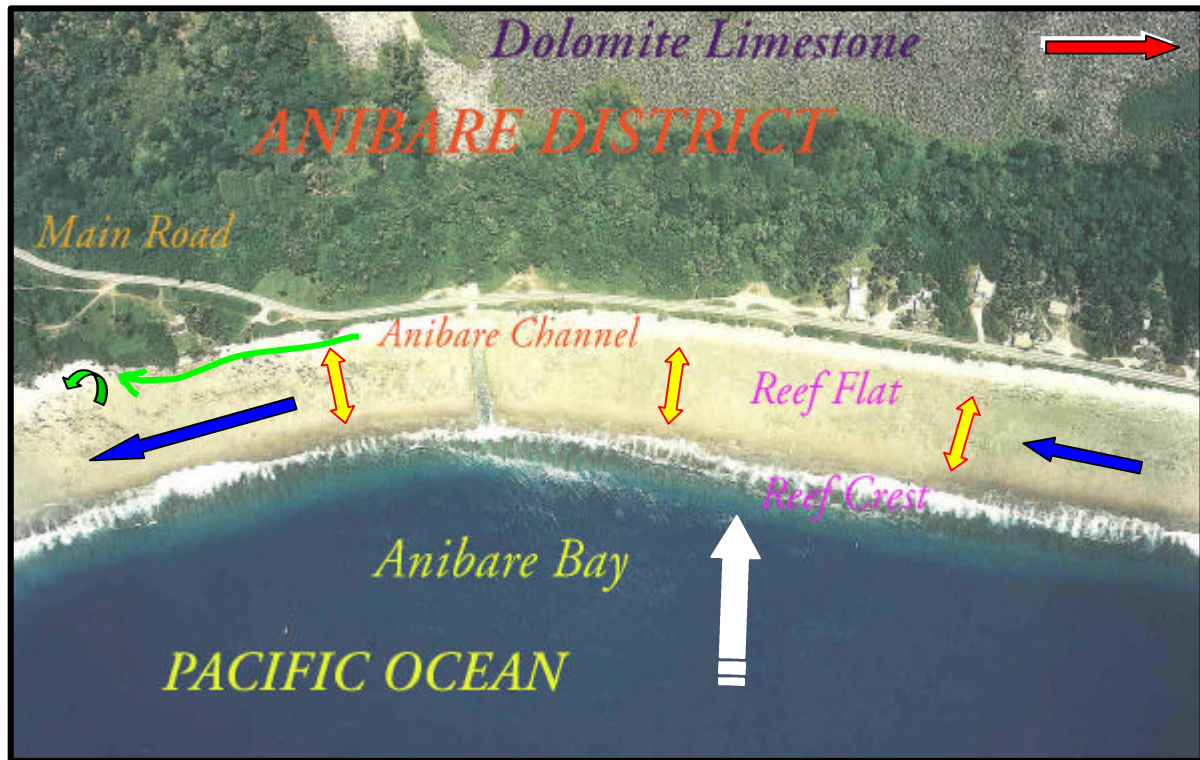
Figure 4. Anibare Bay and the Anibare Channel. This image is part of a 1992, 1:10,000, vertical stereopair collection, taken for topographic mapping of Nauru. This photo is supplied courtesy of Nauru Phosphate Co-operation. Green arrows show shoreline scouring/erosion path created by longshore currents; blue depict the dominant Southerly longshore currents; yellow arrows show swash/wave approach in backreef and gravity-induced backwash; and the white arrow show modal offshore wave approach. The red arrow at the top right points to North.

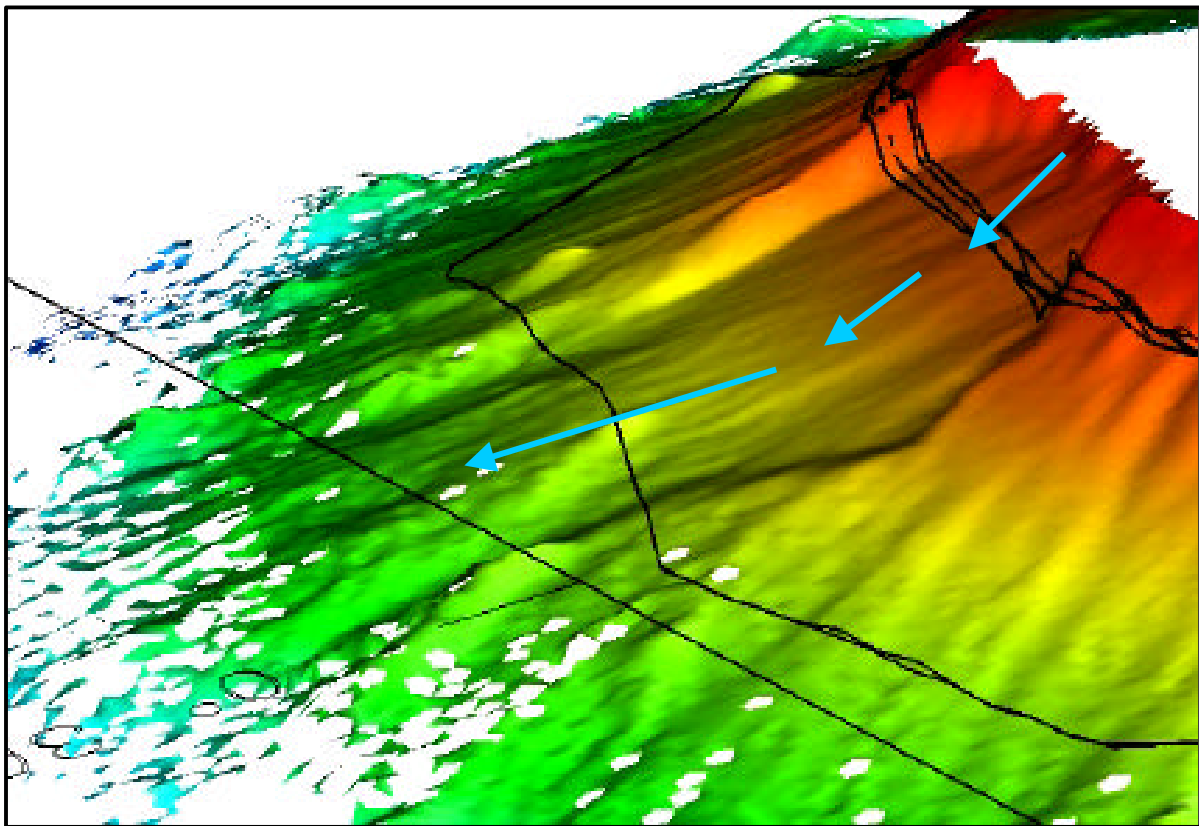
Figure 12. Physiography of the sub-sea landslide which produced Anibare Bay.

The scarp of the landslide has produced the geomorphologic feature, which is now Anibare Bay (Figure 11). The width of the bay corresponds to the maximum width of the main scarp of the submarine landslide. This main scarp is also about 2.5 km wide.

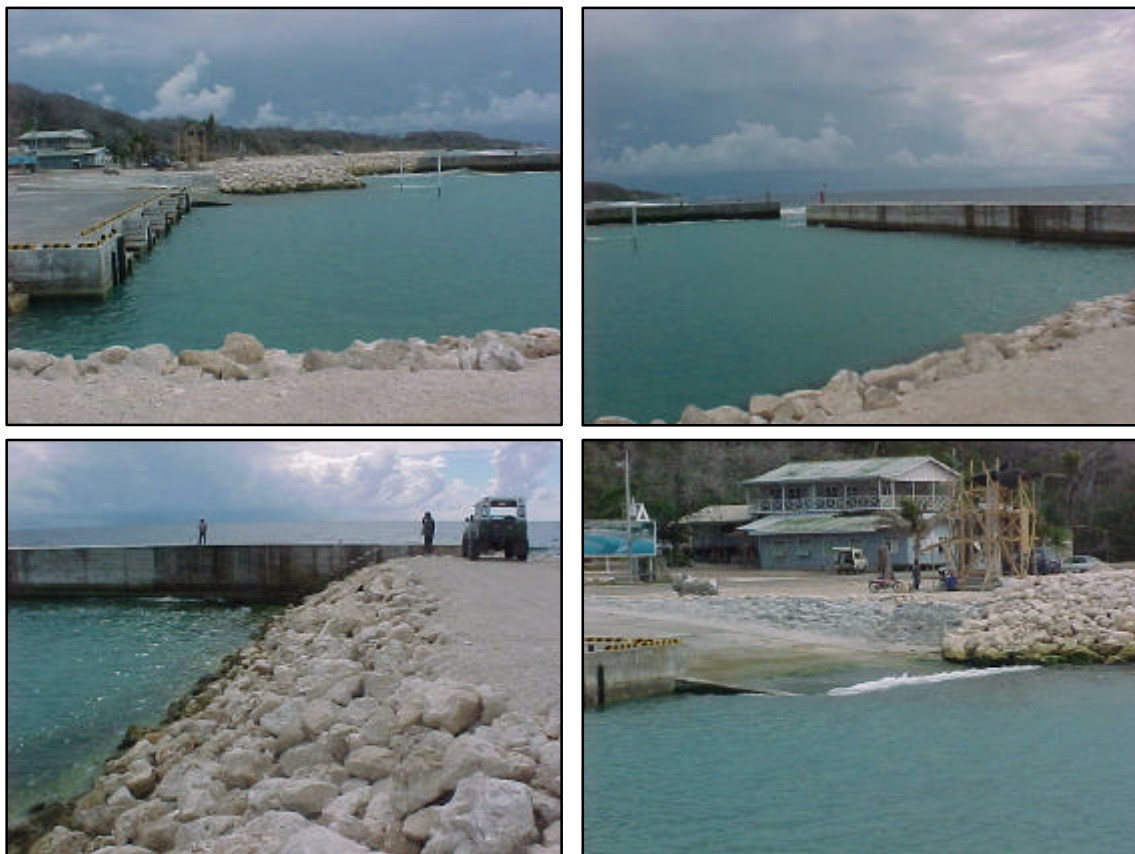
Figure 20. Characteristics of the new harbour facility. Top left – mooring basin/wharf, with quay wall and apron on left of the photo; top right –sub-breakwater and main concrete breakwaters (left and right respectively); lower left – rubble groin, with rip-rap and main concrete breakwater; and lower right – concrete boat ramp, with rip-rap pitched spending slope on the rear right.

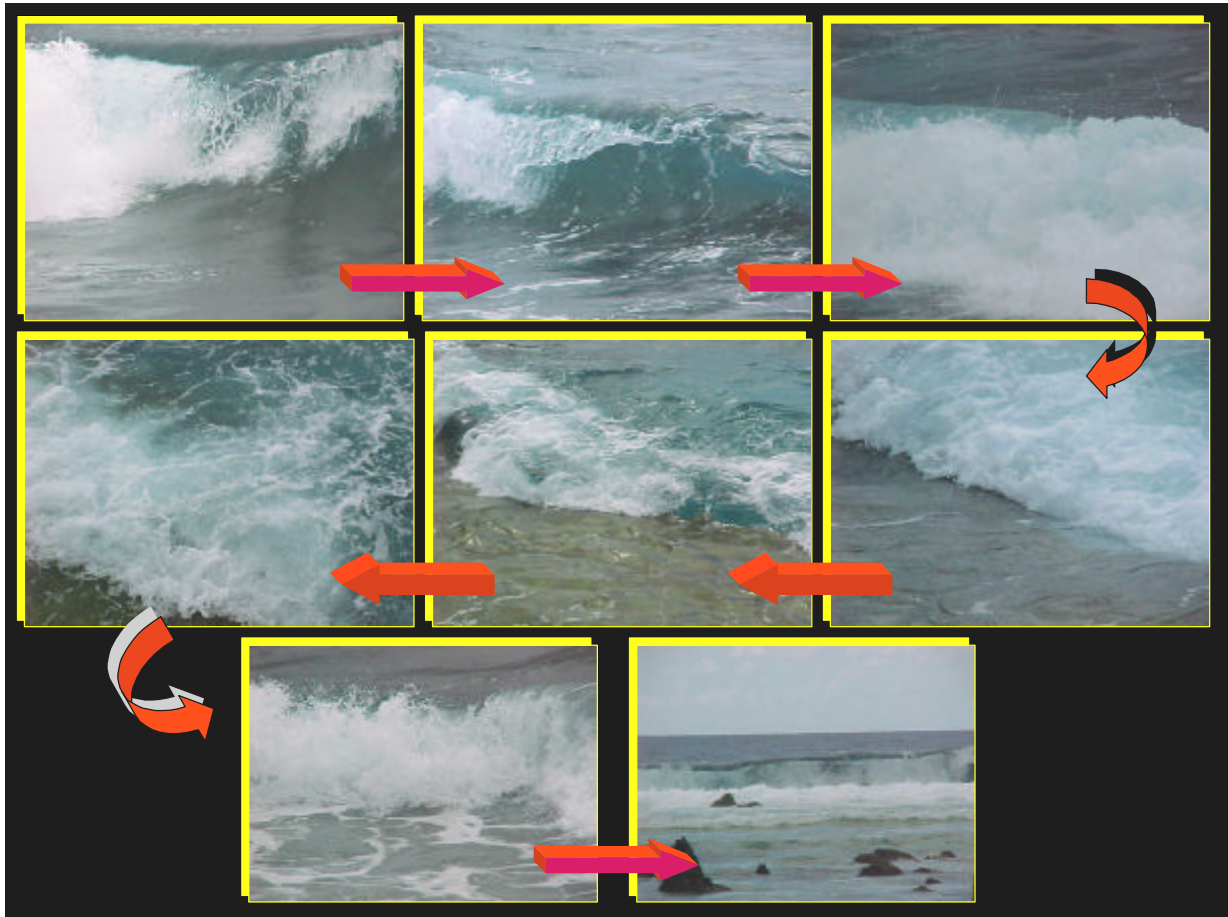
Figure 25. A typical plunging breaker sequence photographed on the East coast of Nauru. The waves shown here were 1.5 m high and broke as plunging breakers, typical for this area. The first photo inclusion show the start of the sequence, while the last shows the beginning of another sequence. When the swash retreats as backwash, almost all the water drains off the backreef platform (middle right inclusion), creating a strong drag effect on the limestone and sediments substrate. This facilitates and leads to amplification of the impact forces of the breaker when it subsequently crashes on the reef crest.

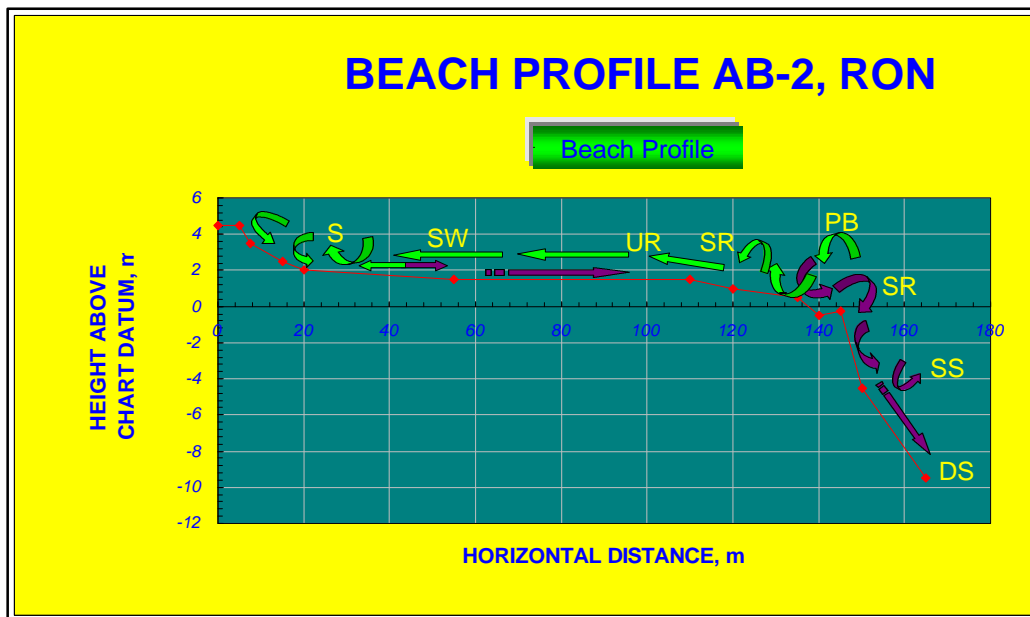
Figure 26. Hydrodynamics of beaches at the harbour site. This is based on an actual beach profile surveyed perpendicular to the coast and along the central part of the harbour development site. Green arrows show the swash sequence, while purple arrows show the backwash sequence. SR – surging (green) and sediment re-suspension (purple); PB - plunging breaker; SW - swash; S-scouring; SS - sediment suspension and DS - deep sea deposition.
