**SURVEY OF CYCLONE OFA DAMAGE
TO THE NORTHERN COAST OF UPOLU,
WESTERN SAMOA**

by
Douglas M. Rearic*
Techsec

Prepared for: South Pacific Applied Geoscience Commission (SOPAC)
Western Samoa Project: WS.13

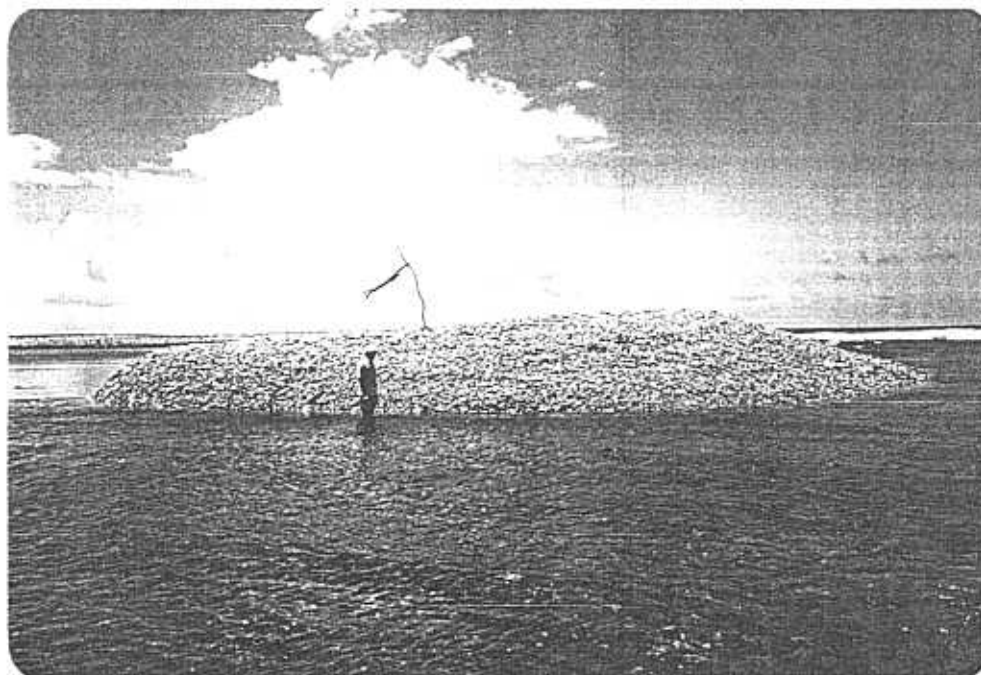
A cyclone bank at Laulii Village (Figures 34-37) lies close to the coast because the reef in this area is also near the coastline. The bank exhibits many of the characteristics of large sand bars and barrier islands, although formed of very coarse material. This bank is steep on the shoreward side, laying at an angle of repose of about 40° from the horizontal (Figure 36). On the seaward side the slope is about half that of the shoreward side, or about 20°. The profile of this feature is that of a sand wave formed by normal current activity, high at the "updrift" edge and gently sloping to the "downdrift" side until the shoreward edge is reached (Figure 35). The bank is 2-3 metres high, 15 metres wide, and about 250 metres long (dimensions approximate). The bank remains above water at even the highest tides. The bank is being reworked by wave action at a slow rate and the material composing the bank will probably be spread over the inner reef area over time.

Figure 34. Cyclone banks were formed by coral rubble dredged from the front of the reefs along the coast of northern Upolu. The banks tend to be curved and possess many of the attributes of sand bars and barrier islands found in other areas of the Pacific.

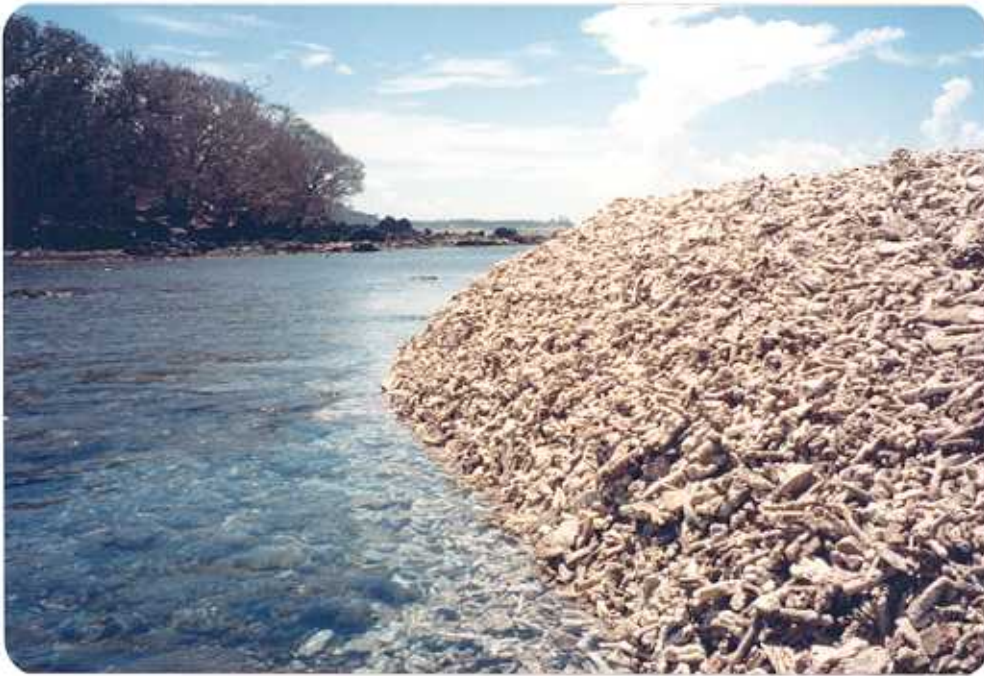
Figure 35. The cyclone banks are 2-3 metres in height and vary considerably in length and width. Some are found near the coast such as this one at Laulii Village whereas others are situated further offshore.

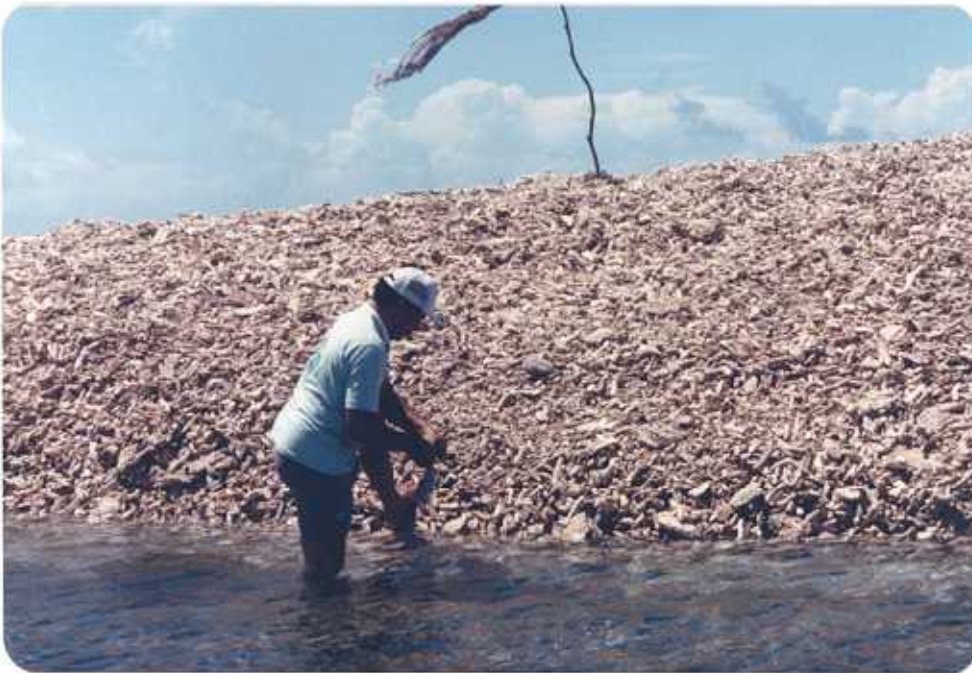
Figure 36. The cyclone banks are steep on the shoreward sides and have a gentler slope on the seaward facing side. In this photograph the coarseness of the material forming the bank can be seen.

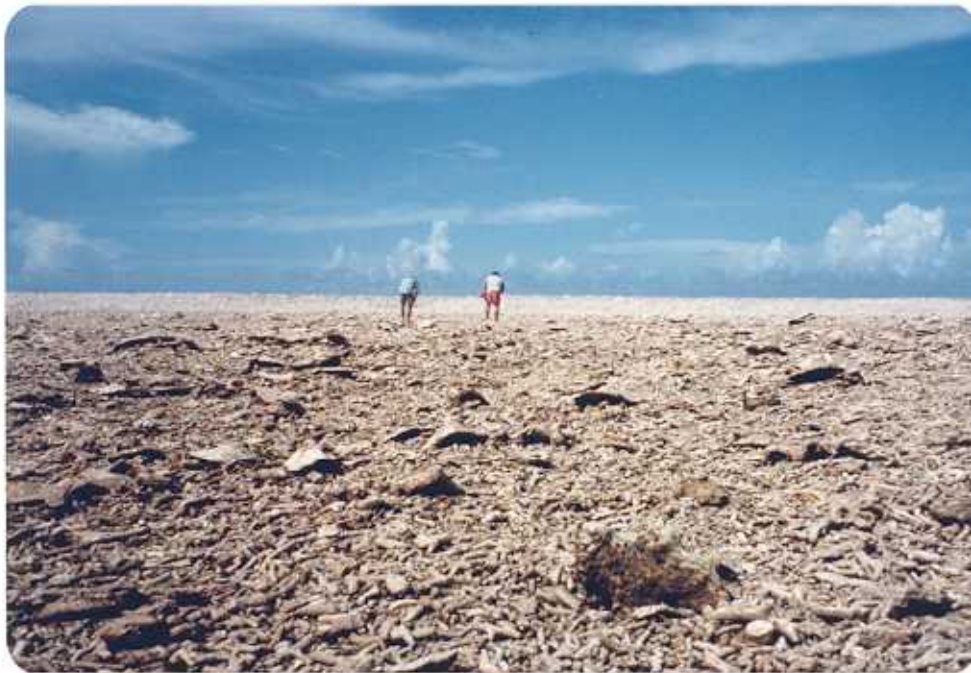
At the edge of the reef, just seaward of the Apia Observatory, lies a very large cyclone bank the survey party has named Observatory Bank (Figures 38 and 39). This bank is now being reworked by normal wave activity, particularly during high tides, and the shape is gradually changing from the original depositional form. The survey party walked most of the length of this bank, taking photographs and collecting selected samples (Figure 40). This bank is over 2 kilometres long, over 50 metres wide in places, and of similar height to that of the bank at Laulii Village. During high tide portions of the bank are under water and the bank then appears as 5 separate banks (Figure 41). The surface of the bank contains depositional features similar in appearance to other submarine and eolian bedforms formed in finer grained materials. The seaward edge of the bank now has a high tide berm formed by the reworking of waves (Figure 38). At one location, a crescentic dune of coarse material overlies a base of similar material except for a greater proportion of sand in the base. The slight difference in sorting is evident in the appearance of the two materials, however the size of sample required to document this precluded collection. The dune is considered to have formed by a separate

Figure 38. Observatory Bank, formed at the reef edge off Mulinu'u Peninsula is a large bank now being reworked by waves during high tides. A high tide berm can be seen in this photograph.
