EU EDF8-SOPAC Project Report 75  
Reducing Vulnerability of Pacific ACP States

## **TUVALU TECHNICAL REPORT**

### **ASSESSMENT OF SALINITY OF GROUNDWATER IN SWAMP TARO (*CYRTOSPERMA CHAMISSONIS*) "PULAKA" PITS IN TUVALU**

**March 2007**

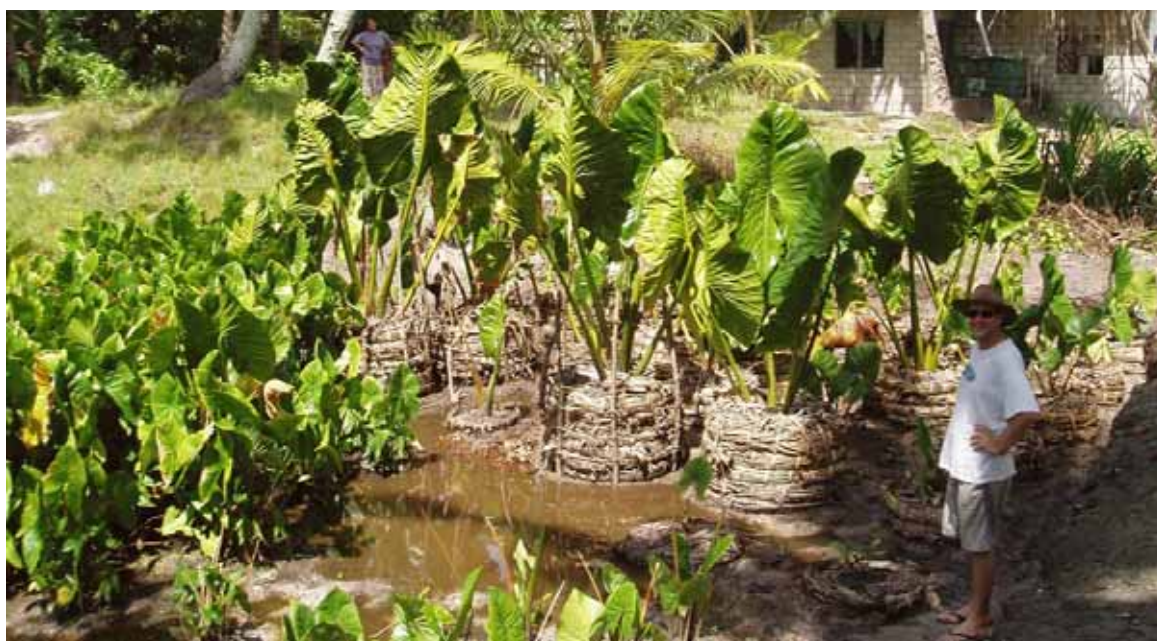
Figure 1. A typical healthy swamp taro pit. This pit is actually located on Tarawa Atoll, Kiribati however, Tuvaluan cultivation practices and varieties are very similar. Note the free standing water indicating the base of this pit is roughly equivalent to the upper surface of the fresh groundwater lens. The two commonly grown varieties are also evident in this picture; to the left is the smaller (*Ikamava* or *Kasusu*) variety; and to the right is the slower-growing much larger (*Teikalaoi*) variety. Note the careful attention to traditional composting techniques on the larger plants (woven pandanus leaf baskets), these may be cultivated for between 5 and 10 years before harvest. Alternatively, the smaller variety may be harvested within 12 months.

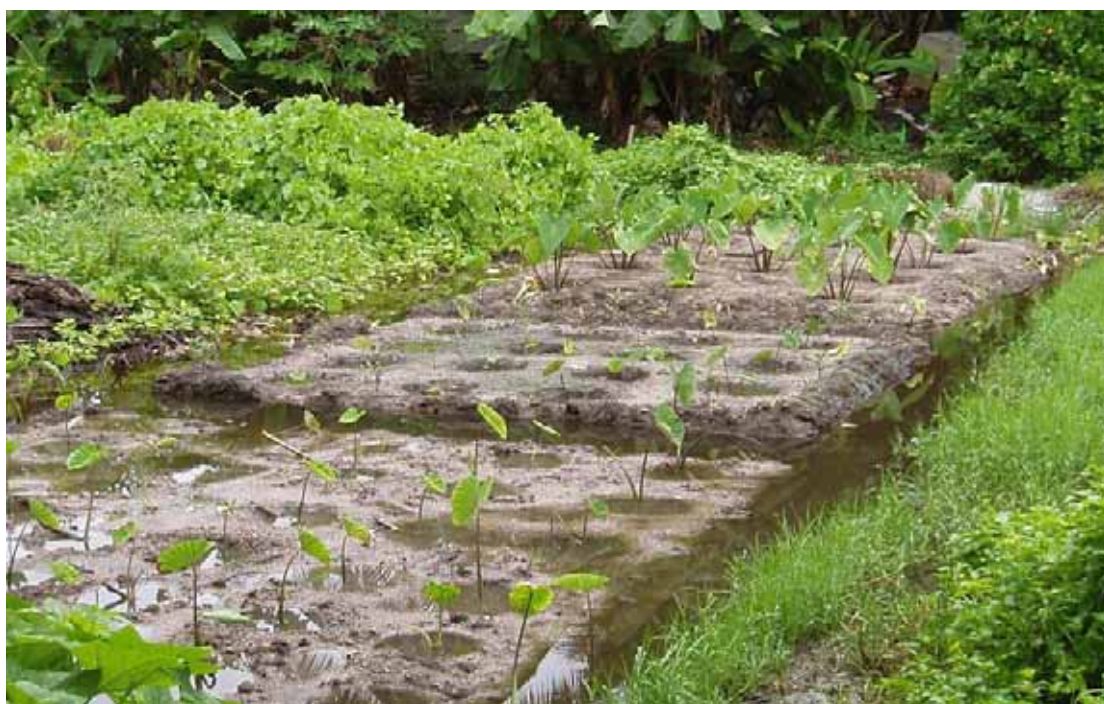
Figure 2. “Dalo” (taro – *Colocasia esculenta*) is currently being grown in this *Fongafale* swamp taro (*Cyrtosperma chamissonis*) pit – it would appear that dalo (*C. esculenta*) has a better tolerance of saline conditions than the swamp taro (e.g. Nyman et al. 1983 and Onwueme 1999). However, dalo is not generally as tolerant of continual water logging and the better health of the plants in the background may be due to the greater elevation of the mounded soil. Average conductivity in this pit, measured in early 2006, was  $4\,493 \pm 1\,203 \mu\text{S cm}^{-1}$ .

Funafuti has ongoing chronic problems with saline incursion in its *Fongafale* pits. This situation appears aggravated during natural high water events but continues as a background problem year round. As such, serious cultivation of swamp taro on *Fongafale* is no longer really practised. During the author's 2005 visit a similar, but likely more salt tolerant species of taro (*Colocasia esculenta*) was being grown in *Fongafale* (see Figure 2).

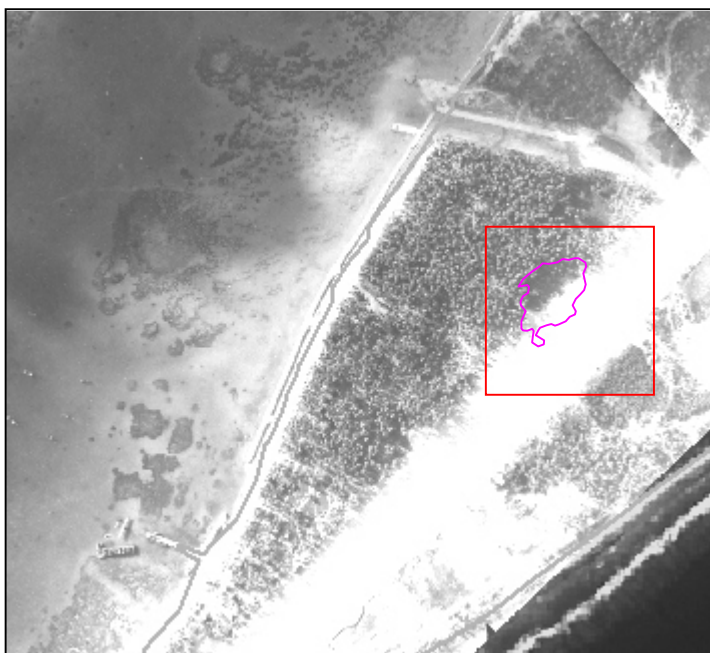
Figure 6. This 1943 aerial photograph shows the same area of Fongafale Islet as Figure 5 and the location of the former swamp taro pit visible in 1941 (purple line). By 1943 approximately 70% of the pit has been filled to allow the completion of the runway. Note also the large clearing and earthworks, north of the pit area and on the southeastern side of the runway. The exact volumes of material shifted, excavated and levelled is unknown however Gibb Australia (1985) estimated over half a million cubic meters of material was required just to fill the borrow pits left by these efforts. Considering Fongafale's meagre land area of 1.43 km<sup>2</sup> (the runway alone accounts for approximately 14% of this surface area) the changes wrought on this landscape cannot be ignored as a likely contributing factor to hydrological change.

There can be no doubts on the massive engineering changes wrought on the *Fongafale* environment by the US Corps of Engineers during 1942-1943 as part of the WWII Pacific Campaign (see comparative figures 5 and 6). The legacy of coastal instability, vast open borrow pits which line the island and the runway which covers a large portion of *Fongafale* are all testament to these unimaginably large changes on this small and extremely fragile atoll environment (McQuarrie 1994; Webb, 2006).

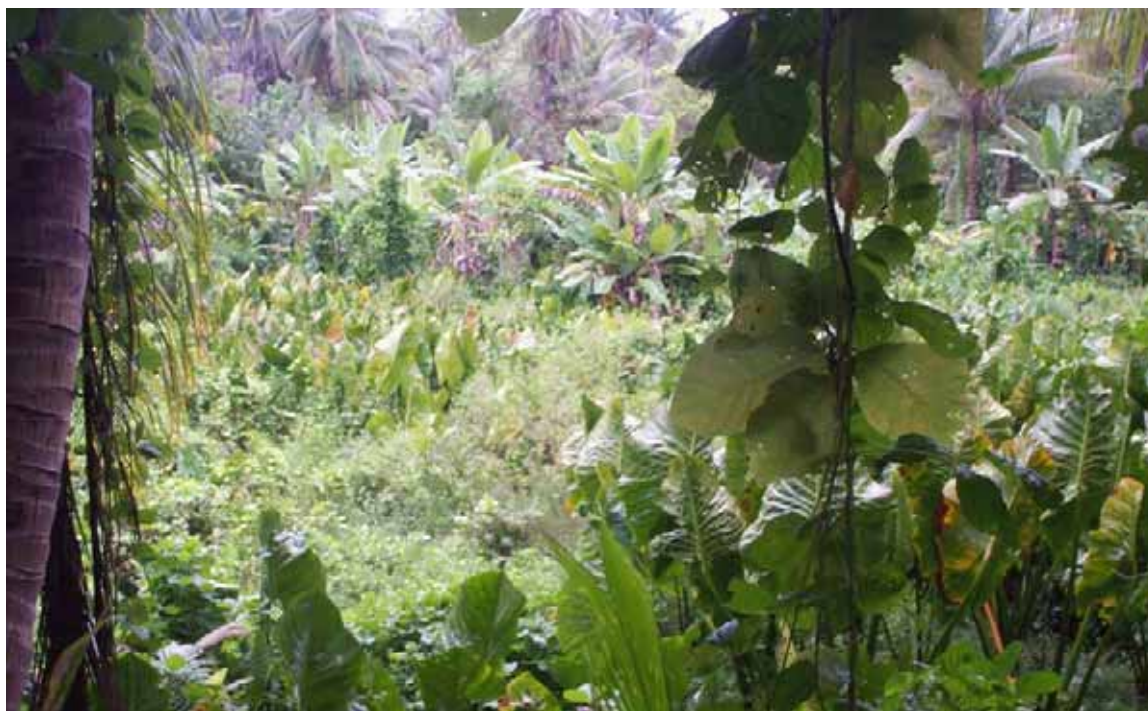
Figure 7. This large pit in Vaitupu is a good example of how habits of swamp taro cultivation are changing. Whilst certainly not representative of all pits, this photo does however make the point that some pits are adequate in terms of water quality but are no longer intensively cultivated (note dense weed infestation and the lack of evidence of traditional composting techniques, etc.).

A further point of interest related more to the outer islands of Tuvalu, were observations of current cultivation practices and activity in swamp taro pits. The cultivation of swamp taro is a hugely laborious and time-consuming task and soil quality and nutritional conditions are only maintained if continual effort is expended carrying out traditional composting and cultivation techniques. A number of observations regarding pit use in various areas suggest that some pits were no longer intensively cultivated despite having acceptable conductivity ranges. Importantly, we need to understand that declining swamp taro production may also be related to life style changes (i.e. declining interest in swamp taro cultivation) and that production may also be negatively impacted by a reduction in cultivation effort; i.e. the improved soil conditions within swamp taro pits are to
