# KIRIWATSAN Water Resources Assessment Nikunau Island, Kiribati

## Water Resources Assessment

### NIKUNAU ISLAND, KIRIBATI

April 2015

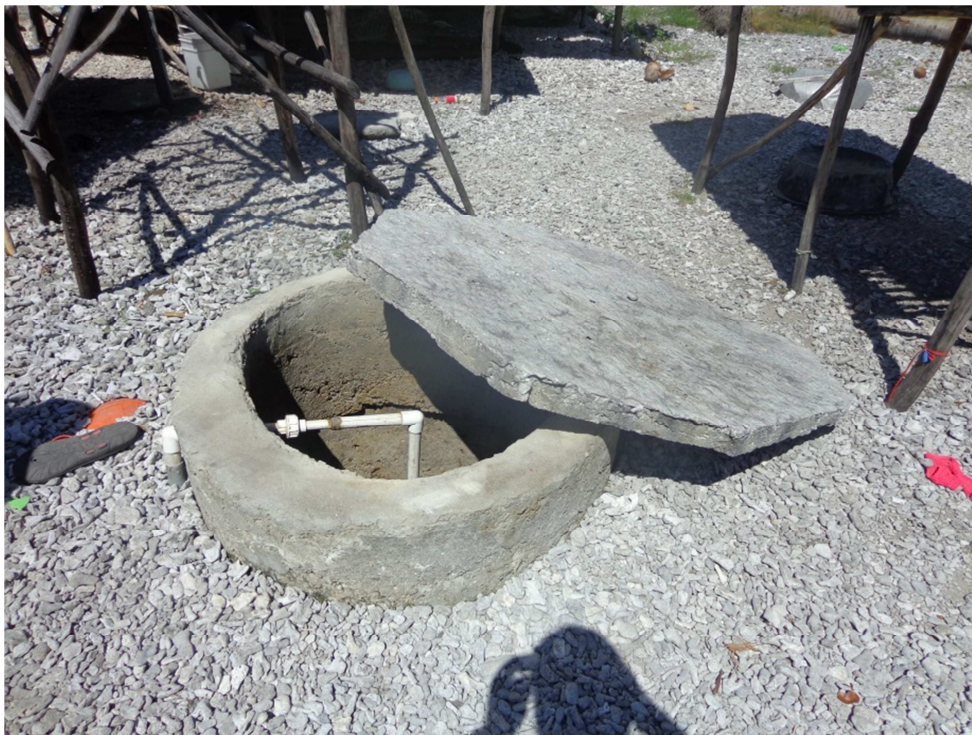
**Figure A11-3. Tamana pump used in a household well in Muribenua.**
